# AN APPLE STORE AT TYPICCA FARM, DRYSLWYN

## STANDING BUILDING SURVEY APRIL 2009

Report No. 2009/52

### AN APPLE STORE AT TY PICCA FARM, DRYSLWYN STANDING BUILDING SURVEY

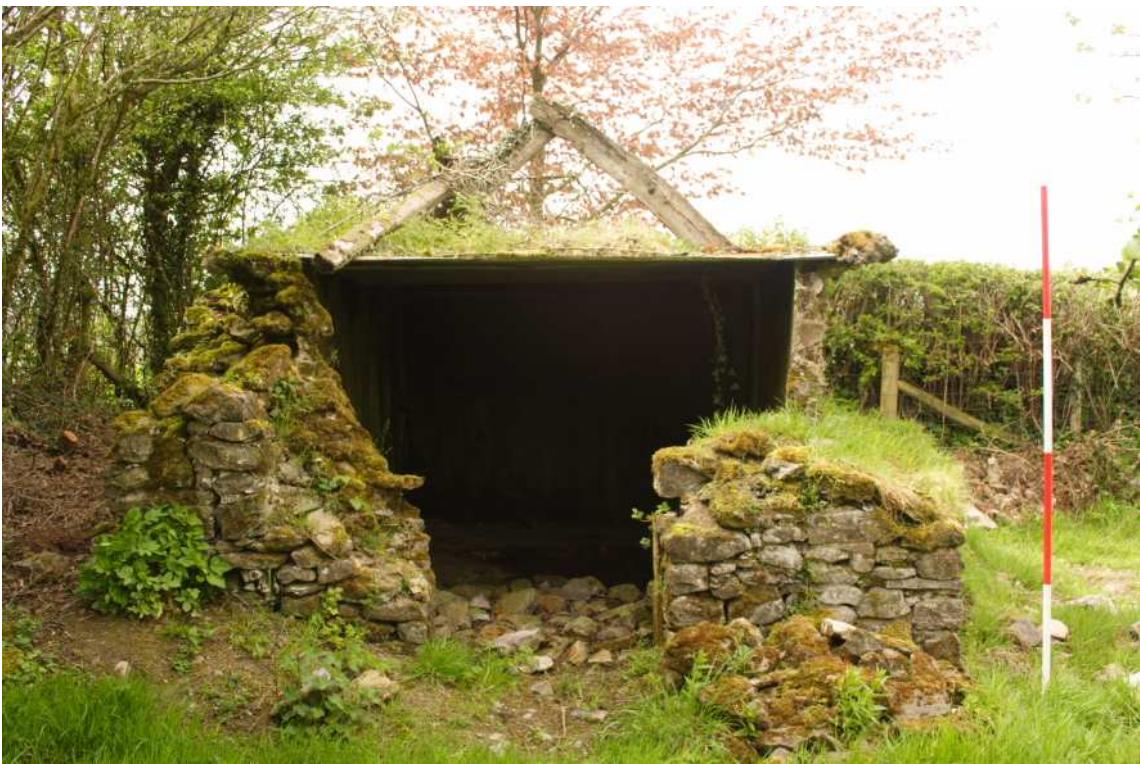
**Photo 2:** Front external east-facing elevation

The front elevation is entirely of stone rubble construction, bonded with a lime mortar. The ruinous walls today stand to a reduced height. Possible straight joints suggest that the opening once spanned the full width of the interior before it was narrowed to form a standard width doorway. The interior is concrete rendered internally. An imprint of a former doorjamb is evident in the edge of the concrete wall render.

- The removal of any fabric should be overseen by an archaeological watching brief to record additional historic or archaeological features or information relating to its construction.
- Excavating a small area around the modified east side of the building should be considered in order to better establish the extent of the modifications (eg. whether this elevation had rounded corners like those found to the rear).

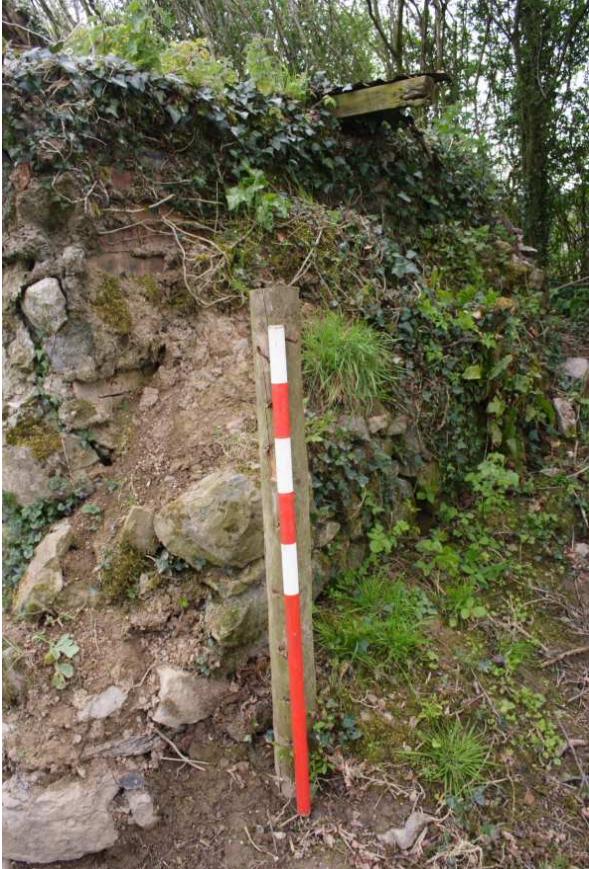
**Photo 3:** Rear external west-facing elevation. Facing south-east

The rear elevation is of stone construction to a height of approximately 0.9m with a clom superstructure. As in other areas this wall height is now diminished since the action of water has led to slumping of the earth walling.

A red brick, single skin wall has been built on the inside of the stone and clom wall which has a few Caernarfon slates on edge between the brick and earth, possibly remnants of former slate hanging. The brick wall is rendered internally.

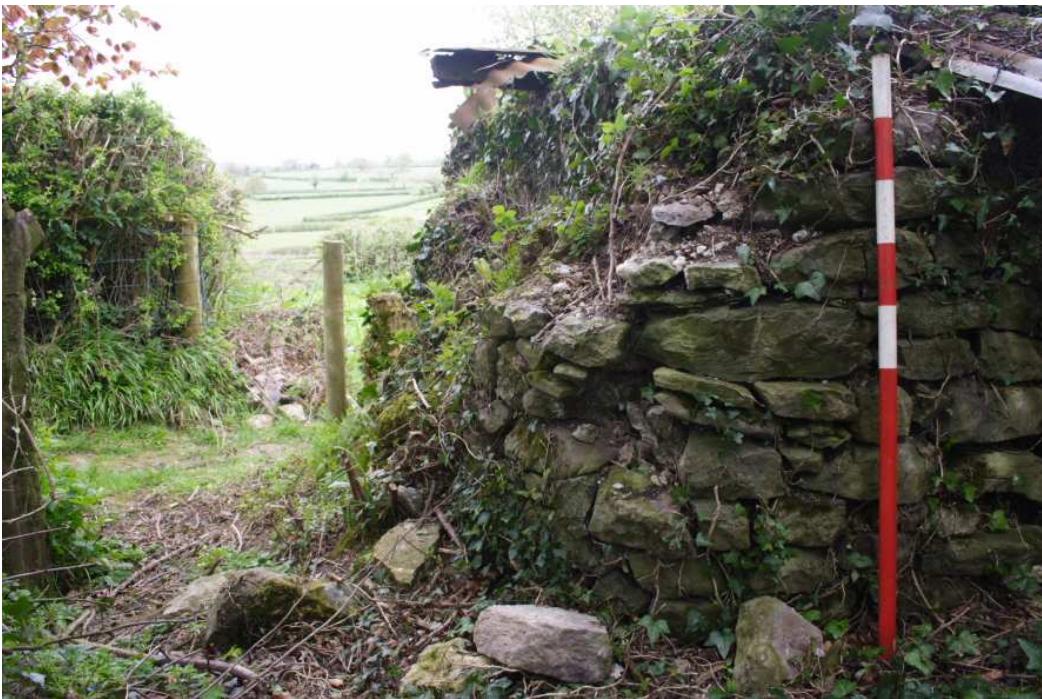
**Photo 5:** Rear external west-facing elevation (looking north)

The arrangement changes towards the south end of the elevation where stone replaces clom in the upper wall courses. The stone walling survives to eaves height.

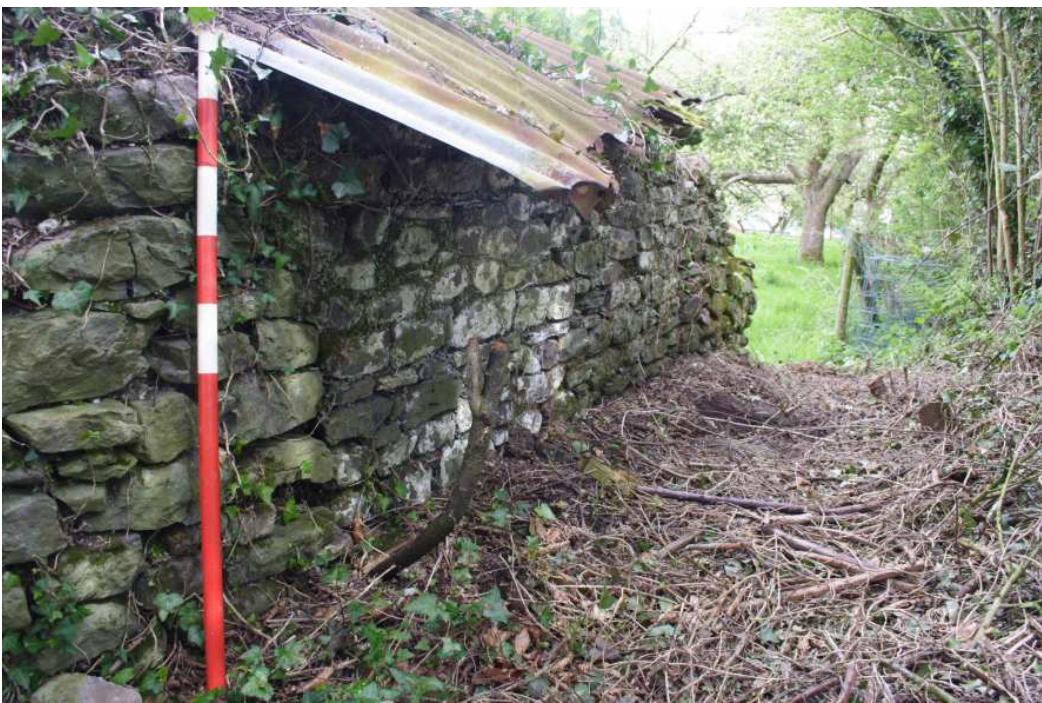
**Photo 6:** External south facing elevation (looking east)

This elevation still stands to eaves height. It is entirely of stone construction and shows evidence of having been substantially rebuilt. Ragged joints visible externally identify the extent of the rebuilding which encompasses the middle section of the wall. The rubble stone coursing which characterises other parts of the building is here replaced by stone brought to rough courses. Occasional bricks within the wall structure suggest a later 19<sup>th</sup>/ early 20<sup>th</sup> century date for this repair. Limewash traces on the masonry suggest reuse. A concrete wall render obscures the internal elevation of the wall.

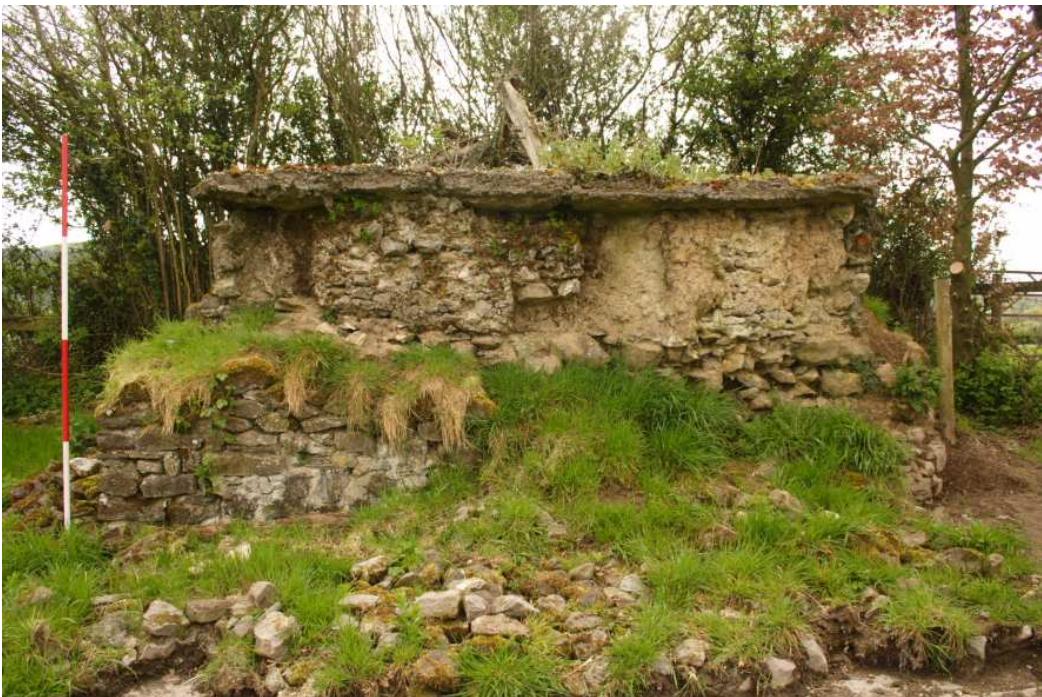
**Photo 7:** External north facing elevation

The north side wall is the most complicated elevation, showing evidence of several phases of alteration and rebuilding. This wall still stands predominantly to eaves height, although the external wall face has since weathered away leaving only the wall core visible. The wall has a rubble stone base, originally with a clom superstructure which appears to have been latterly repaired with lime mortar and stone. The central portion of the elevation had a square window which was later blocked with stone and lime mortar. The wooden lintel partially survives, otherwise visible in relief against the internal concrete render. There are no other clearly discernible openings visible.

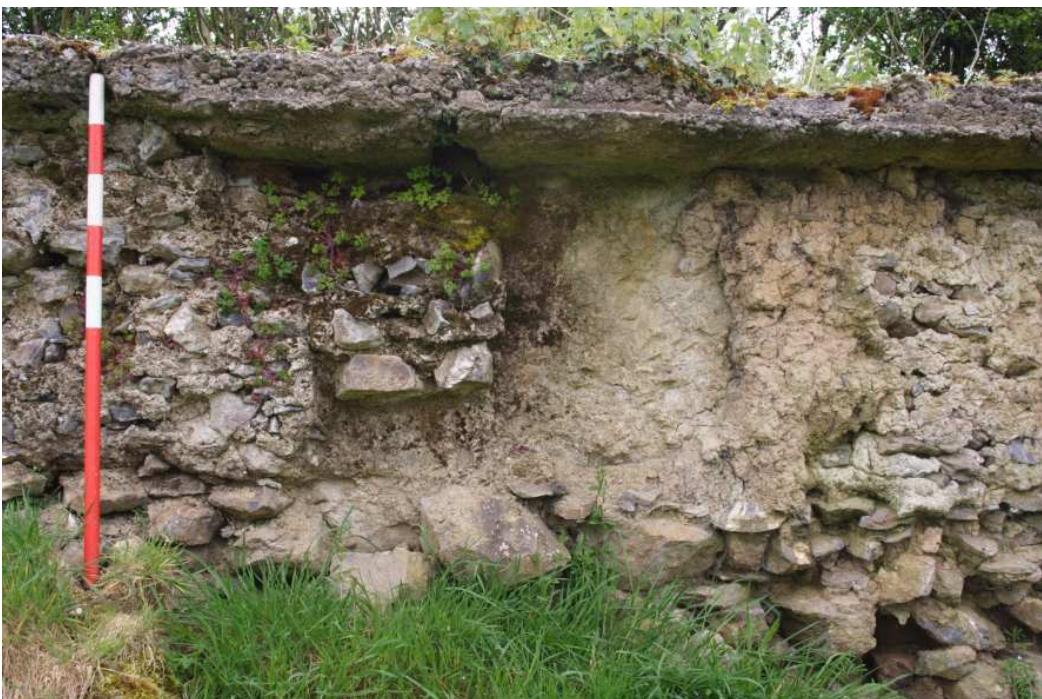
So what of the example at Ty Picca? It is clear that at least two of the walls would have been clom construction although later repairs have since removed or obscured the original material in other areas making further interpretation problematical. The building once had a window in the north wall although this has since been blocked and it would appear that the east facing front wall has been altered over the years.

**Photo 8:** Detail showing blocked window (external north facing elevation).

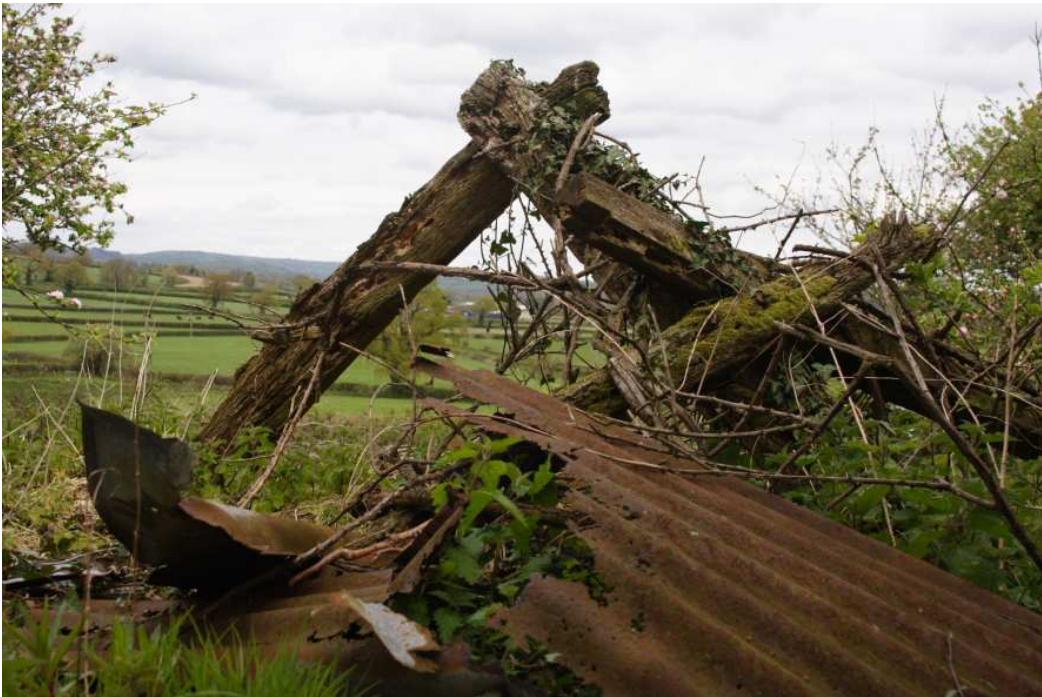
**Photo 9:** Detail of roof truss. Facing north-east.

The original roof structure is today evidenced only by a hardwood A-frame truss, wooden pegged and positioned roughly centrally within the building. The bottom of the roof trusses were set into the wall tops some distance back from the outer wall edge. A tin roof covered the building latterly.

The roof has also been much altered: the central A-frame truss had been removed and reinstated, probably by the end of the 19<sup>th</sup> century following structural repairs whilst the other roof material present today (corrugated tin, machine sawn purlins) is modern. Excavations around the north and west walls uncovered no evidence of the other roofing materials (eg. slate or tile stone) which might commonly be expected to survive had they been used.

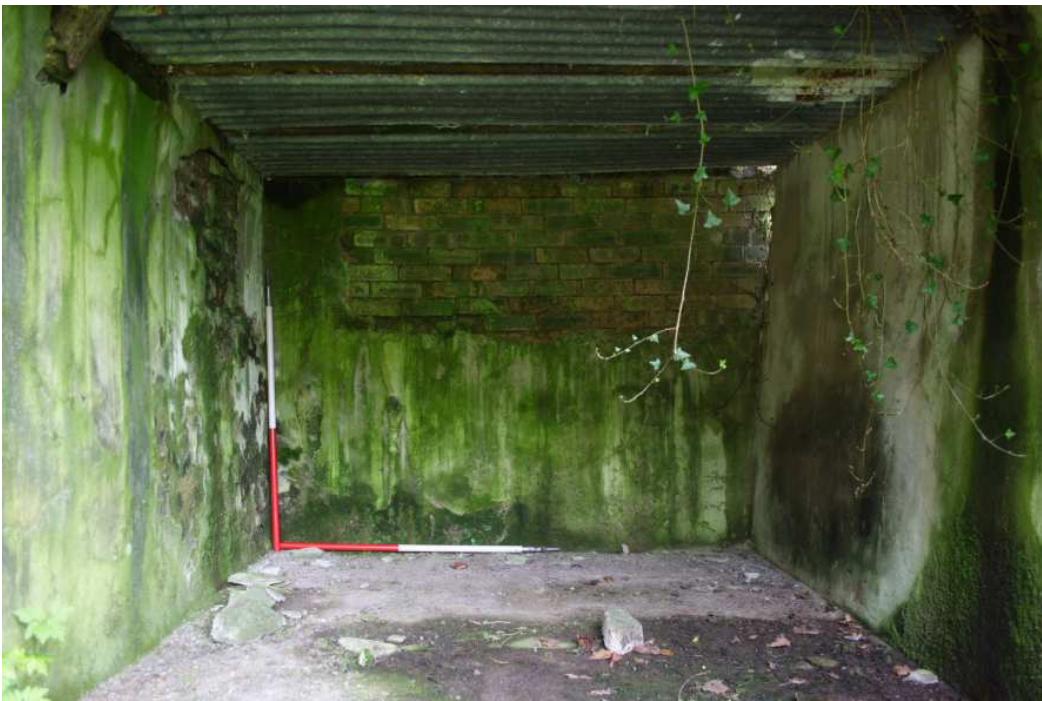
**Photo 10:** Building Interior. Facing west.

All interior elevations of the building are today obscured by a cement render which masks the original wall fabric and features.

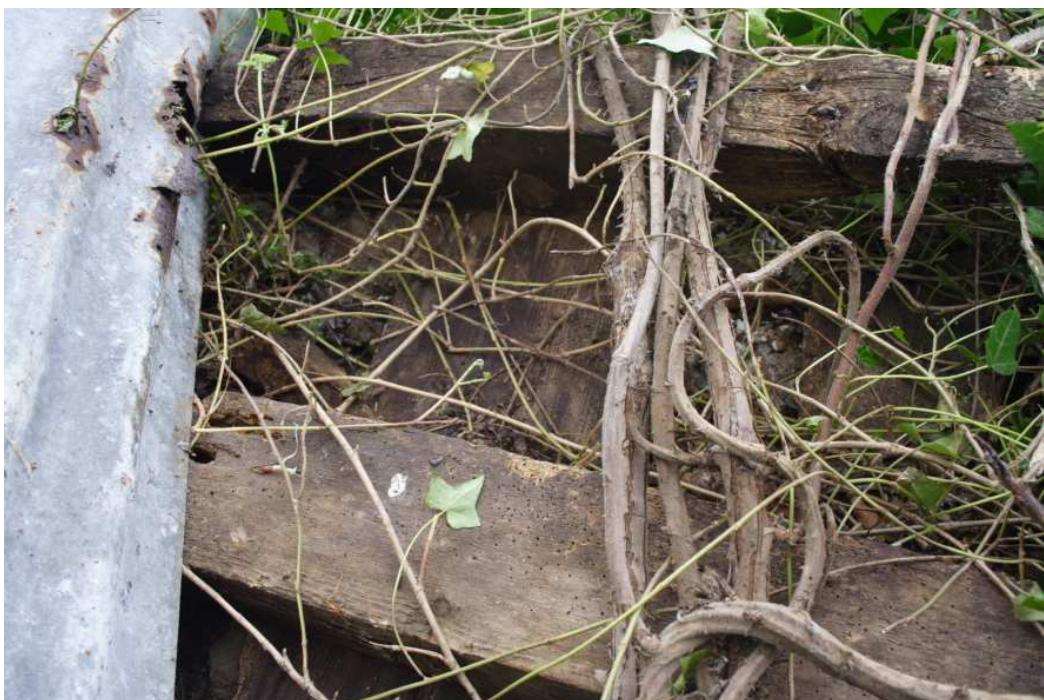
**Photo 12:** Detail of roof structure

Modern repairs have influenced the present appearance, when a red brick single skin wall was built up against the rear (west-facing) wall, a cement render was applied internally and a concrete floor added. Cemented into the wall tops is a flat corrugated iron ceiling. Above this was a corrugated tin roof with narrow deal boards nailed onto the purlins below.
