# EXCAVATIONS AT THE COLD BATH HOUSE DINEFWR PARK

RHIF YR ADRODDIAD / REPORT NO. 2007/74  
RHIF Y PROSIECT / PROJECT RECORD NO. 63189

## EXCAVATIONS AT THE COLD BATH HOUSE DINEFWR PARK 2007

**Duncan Schlee**

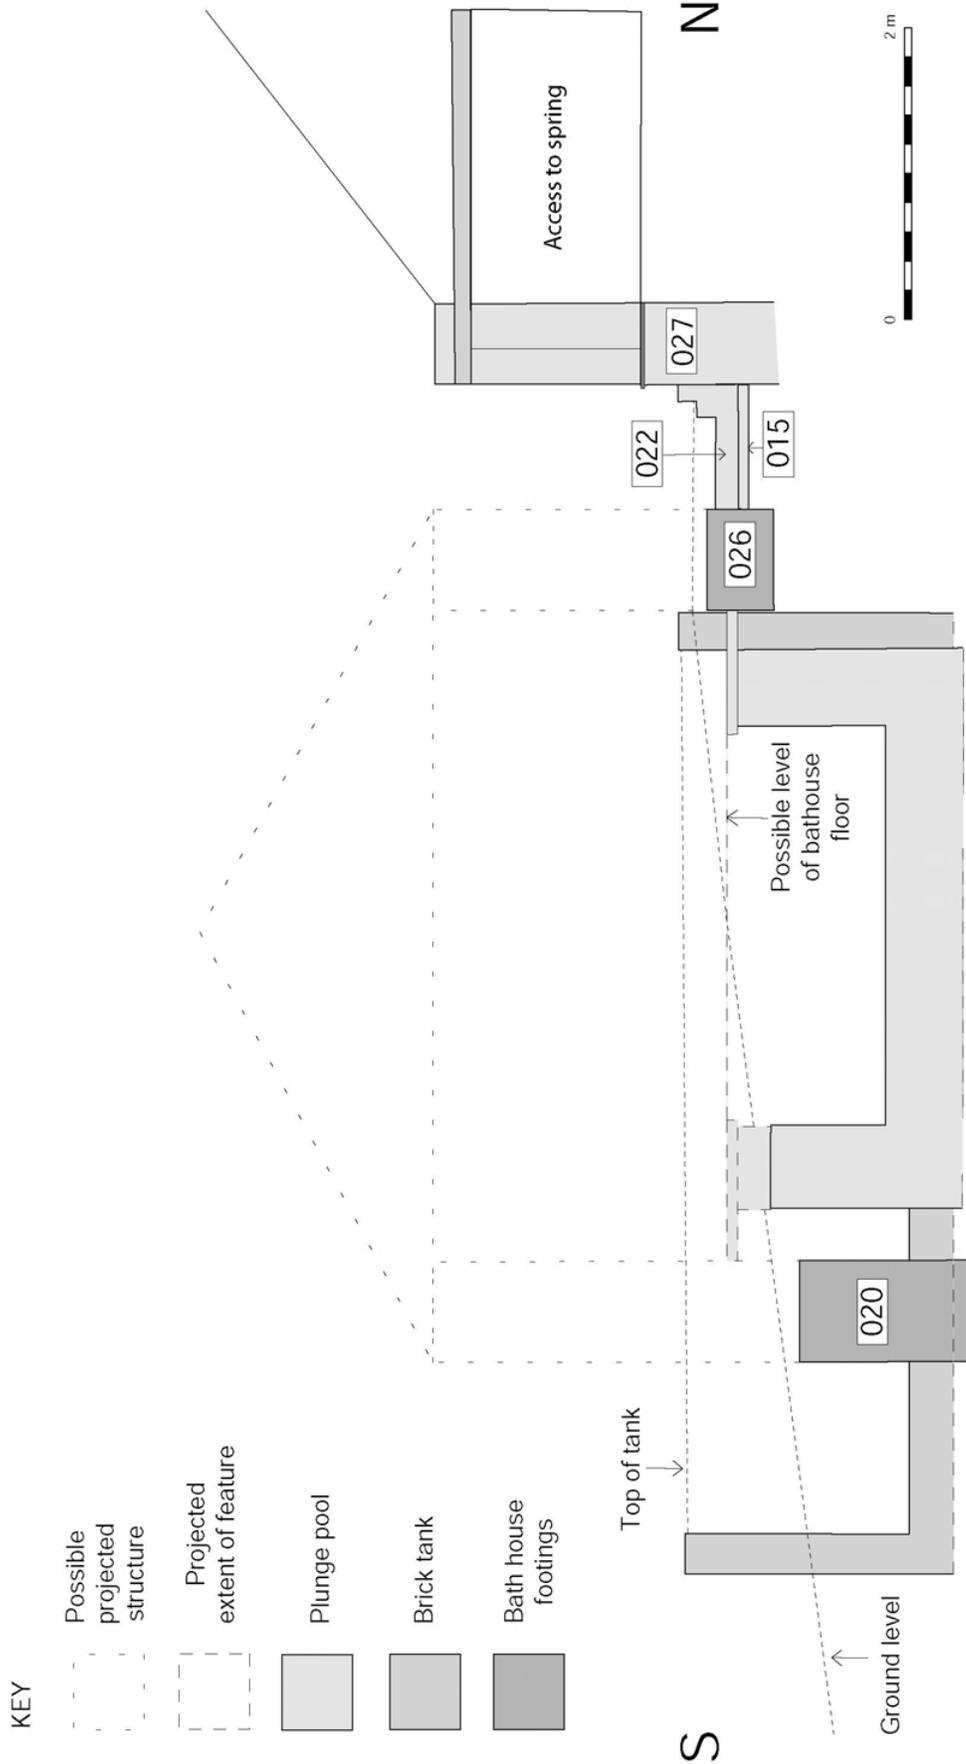
**Figure 2:** Schematic transect through excavated structures

The later red brick tank cuts through the plunge pool and the south wall of the building, but the north and west walls may remain intact. Although not excavated, comparison of the levels of the base of the brick tank and the base of the plunge pool suggests that brick tank has cut through the base of the plunge pool (see figure 2).

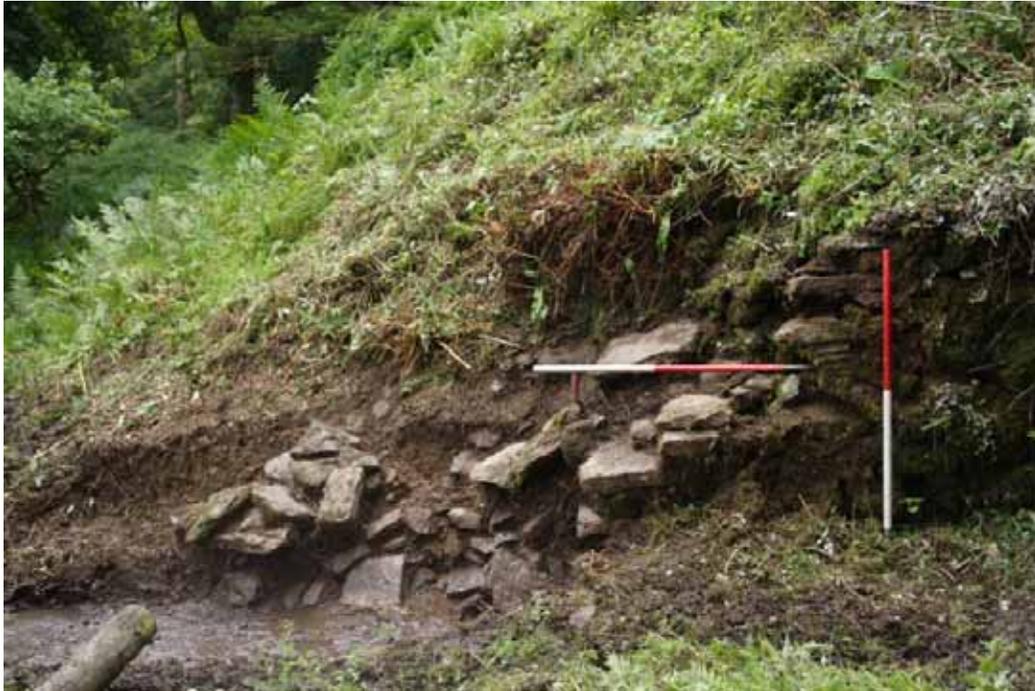
The approximately L-shaped retaining wall cut into the hill slope defines the north and west limits of the site. The western length has collapsed at its southern end, where it has been undermined by the flow of spring water. The wall face shows

evidence of at least one repair (see photo 1). The northern portion of the retaining wall (photos 2,3 and 4) also shows evidence of at least one re-build. The basal 0.60m of the wall is the original construction. The later rebuild is set back from the lower face, forming an irregular ledge or sill.

**Photo 1:** East facing side of retaining wall (collapsed)

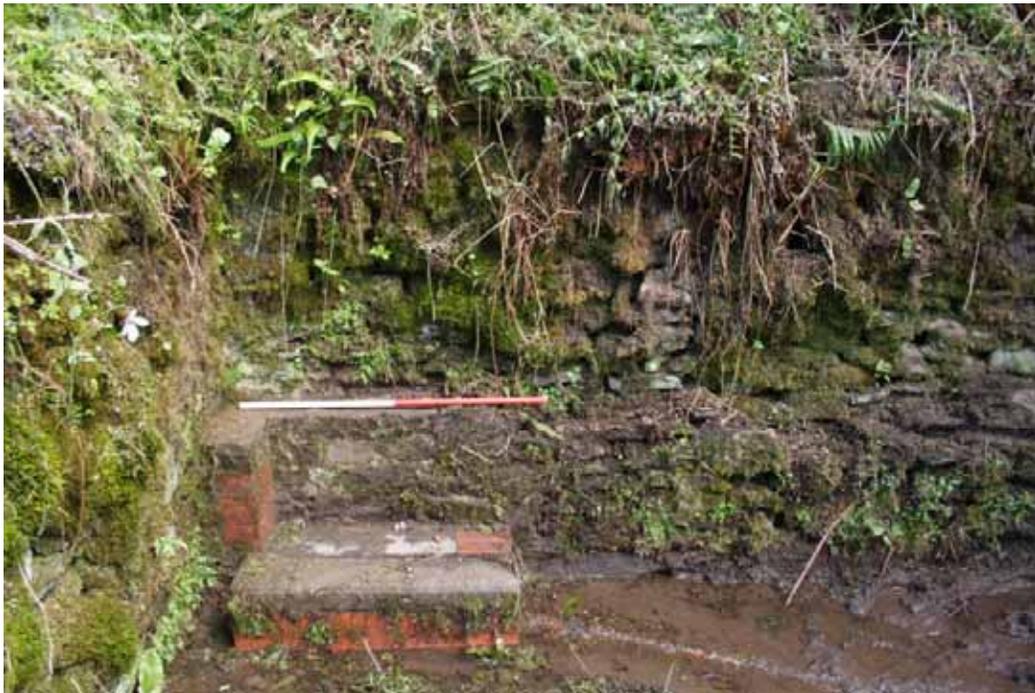
**Photo 2:** West end of south facing retaining wall with later brick and stone water management feature

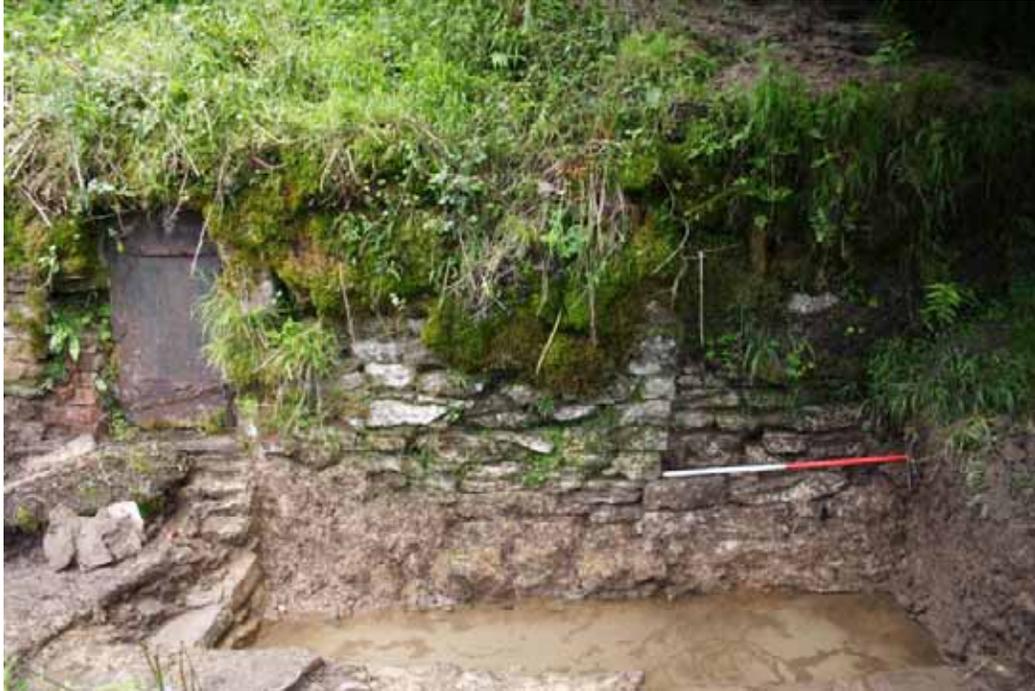
The area between the retaining wall and the brick tank has been covered with concrete, obscuring pipework associated with the brick tank and also obscuring remnants (022) of the connection between the retaining wall and the original plunge pool (photos 3 and 5).

**Photo 3:** South facing retaining wall showing door to spring, and exposed masonry (to left) connecting spring to bath house. Beneath the water is a stone surface

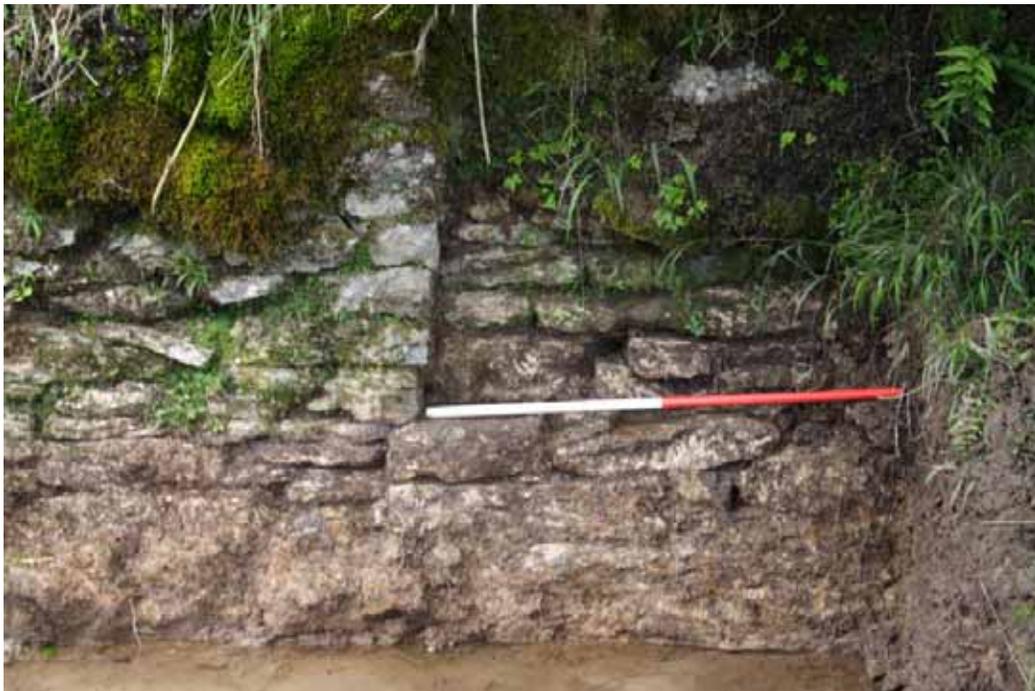
**Photo 4:** Detail of recess/rebuild in retaining wall

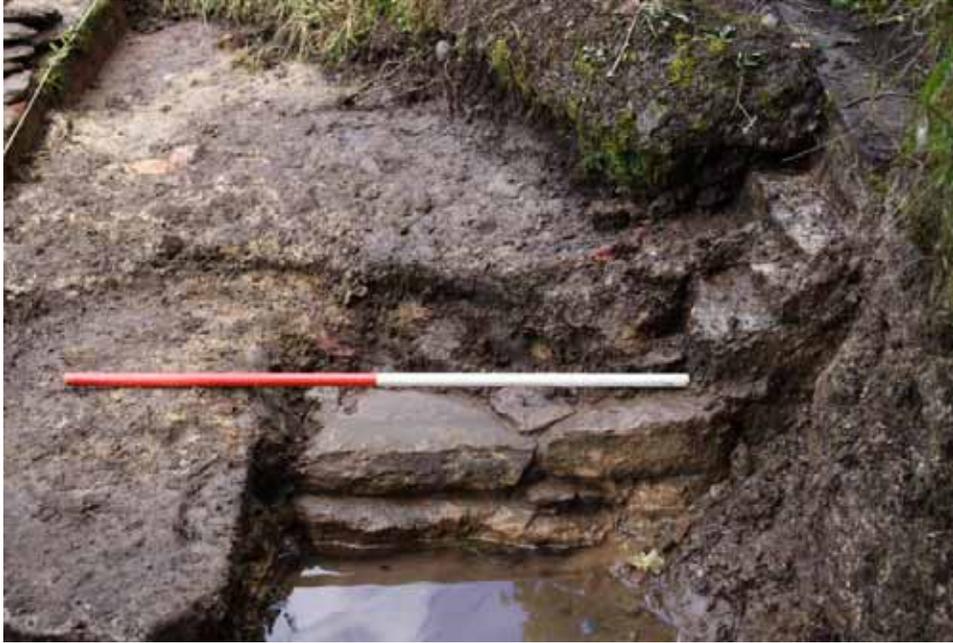
**Photo 5:** Detail of exposed masonry linking the bath house to the spring

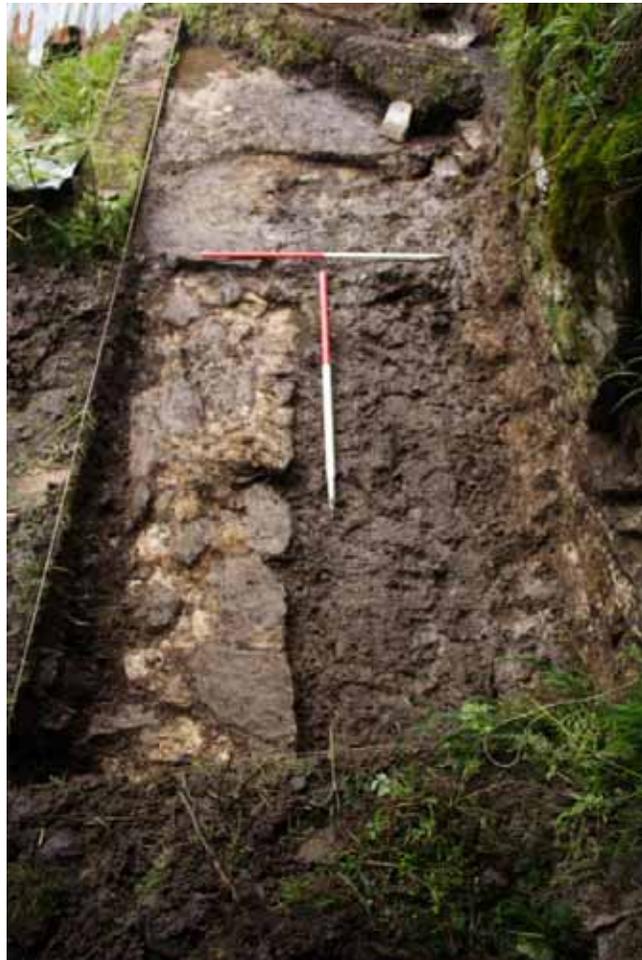
**Photo 6:** The north wall of the bath house (left) looking west

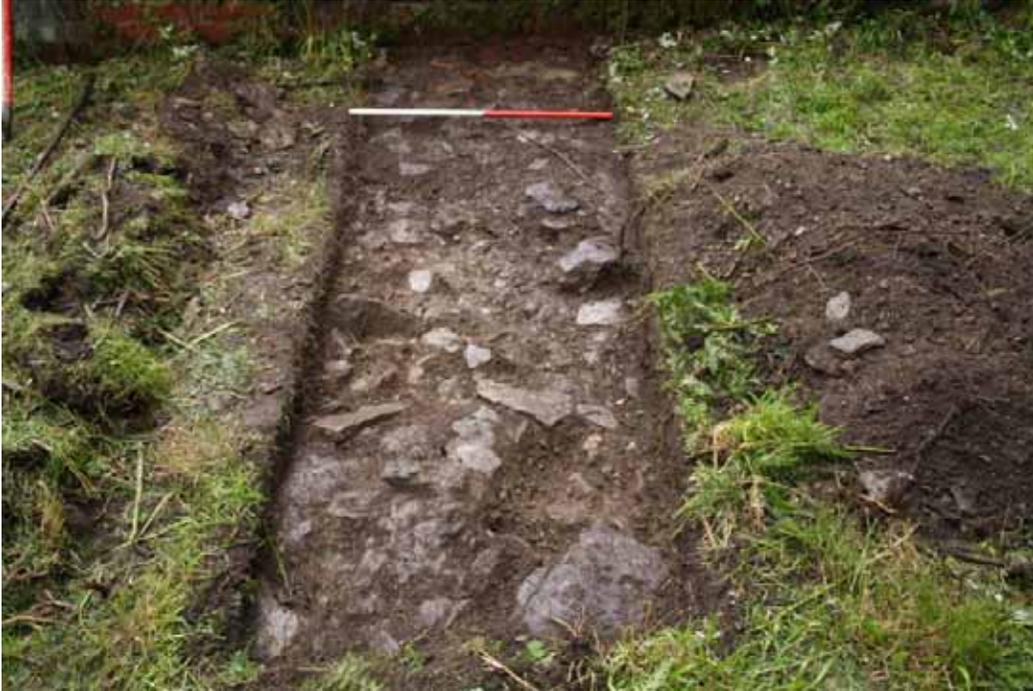
Turf and topsoil (001) was removed to reveal the top of a deposit of demolition debris (011) extending across the whole of the excavated area (see photo 7). The demolition debris included roof tiles, ceramic drainage piping, mortar fragments, rubble stone and glass fragments.

**Photo 7:** Exposure of top of demolition rubble

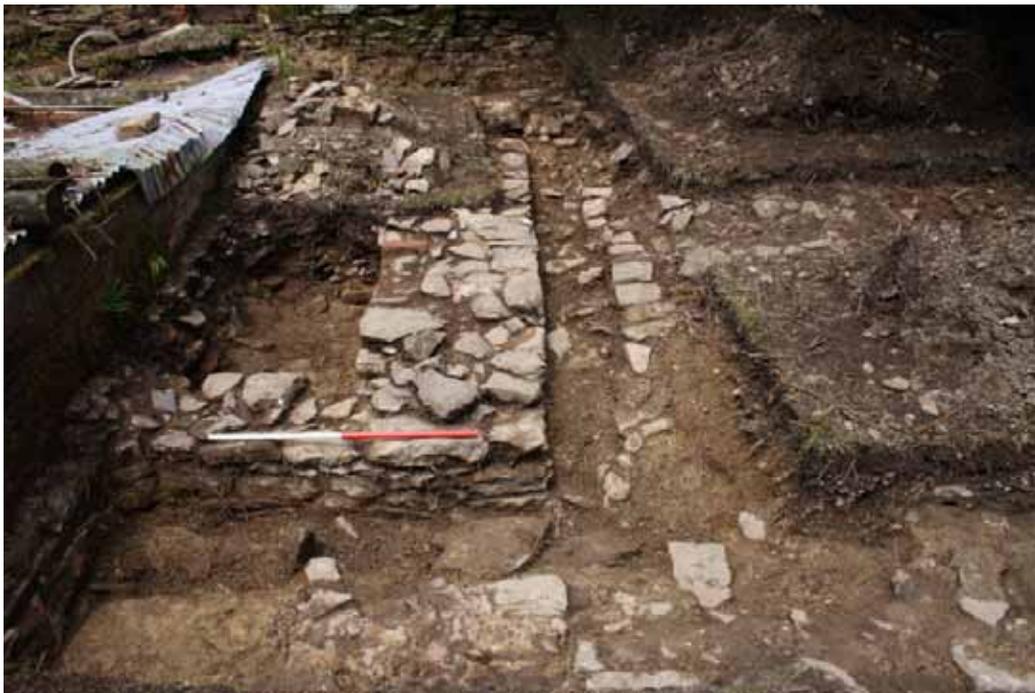
**Photo 8:** Pool walls (left center) and south wall of bath house (foreground), looking north. Note aligned stonework (023) to right of pool walls.

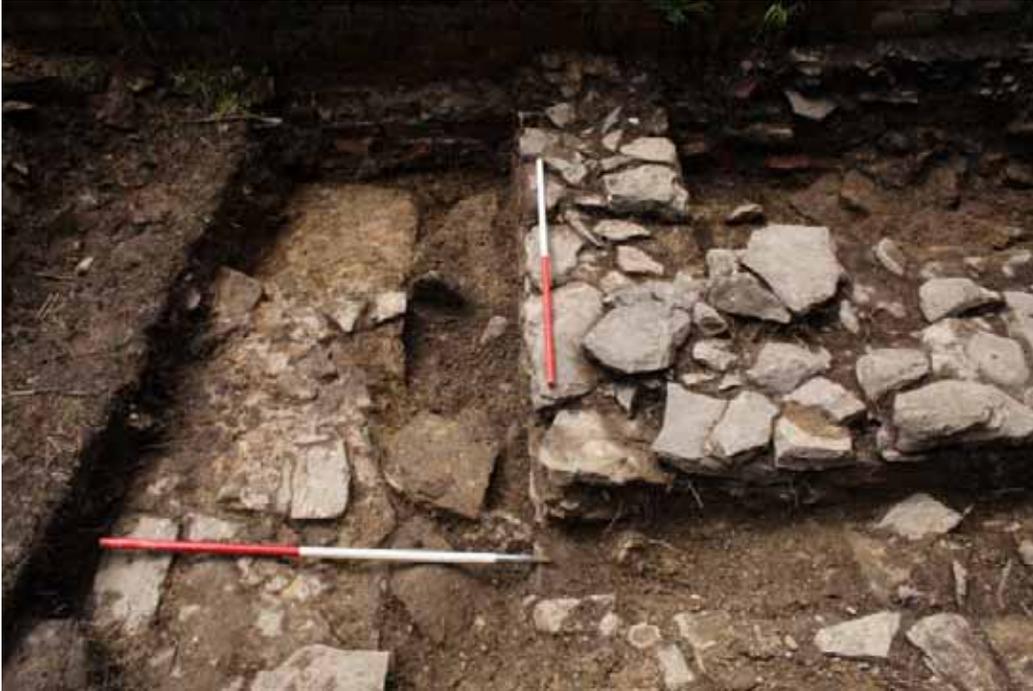
**Photo 9:** Southeast corner of pool structure (right) looking west, with south wall of bath house to left

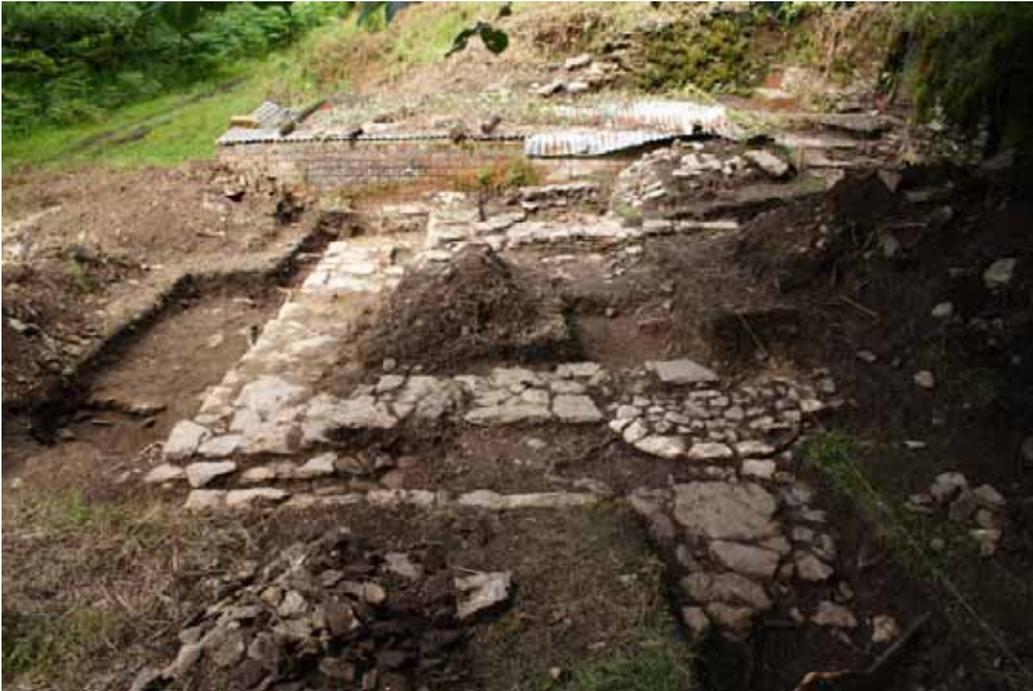
**Photo 10:** Exposed footings looking west. Note remnants of stone flag surface in foreground

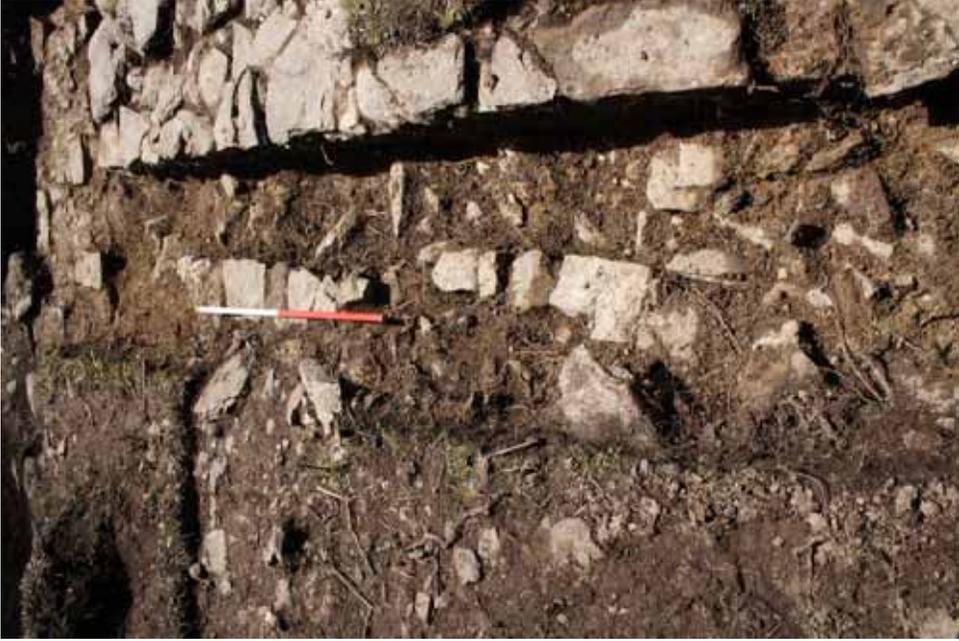
**Photo 11:** Aligned stonework 023, looking south

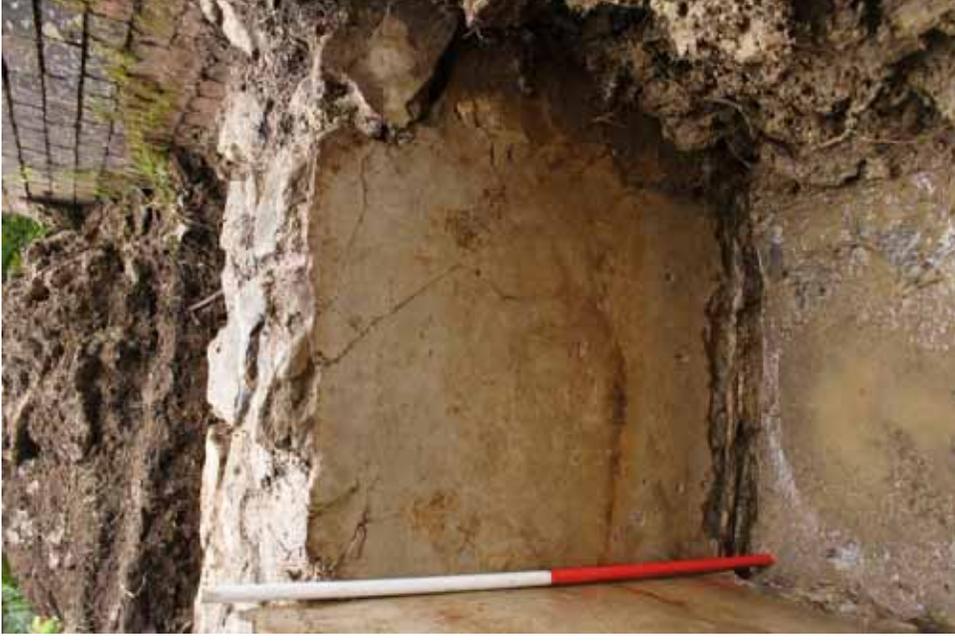
The interior of the plunge pool was found to be faced with very hard smooth lime mortar, with no evidence of paint, tile grouting scars, or other evidence for having been faced with a more durable or decorative material. The base of the plunge pool, however, had been removed, perhaps suggesting it had been lined with marble.

**Photo 12:** Plaster lining of plunge pool, looking south

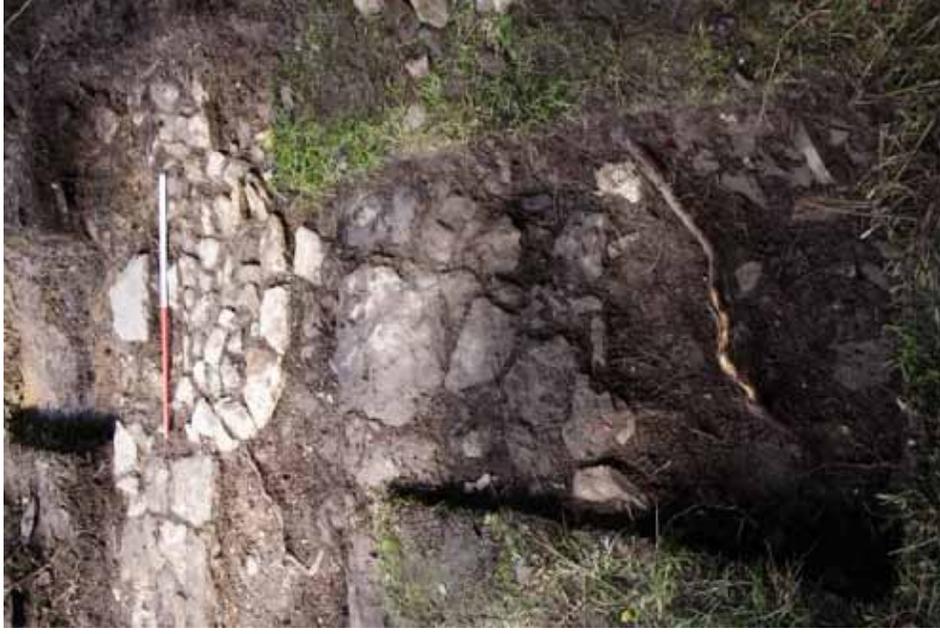
Extending from the wall face half way along the footings of eastern wall, a semi-circular arrangement of stones was revealed, with a diameter of 1.20m. These are presumed to indicate the location of a semi-circular stepped entrance into the building. The stones forming the outline of the semi-circle are of dressed limestone, and appear to be covered by a layer of lime concretion, perhaps derived from the spring water. The interior stones are not dressed, but are recessed into the footings. There was no surviving evidence of the stones of the semi-circle ever having been mortared, perhaps suggesting they were a bedding layer or in-fill behind steps of finer materials and construction, that was subsequently robbed for re-use elsewhere.

**Photo 13:** Semi circular step footings 030 and remnants of surface 028, looking west

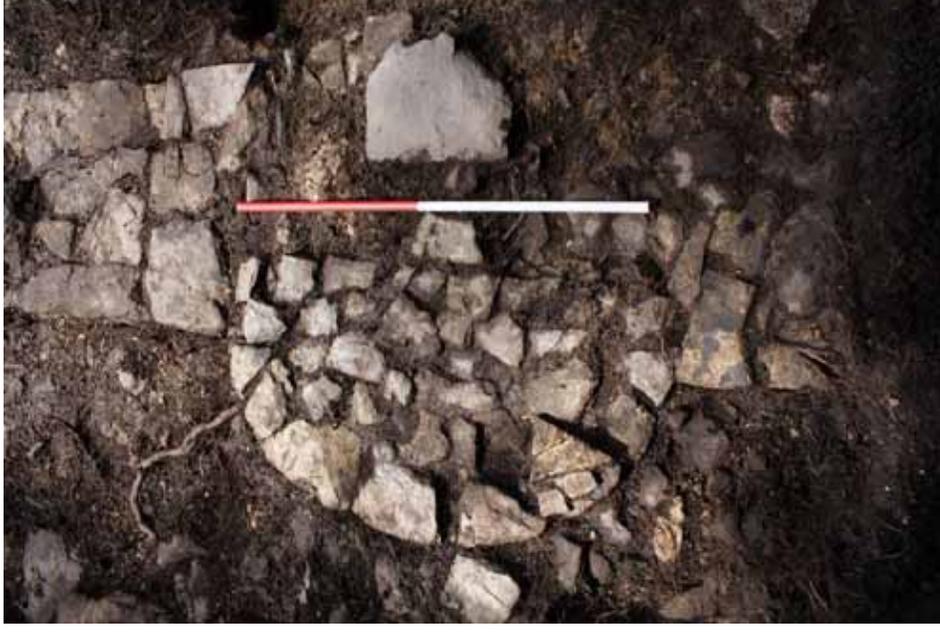
**Photo 14:** Detail of semi-circular step footings 030, looking south

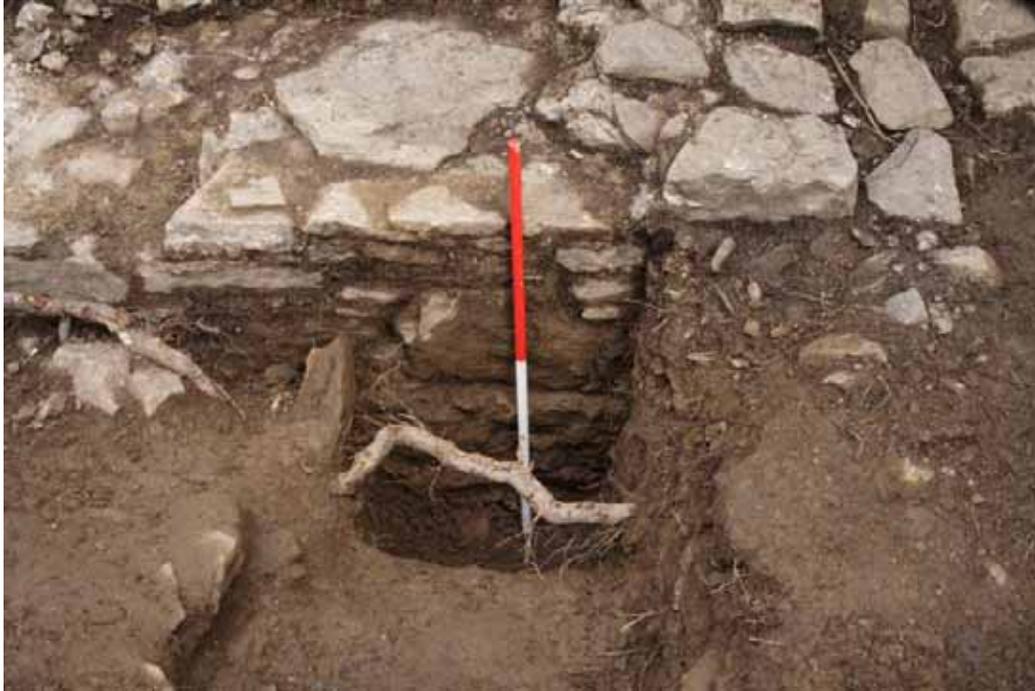
**Photo 15:** Exposed footings of wall 020 looking north

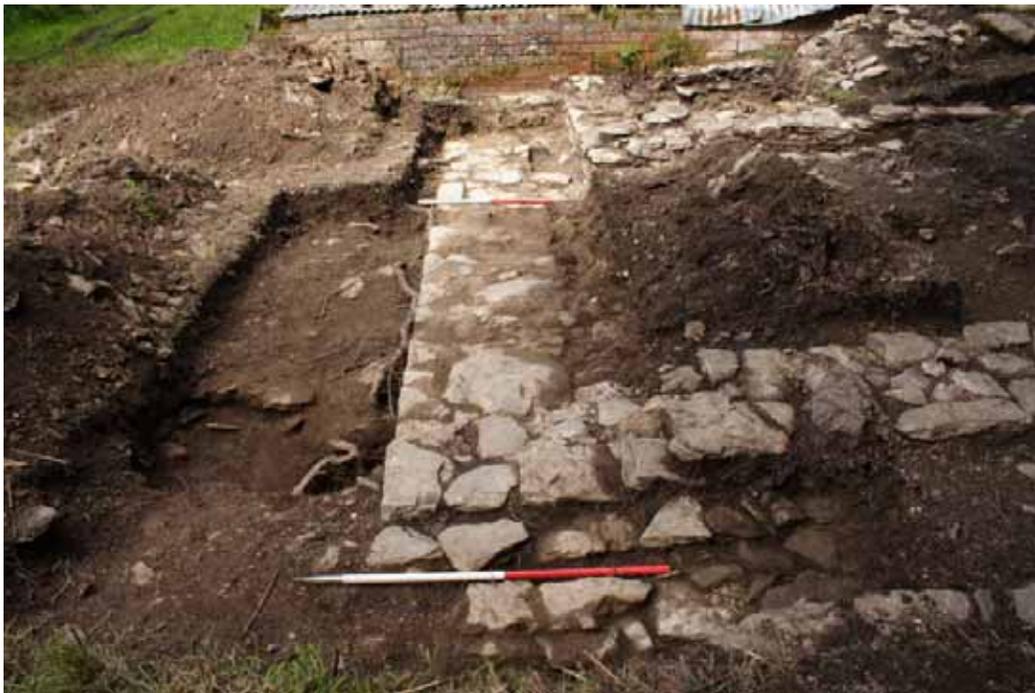
**Photo 16:** Bath house footings looking west

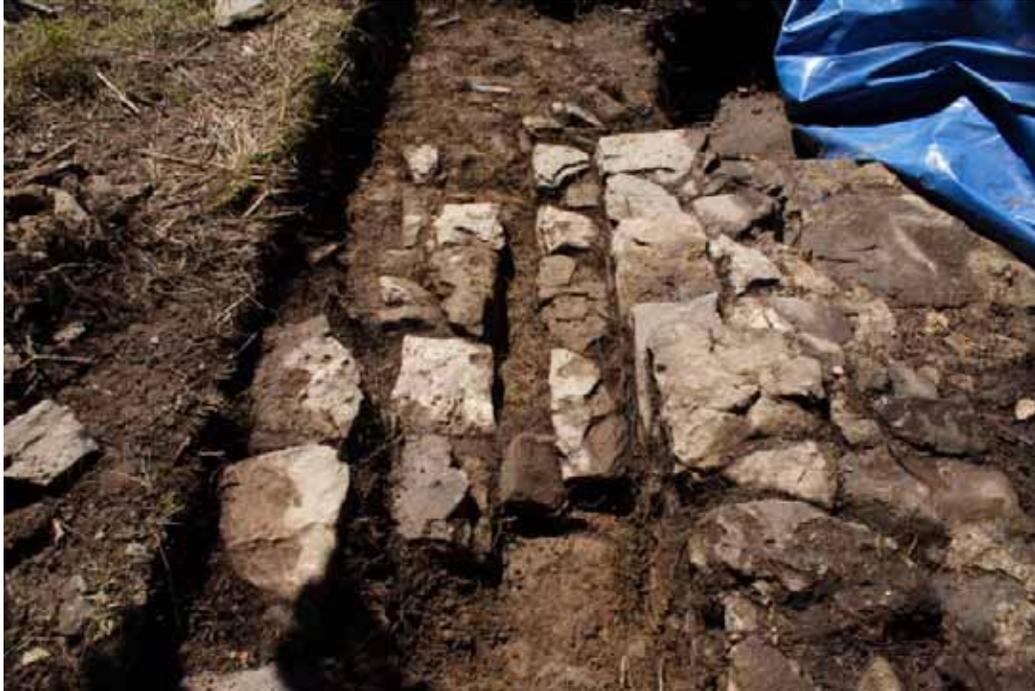
To the east of the building, the remains of a surface roughly constructed from crudely dressed limestone slabs (028) was revealed. The western edge of this surface was 0.70m from the eastern face of the bath house wall (025). One explanation for this gap is that the stone surface pre-dates the construction of the bath house, and was truncated when the footings and semi-circular step were built. Alternatively, the gap may have been filled with stone slabs that capped a possible drain suggested by two alignments of stones at the southeast corner of the building (029).

**Photo 17:** Surface 028 (to left), aligned stonework 029 (center), and wall 025 (to right) looking south

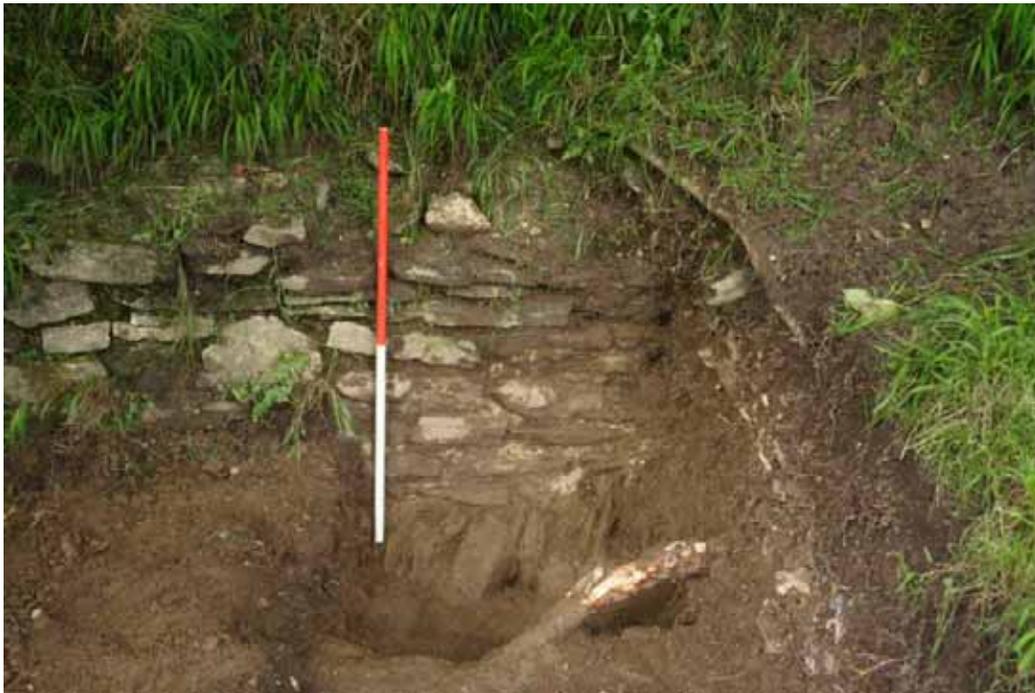
**Photo 18:** Retaining wall 027, built on top of bedrock

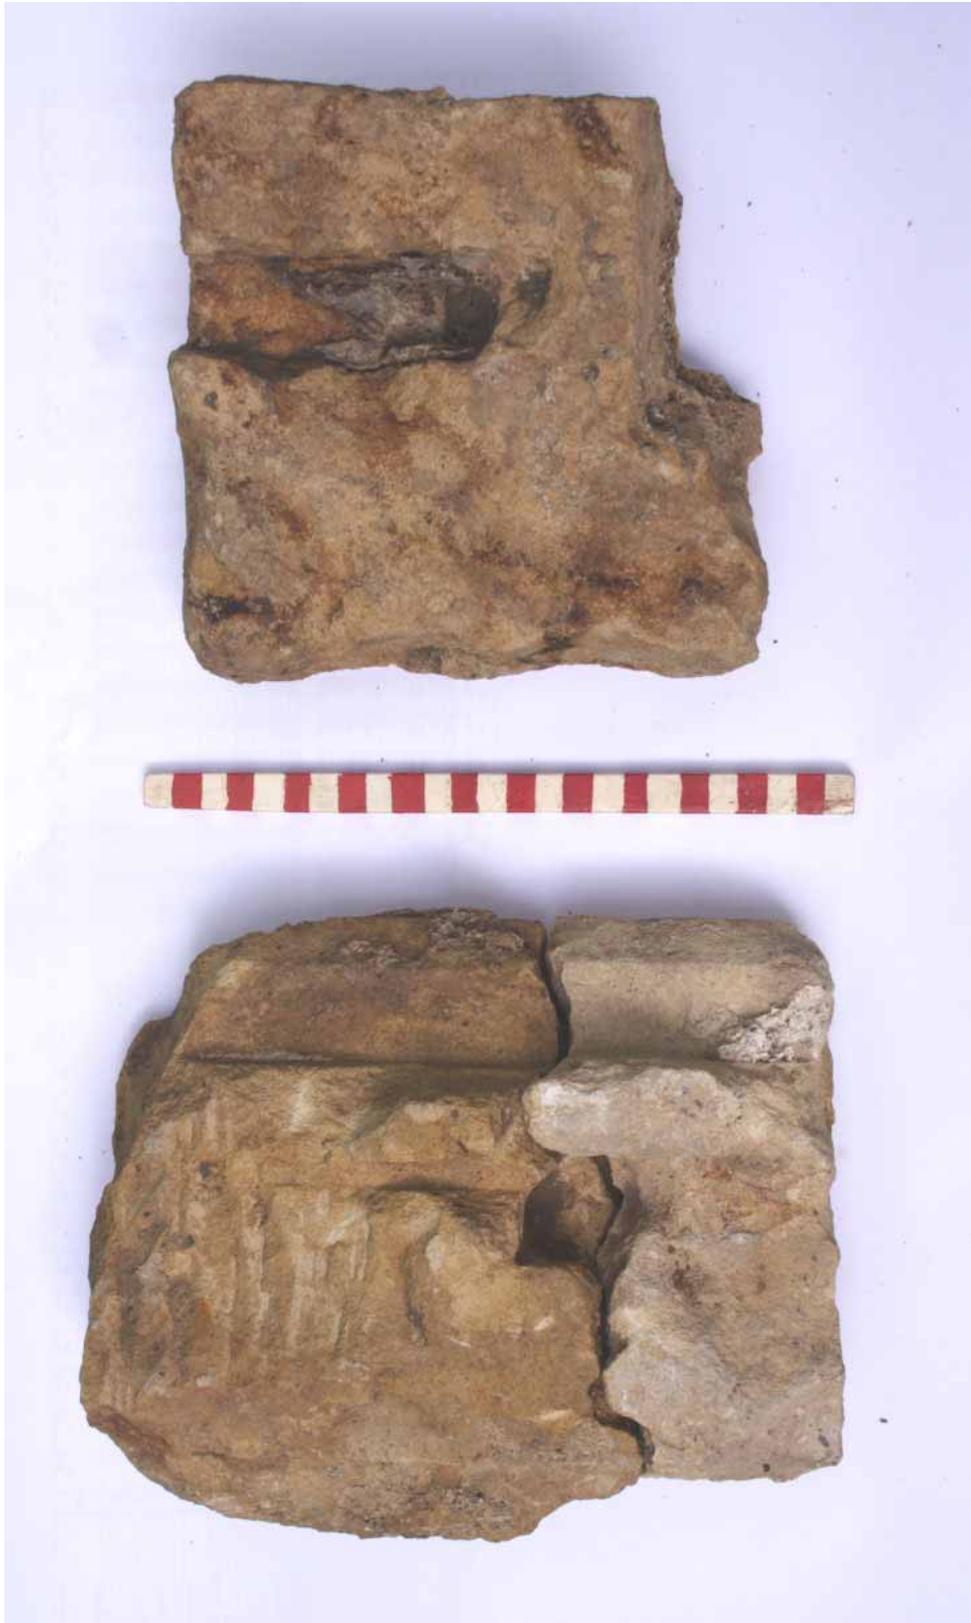
Two fragments of carved oolitic limestone were recovered from within the backfill of the pool (see photo 19). These are thought to be fragments of window surrounds, although it is not possible to confidently extrapolate the style of openings from the fragments recovered.

**Photo 19:** Fragments of dressed stone window surrounds recovered from backfill of plunge pool (25cm scale)

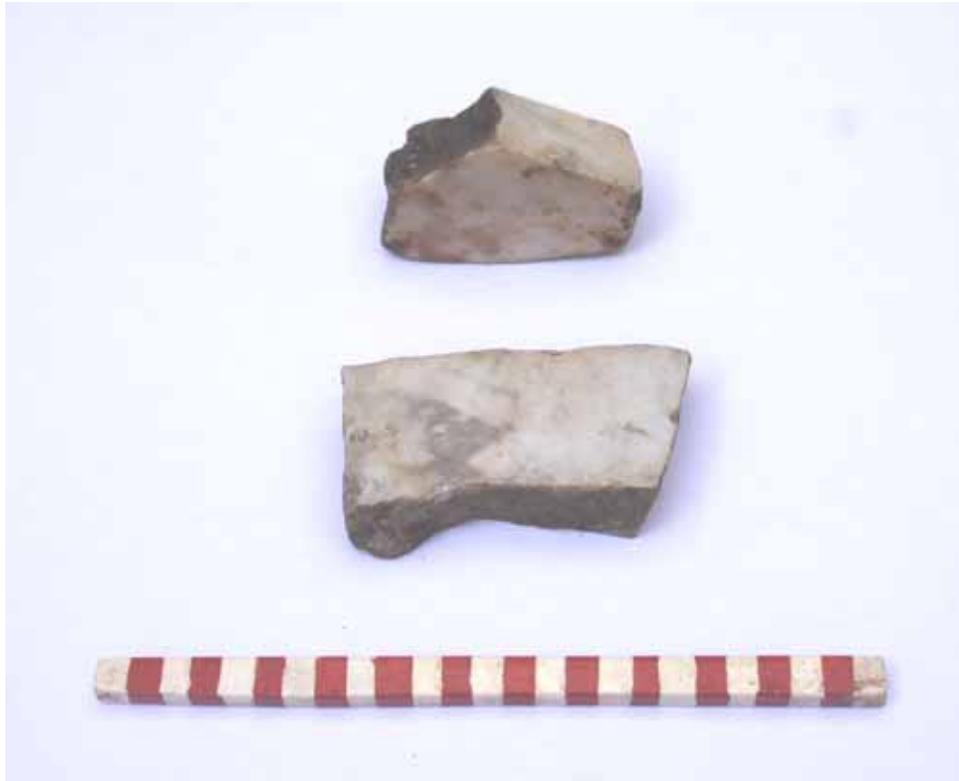
Fragments of marble were also recovered (see photo 20). These are presumed to be remnants of the material with which the floor and walls may have been clad.

**Photo 20:** Fragments of polished marble recovered from demolition debris  
(25cm scale)
