# ARFORDIR COASTAL HERITAGE 2010 - 2011

**RHIF YR ADRODDIAD / REPORT NO. 2011/18**  
**RHIF Y PROSIECT / PROJECT RECORD NO. 100612**

**ARFORDIR**  
**COASTAL HERITAGE**  
**2010-2011**

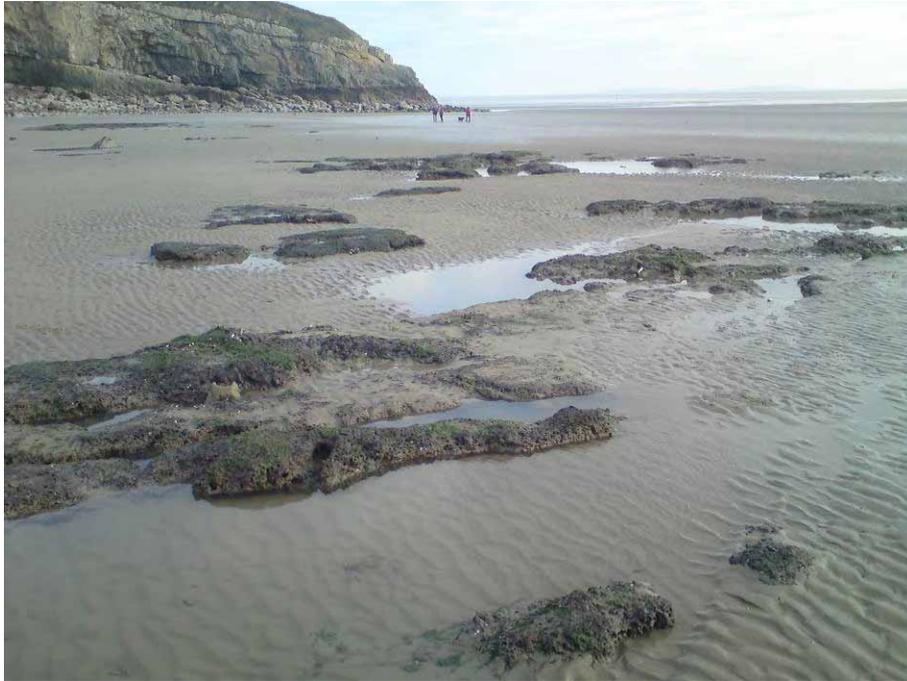
**Photo 8:** Peat Exposures at Morfa Bychan, 23<sup>rd</sup> January 2011

*Morfa Bychan, Carmarthenshire* – PRN 33468. A site visit on 23<sup>rd</sup> January ascertained some extensive exposures of peats on the beach at Morfa Bychan. This corresponded with a general reduction in sand cover across many of the beaches in this area.

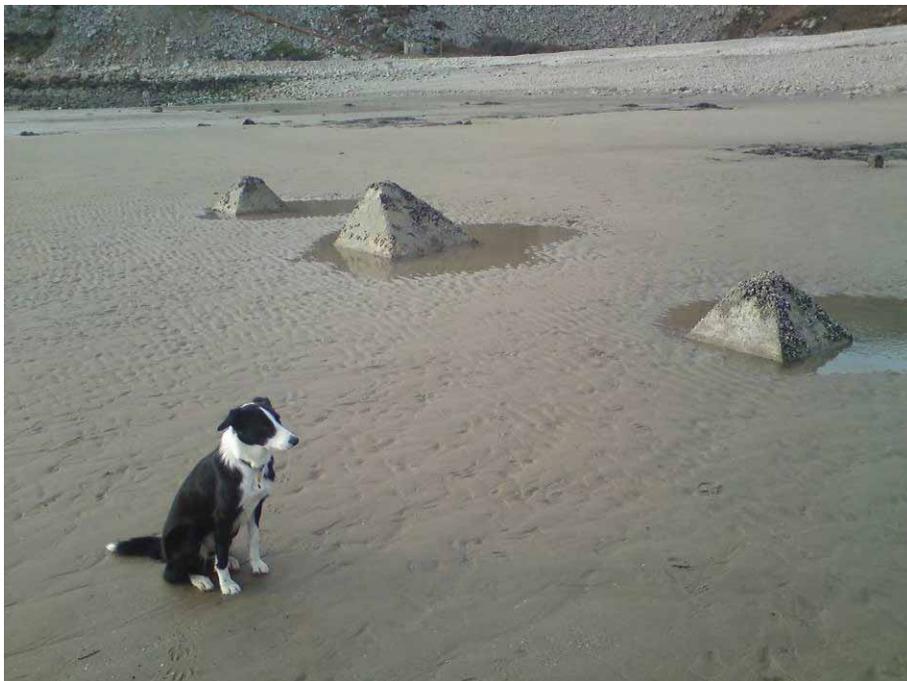
**Photo 9:** Anti-tank pimples, with peat exposures behind, Morfa Bychan

The site visit also gave the opportunity to note the survival of some of the World War II defences that also lie within the beach area, including anti-tank pimples (PRN 26520) for which little information presently exists on the HER.

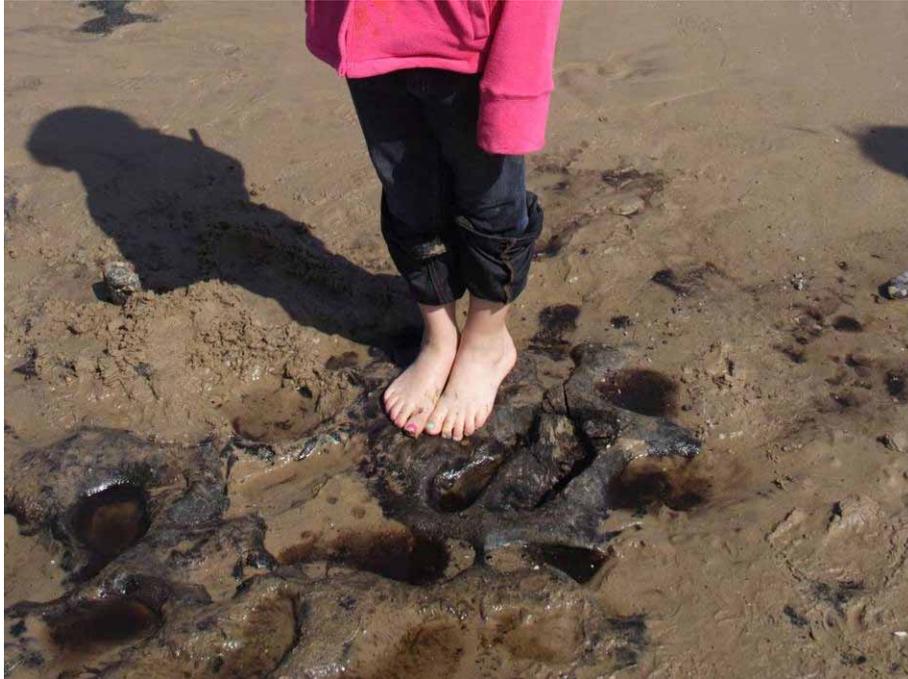
**Photo 10:** Child's footprints in peat (with 9 year old standing adjacent) at Lydstep Haven, 16 April 2010

*Lydstep Haven, Pembrokeshire* – PRN 33459. Following notification from a local resident that the exposed peats had footprints in them, site visits were

undertaken to observe the site on 16<sup>th</sup> April 2010. This was followed up by a programme of recording and survey on 17<sup>th</sup> May 2010.

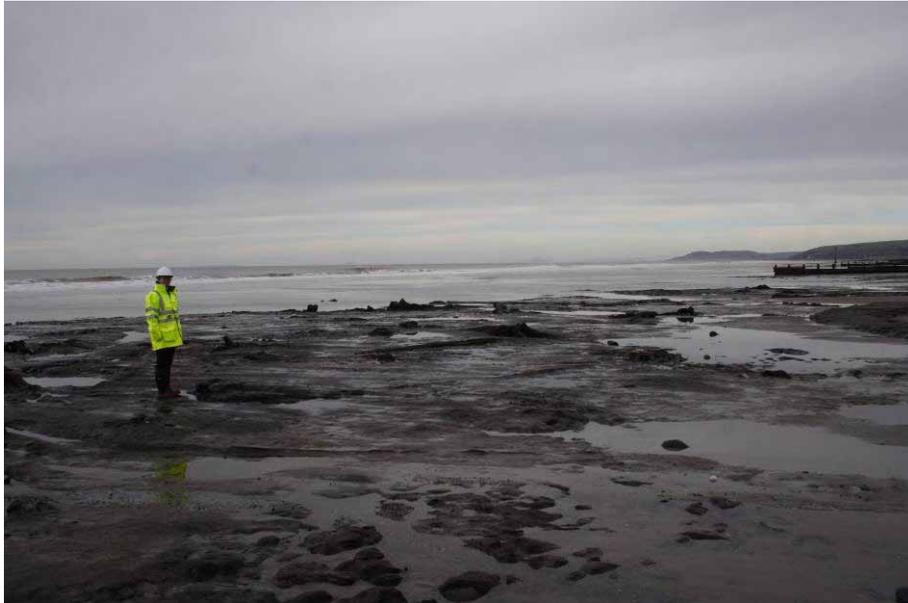
**Photo 12:** Peat and submerged forest exposures at Borth – 16<sup>th</sup> February 2011

*Borth, Ceredigion* – PRN 45106. Although undertaken as part of archaeological monitoring works associated with the construction of the new coastal defences at Borth, it was possible to undertake some wider observation of the exposed peat deposits in the area. Exposures were most notable in early February 2011 in an area close to the southern end of the beach, an exposure which is said to have been the largest for many years by local residents. These peats have subsequently been completely covered by sand again.

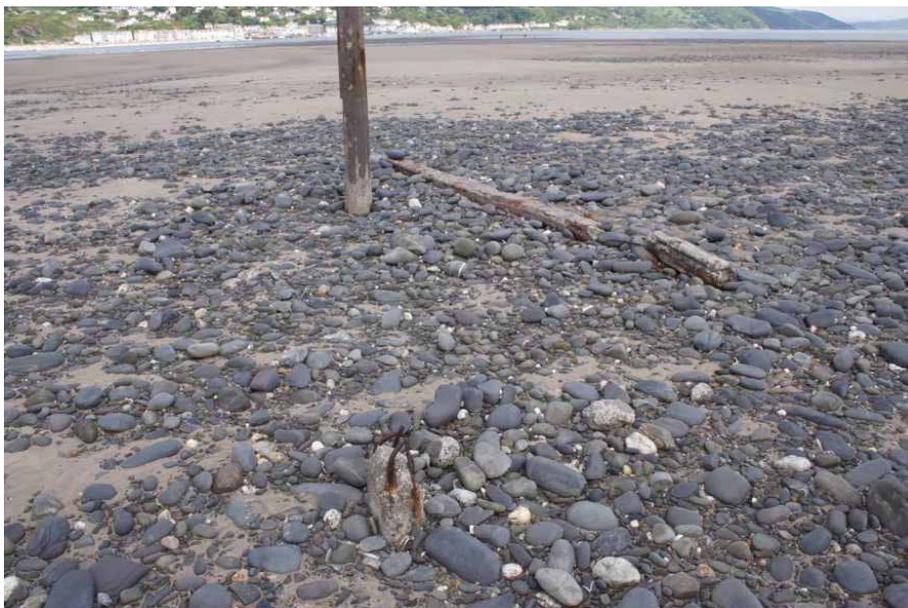
**Photo 3:** Collapsed navigation marker Ynylas Las Ferry

A medieval ferry crossing is recorded in the vicinity of Ynyslas but its exact location is unknown. A collapsed reinforced concrete pillar was noted on the beach at NGR SN 6088 9509 that had recently been replaced with a further reinforced concrete pillar topped with a diamond shaped panel that may represent a navigation marker. A short distance to the southeast of the possible navigation marker a partially buried timber construction with a cast iron gear wheel and pulley was identified which is considered to form the remains of a possible cable or chain ferry point.

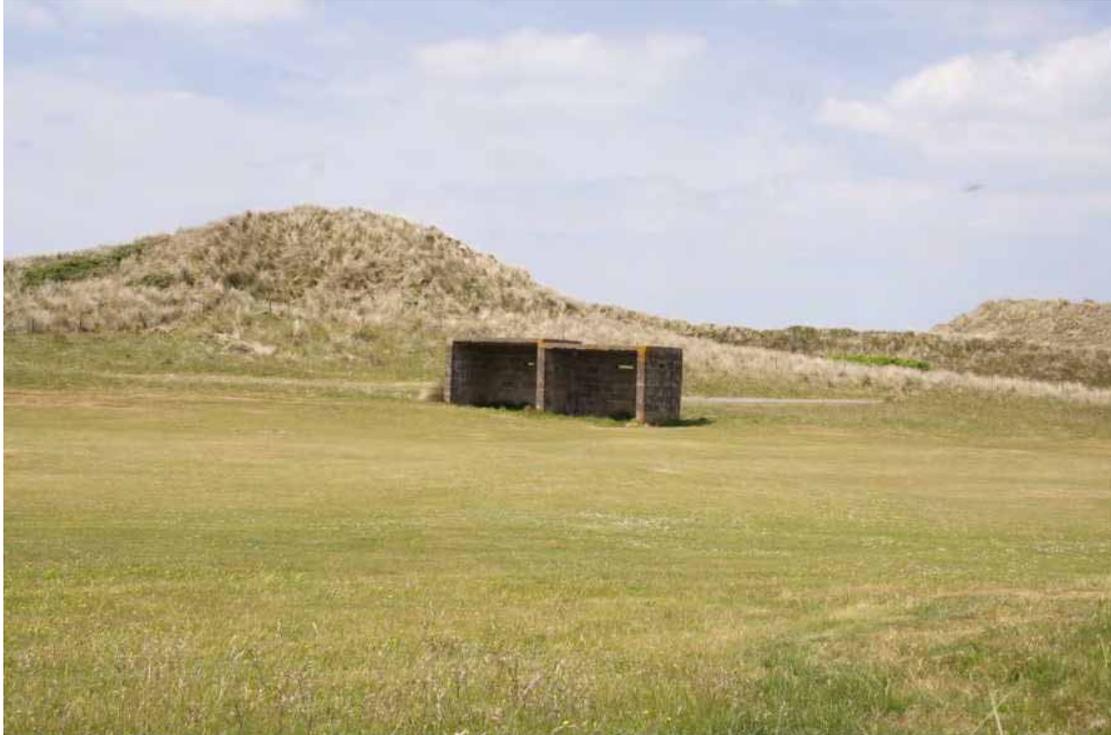
**Photo 5:** Military structure, Ynylas Golf Course.

The structure appears to be in a good state of repair due to its location on the golf course and is not threatened by erosion.

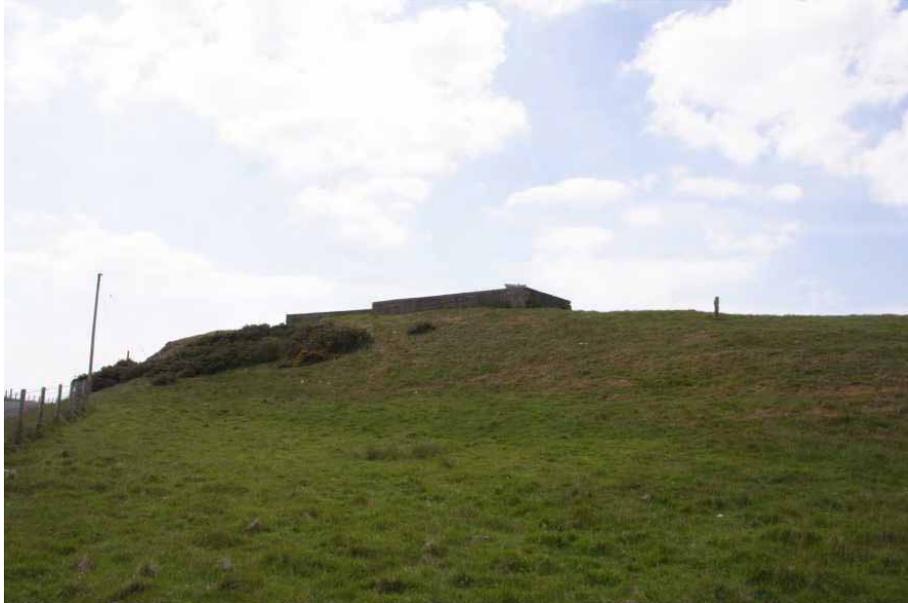
**Photo 6:** Possible military structure at Plas Ynys.

The structure appears to be in a good state of repair.

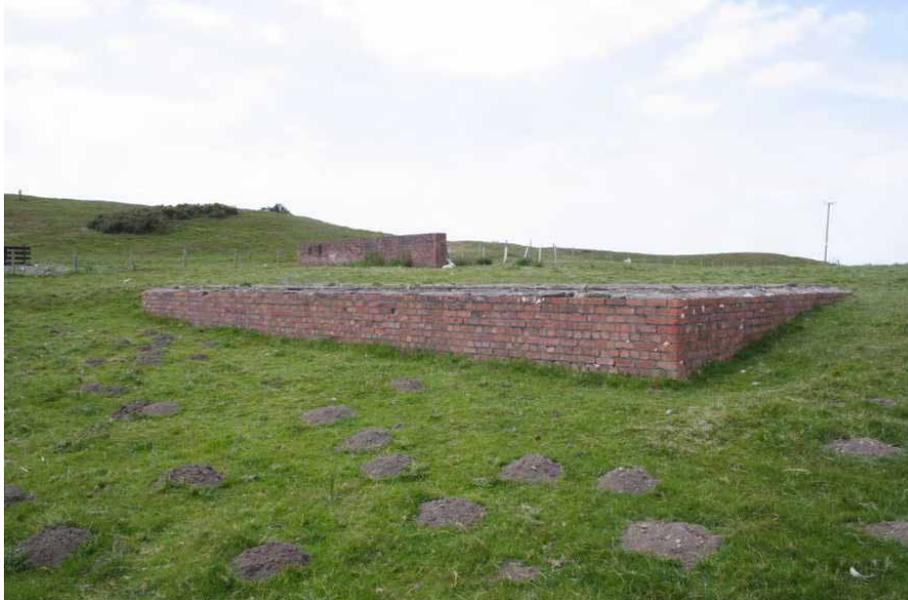
**Photo 7:** Brick structures at Saxondale.

Although both structures have been partially demolished the surviving remains appear to be stable given their substantial construction. Both are free of coastal

erosion but animal burrowing noted around the structures may eventually destabilise them.

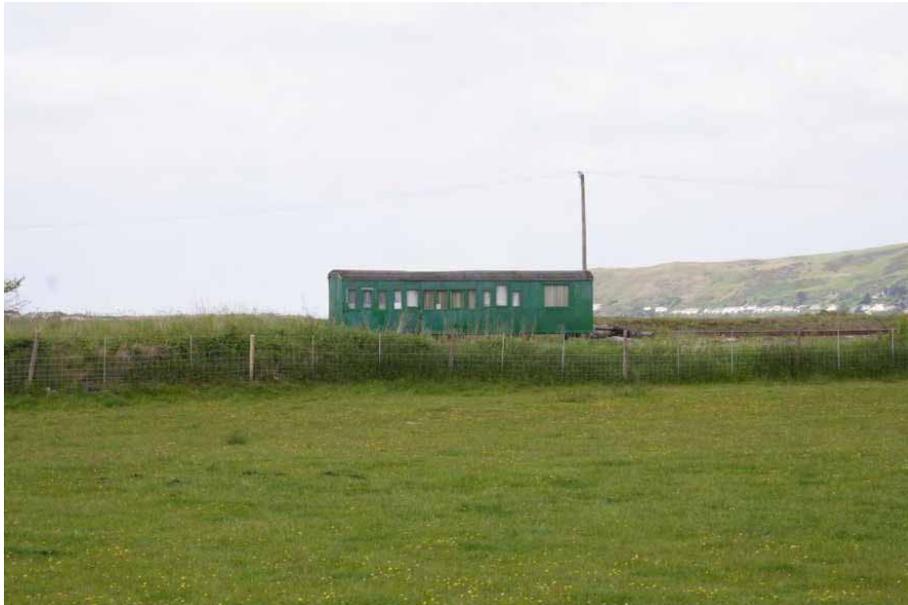
**Photo 8:** Railway coach utilised as dwelling as site of Ynys Las station.

It was not possible to closely examine the railway coach as it was located on private land immediately adjacent to the railway line. Outwardly the coach appears in relatively good condition but given its location, propped up nature and probable wood construction decay would set in quickly without regular maintenance.

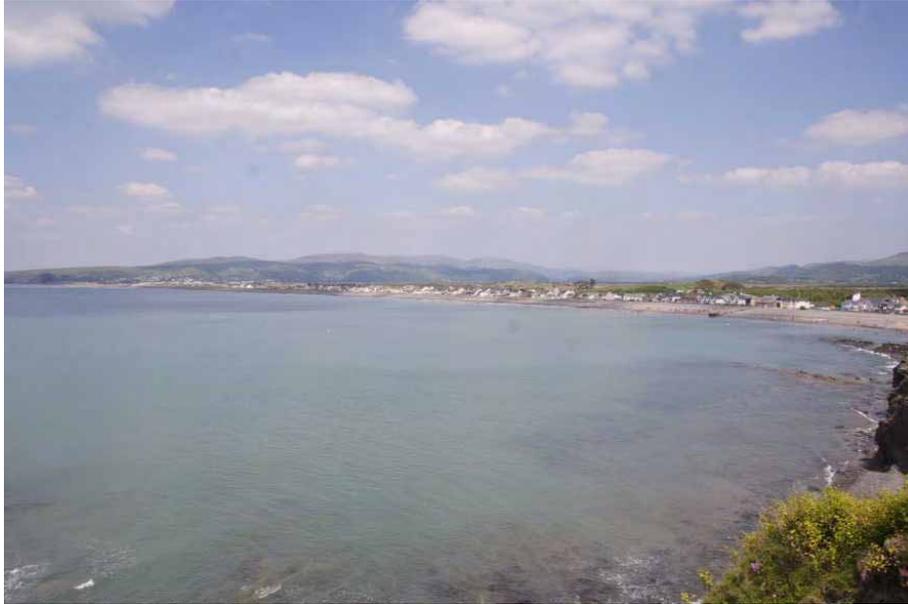
**Photo 9:** North east view of Borth.

The Borth site visit area is located in an area of stable/ slight coastal erosion and generally this is the case with much of the sea front protected by breakwaters and substantial modern concrete sea defences.

Since February 2011 an extensive scheme of coastal defence replacement has been undertaken, involving removal of older wooden groynes and replacement with two large rubble stone groynes, two breakwaters and an offshore reef. This would indicate that coastal erosion is considered of sufficient threat to the main village of Borth to warrant the investment in new defences.

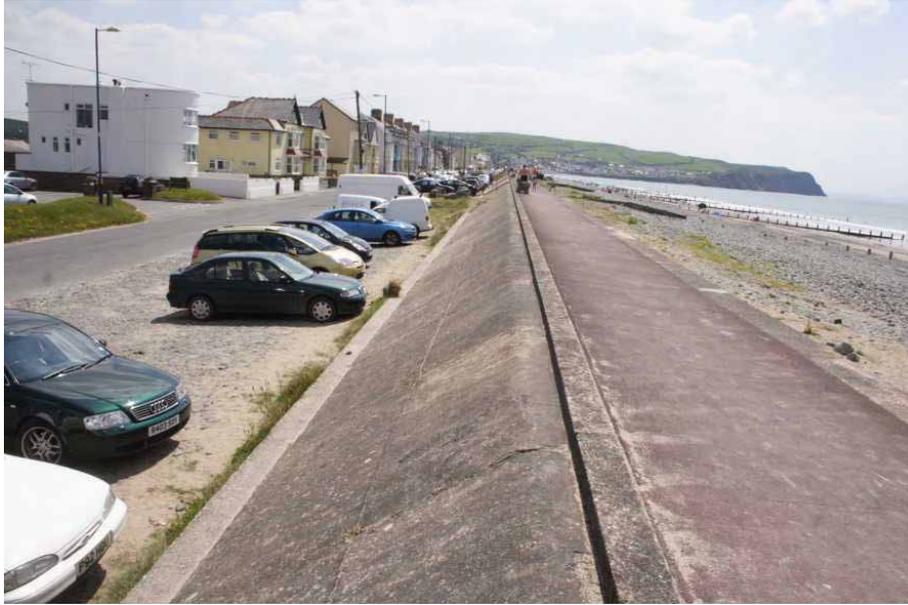
**Photo 10:** Modern sea defences at Borth sea front.

Directly to the north of the town a massive concrete wall is present, whereas along the sea front through the town a massive timber and metal breastwork creates the defence between the rear of the houses and the beach.

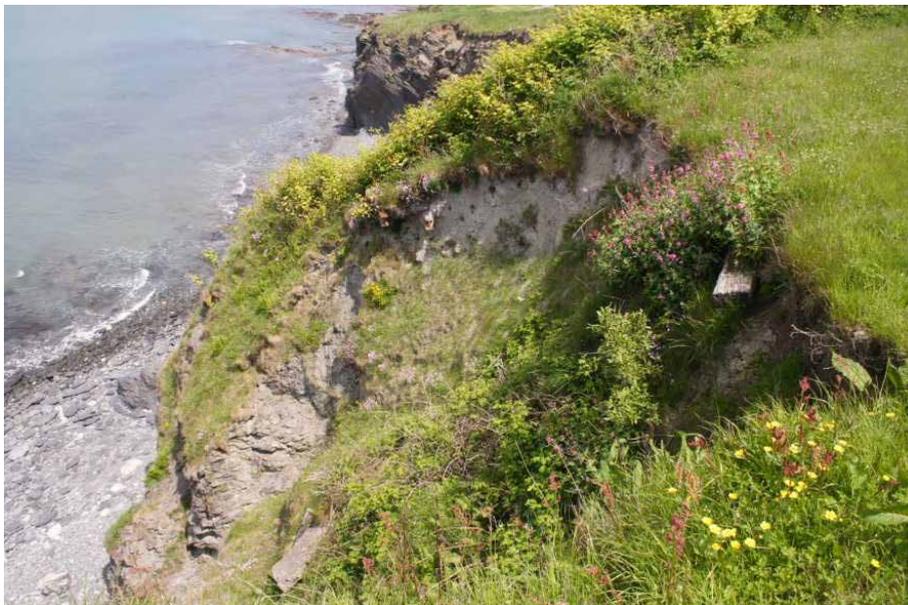
**Photo 11:** Collapsed cliff to south of Borth village.

At the south end of Borth sea front between NGRs SN 60679 88829 and SN 60327 88720, an area also classed as being at risk of slight coastal erosion, it was possible to view that part of the cliff has collapsed suggesting more serious erosion in this area. The upper area of the collapsed cliff had a timber beam and former railway track protruding from it suggesting haphazard shoring up of the area. It is considered that coastal erosion in this area should be reassessed to a medium category and the area would benefit from additional monitoring.

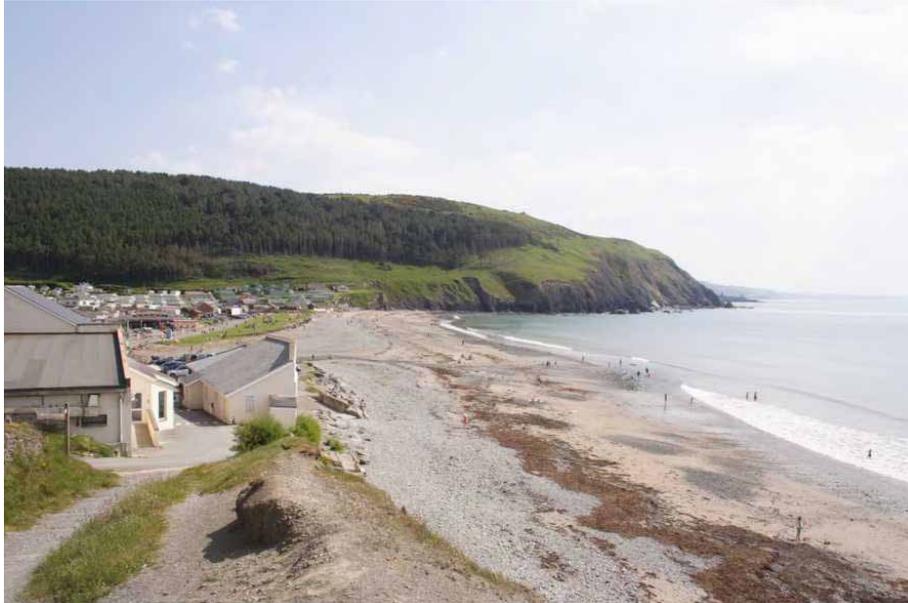
**Photo 12:** Clarach bay from the north.

Clarach Bay was targeted for a site visit as it is located at the beginning of a long stretch of coastline classed as under medium threat of coastal erosion. The main bay area appears to be relatively stable with very little erosion apparent. However, towards the north the effects of erosion become much more apparent with large areas of cliffs noted as collapsed leaving large areas of overlying soil open to the elements. In addition the area appears to be popular with walkers given that it lies on the Ceredigion Coast Path and in places 'footfall' is starting to erode areas around the path. The area contains a large camping and caravan park popular with visitors. It is considered that the medium coastal erosion classification of the area may need to be reassessed.

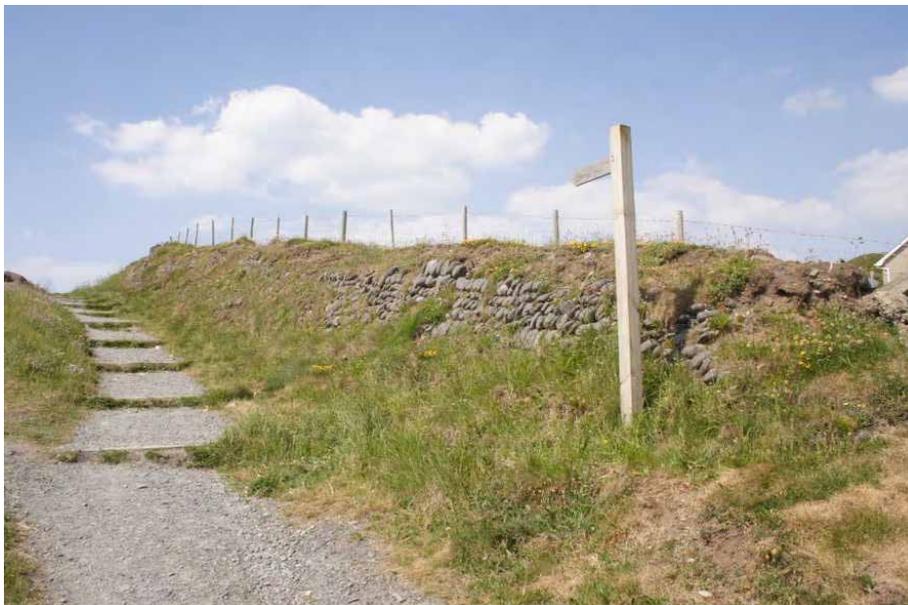
**Photo 15:** Boundary bank at Clarach Bay.

During the course of the site visit to Clarach Bay a substantial revetted boundary bank was identified immediately to the rear of the entertainment complex of the caravan park. The bank survives a height of over 1m and is in a stable condition, but vegetation is growing through which may suggest root damage. It is considered that the bank is under no immediate threat from coastal erosion but more immediately from human and animal activity. The date for the bank is unknown.

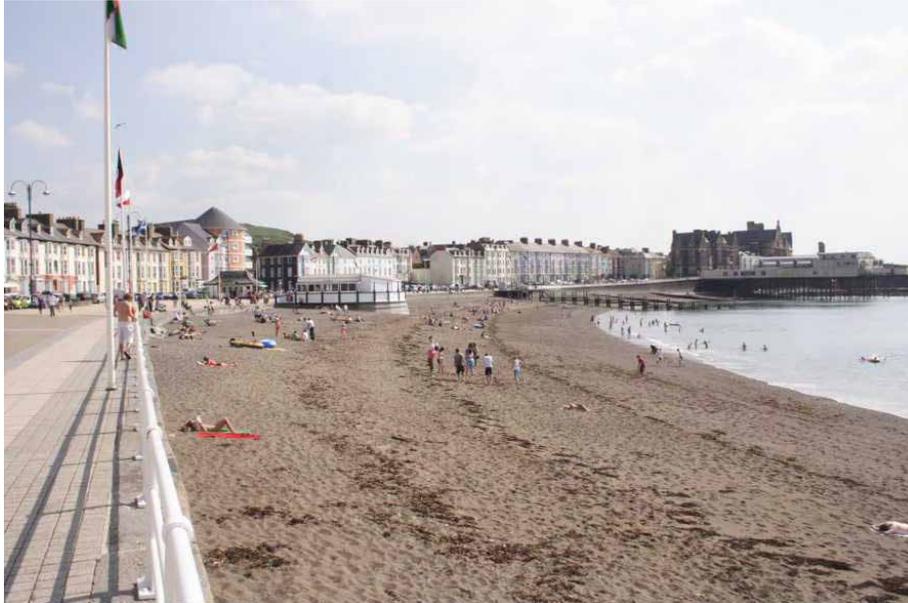
**Photo 16:** Aberystwyth sea front facing south.

Although Aberystwyth lies in an area of stable coastal erosion the area was targeted as it is a substantial coastal town that is considered more likely to suffer from the effects of other forms of erosion. The area visited confirmed that the coastline is stable at this location as it is protected by substantial stone sea walls and timber groynes.

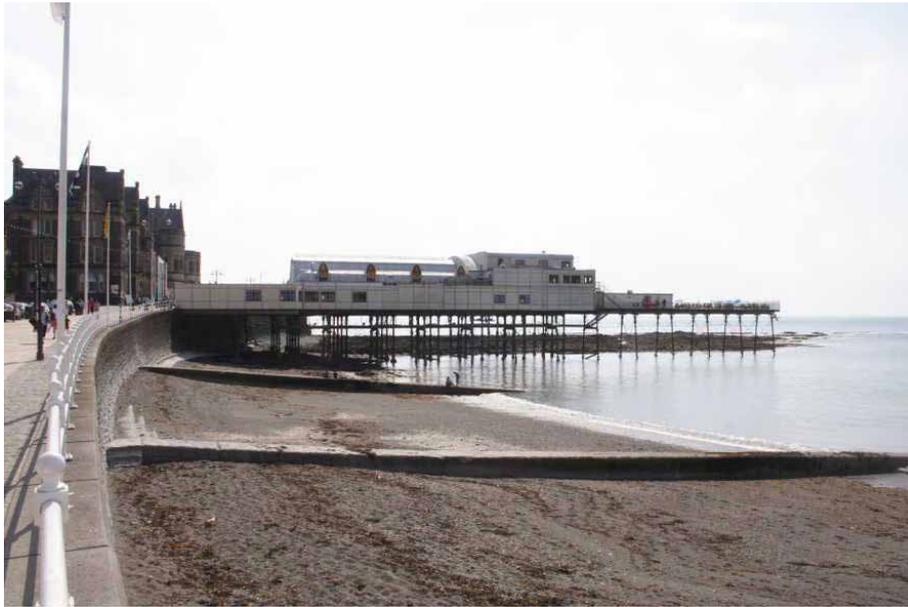
**Photo 17:** South facing view of Aberystwyth Pier.

Constructed in 1865 Aberystwyth Pier was the first purpose built pleasure pier in Wales. Following rebuilding and extension work the pier attained a length of 800 feet (243m). The length was halved following storm damage in 1938.

The pier is currently occupied by a snooker club, restaurant, bar and amusement arcade, the signage of which is not in keeping with a 19<sup>th</sup> century structure. The structure itself is supported on cast iron pillars set on concrete bases. The cast iron supports seem to be stable but do appear to be outwardly corroded which may suggest internal corrosion of the iron resulting in structural weakness. Cast iron is a strong building material when under vertical pressure, however, when exposed to lateral pressure it is relatively weak and prone to failure. Similarly concrete also has the potential to degrade and fracture. Given that the pillars and supports of the pier are exposed to the tide and elements it is possible that this may be concern. Cross tie bars visible between the pillars suggest an attempt to address this weakness.

The pier structures appear to be in a good state of repair externally, but some of the sash windows on the south side appear to be decaying and in need of attention.

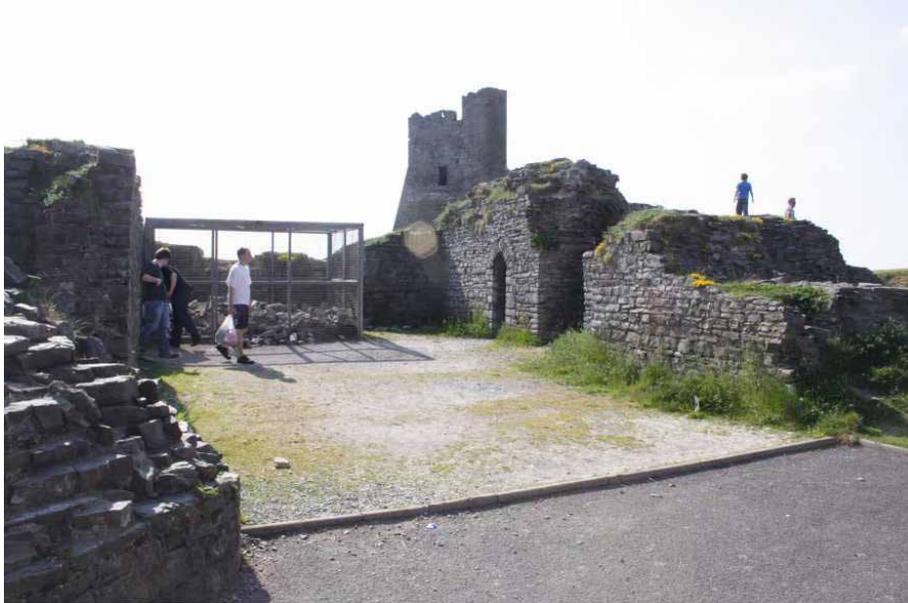
**Photo 23:** Vegetation growth and public climbing on walls at Aberystwyth Castle.

Substantial remains of medieval castle overlooking the sea at Aberystwyth. The castle remains and grounds are now utilised as a public park and are not under threat from coastal erosion. However, the use of the castle and its grounds as a public park, which appears to be accessible both night and day, present a different threat of erosion. It was noted that graffiti was present on the remains and it was witnessed that members of the public climb on the masonry remains which has the potential to dislodge stonework. In addition vegetation was also to be seen growing on the remains which left unchecked could potentially weaken the structure through root action.

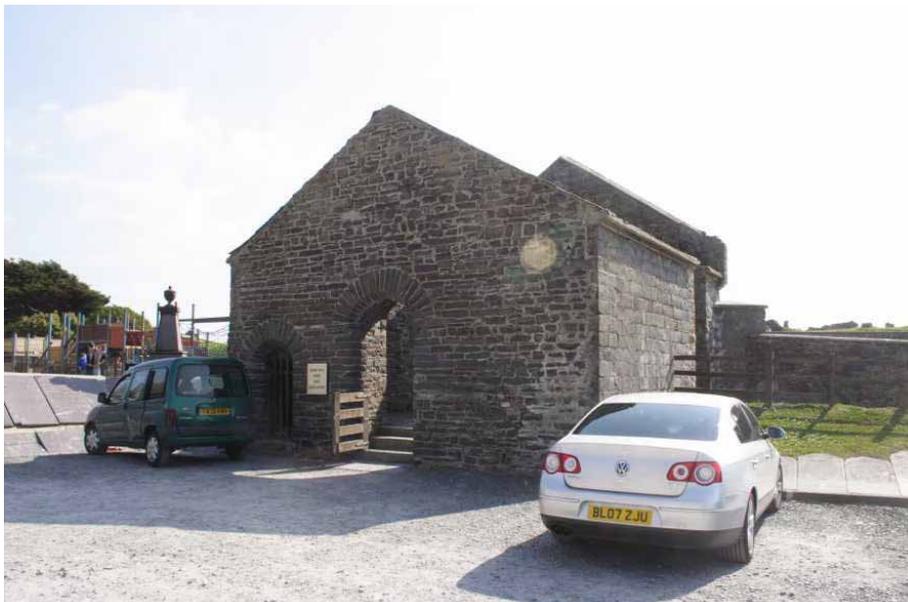
**Photo 24:** Former vestry of St Mary's and All Angels Parish Church.

Former vestry constructed in 1833 as part of St Mary's and All Angels parish church which stood on the site and extended eastwards from the surviving structure. The surviving structure was intended to form the base of a tower that was planned for the church but never constructed. However, the smaller doorway

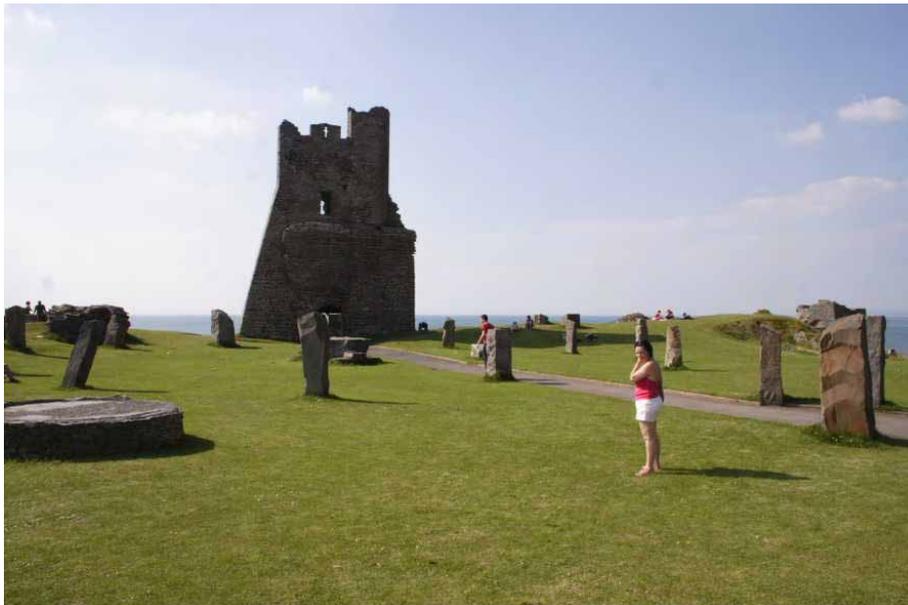
**Photo 25:** Gorsedd stones at Aberystwyth.

The circle is in good condition and generally appears to be free from erosion. However, graffiti was noted on some of the stones which is considered unsightly and suggests that the stones are open to access both day and night.

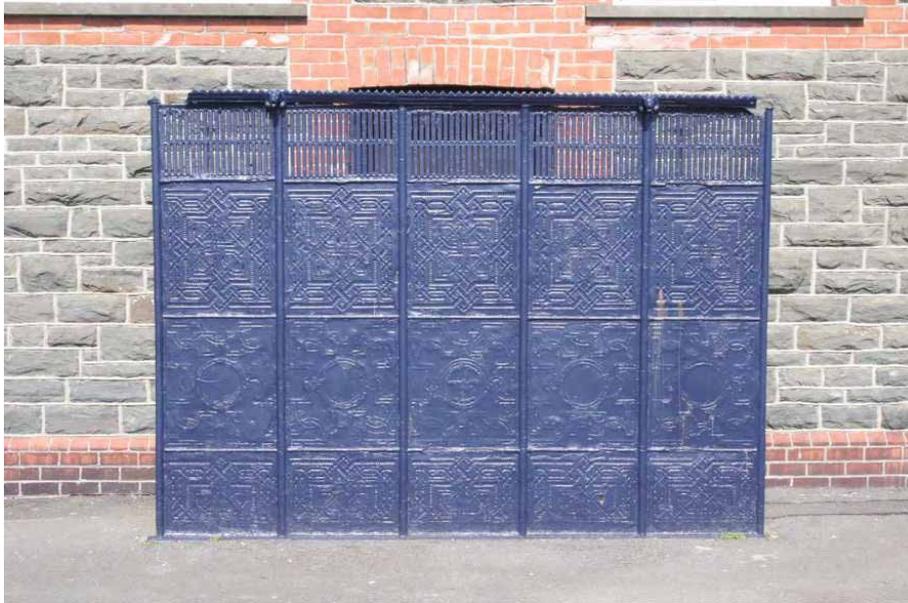
**Photo 26:** Privacy screens at Castle conveniences Aberystwyth.

The structure and privacy screens appear to be in a good state of repair the only visible problem being small areas of surface rust on the privacy screens which could be easily treated.

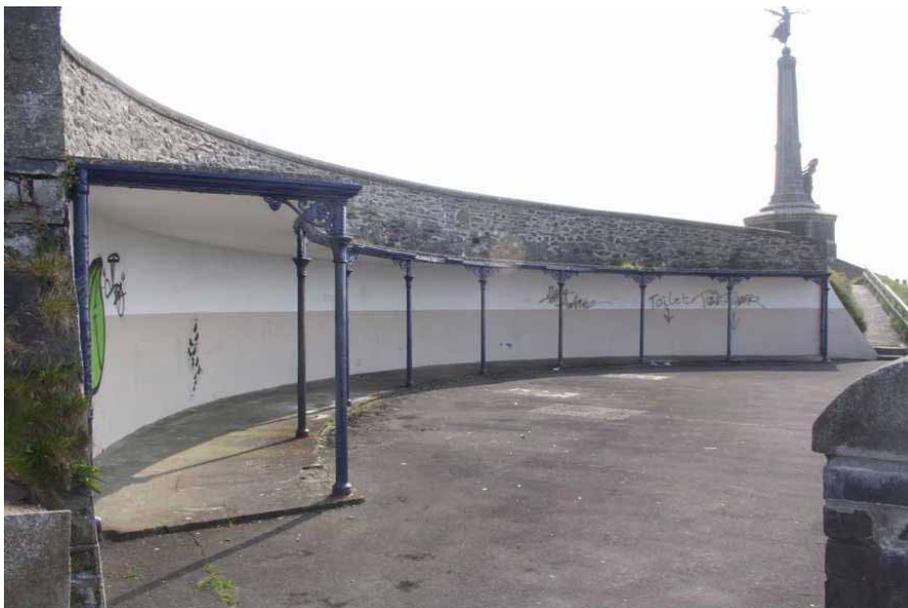
**Photo 27:** Early 20<sup>th</sup> century curved shelter adjacent to Aberystwyth Castle.

Early 20<sup>th</sup> century curved shelter constructed of cast iron columns with decorative scrollwork capitals. The shelter appears to be stable but has been vandalised with graffiti, in addition to graffiti the capital of one of the cast iron columns has been broken and much of the guttering has been damaged, particularly in the mid section of the structure.

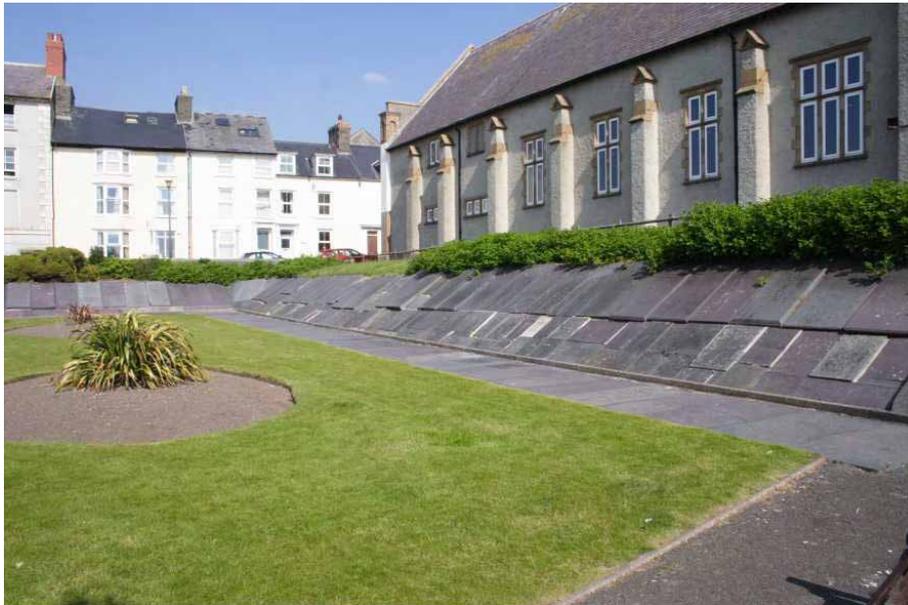
**Photo 28:** Former St Michael's churchyard.

Former churchyard of St Michael's church which dates from the 19<sup>th</sup> century but may be on the site of the medieval chapel of the same dedication.

The churchyard has been converted for use as a public park and car park the gravestones now incorporated into the sloping boundary banks of the park. It is unclear if the graves were removed prior to conversion or lie intact below the surface.

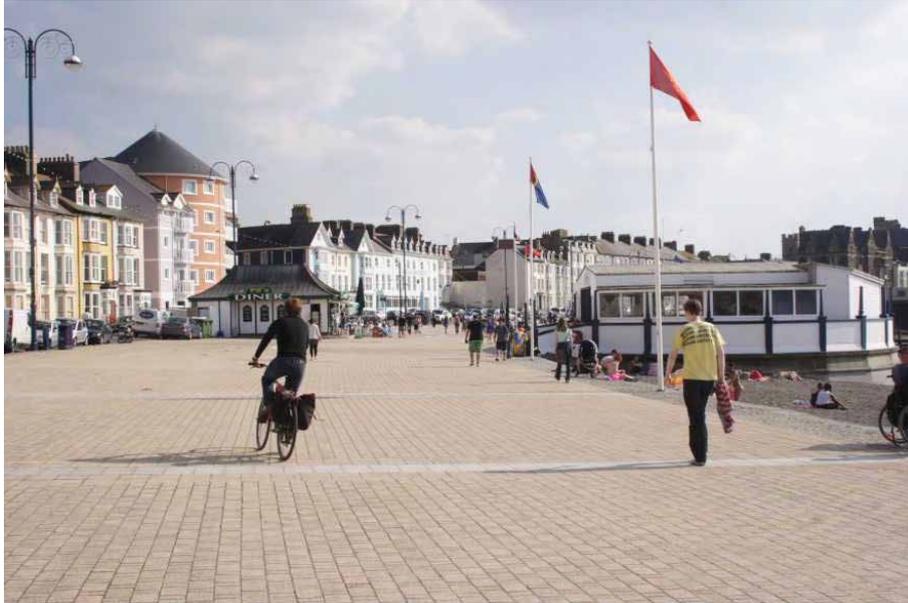
**Photo 29:** View of bandstand, Marine Terrace, Aberystwyth.

Late 19<sup>th</sup> - early 20<sup>th</sup> century bandstand on seafront. The structure stands on a concrete base projecting onto the beach. The structure appears to be in a good state of repair and free from the effects of erosion.

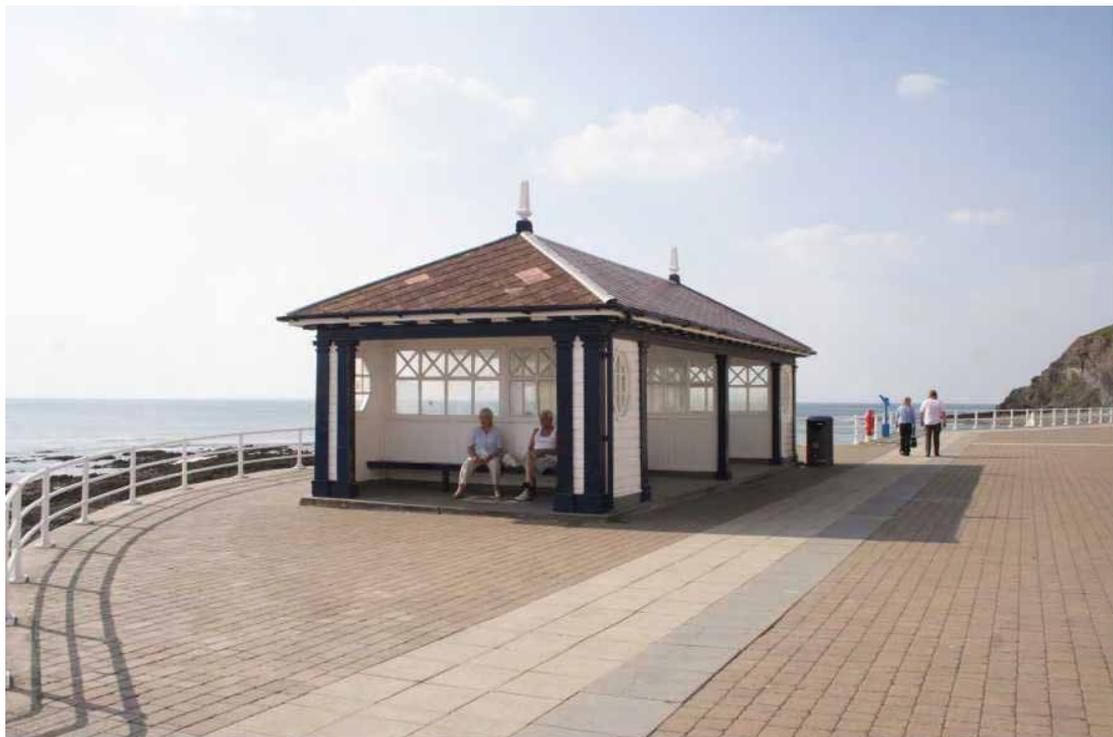
**Photo 30:** Shelter at seafront, Marine Terrace, Aberystwyth.

The structure is in a very good state of repair and appears to have been recently entirely painted and re-roofed on the east side.

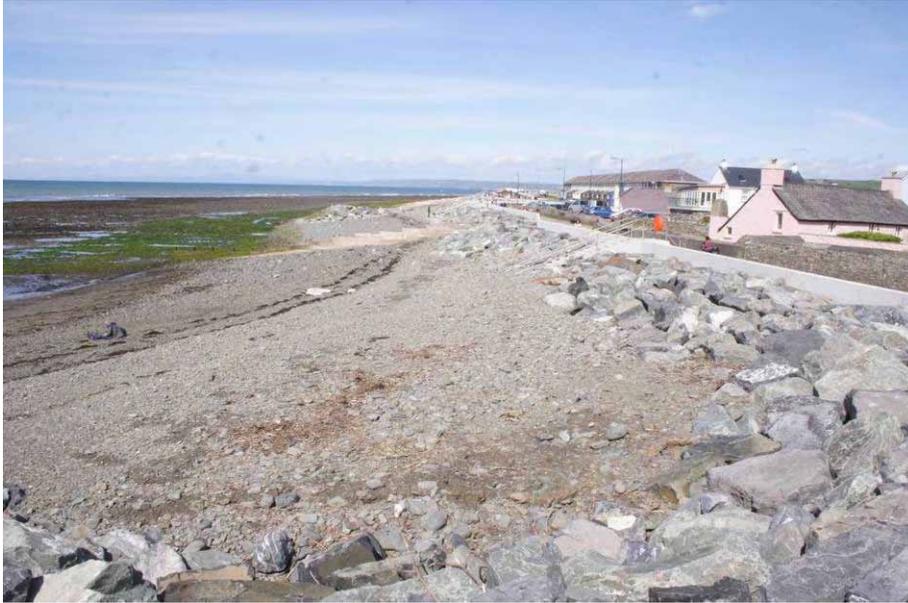
**Photo 31:** Renewed sea defences north of Aberaeron Harbour.

Aberaeron was targeted for a site visit as it is categorised as being stable but is known to have suffered from heavy flooding and deteriorating sea defences in recent years suggesting that this categorisation may need to be reassessed.

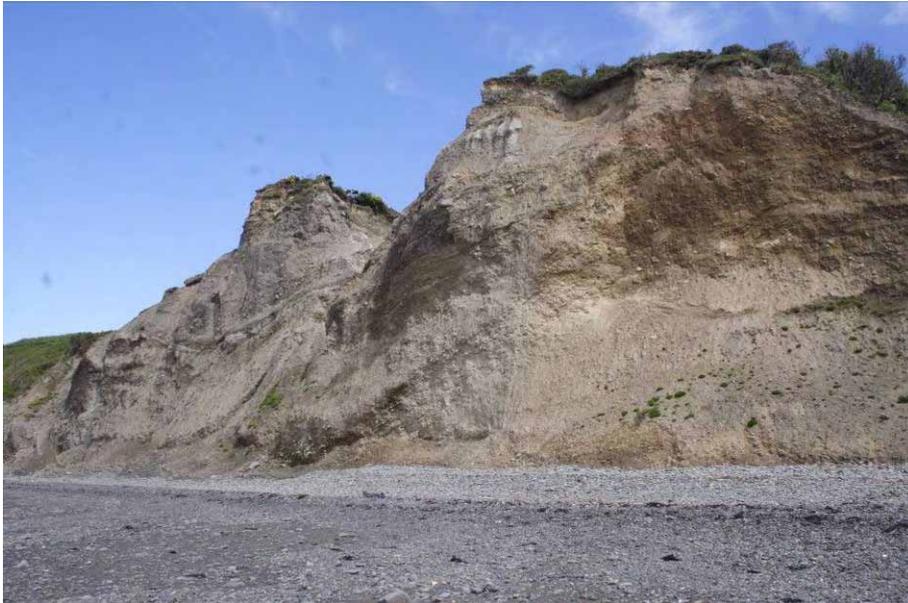
**Photo 32:** Heavily eroded coastline at Gilfach y Halen.

The coastline at Gilfach y Halen was targeted as it has been previously categorised as an area of major coastal erosion. Heavy erosion was visible in all areas of the coastline at this location with access to the northern end prohibited by road closure due to its dangerous nature. A number of large collapses were noted below an adjacent holiday park suggesting that coastal erosion is a major problem in this area and is considered to be the worst case seen on the Ceredigion coast so far. Access was not permissible to either of the two recorded PRNs at this location.

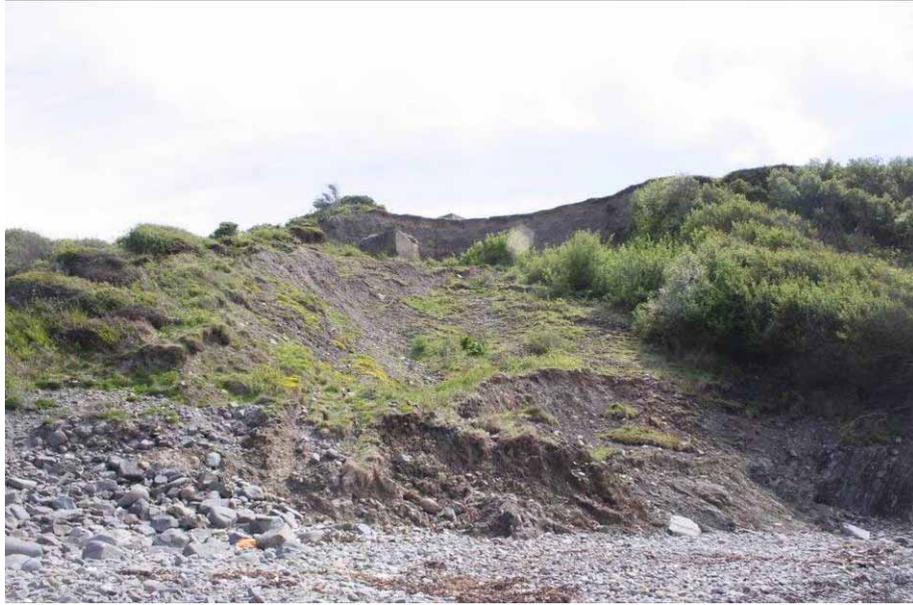
**Photo 33:** Possible military structure at Gilfach y Halen.

Concrete possible military structure identified at Gilfach y Halen. The structure was visible from a distance, set on top of a large area of collapsed cliff. It is unclear whether the structure was originally located on top of the cliff face and has subsequently slipped down or it was constructed after the collapse.

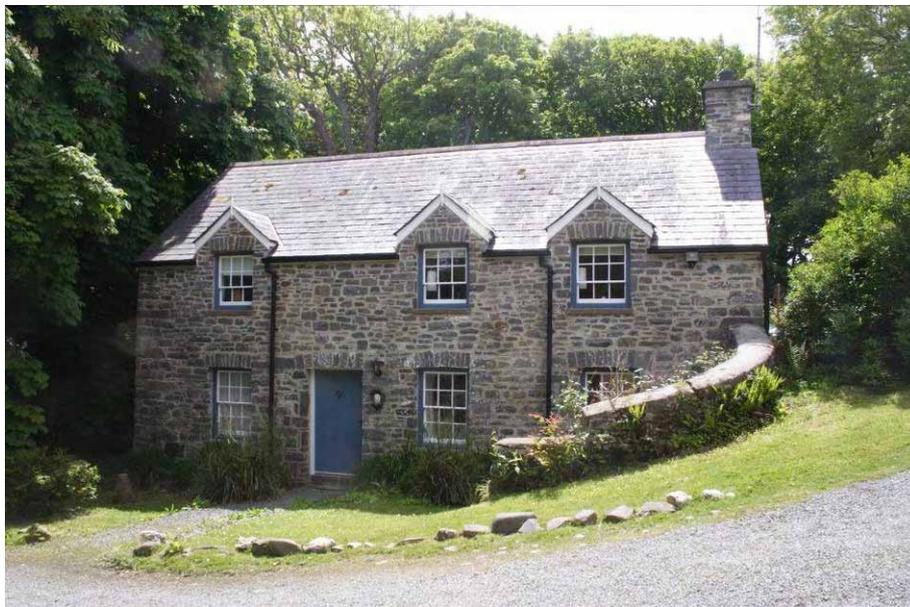
**Photo 34:** Post medieval house on site of Llwynon; Llwyn-Onn.

Medieval settlement site of Llwynon; Llwyn-Onn recorded on the regional HER. No trace of the medieval settlement was identified at this location suggesting that it has been destroyed. However, it was possible to identify a post medieval house on the site consisting of a three bayed two storied stone structure with slate roof. The house appears to have been recently sympathetically restored and is in a very good state of repair.

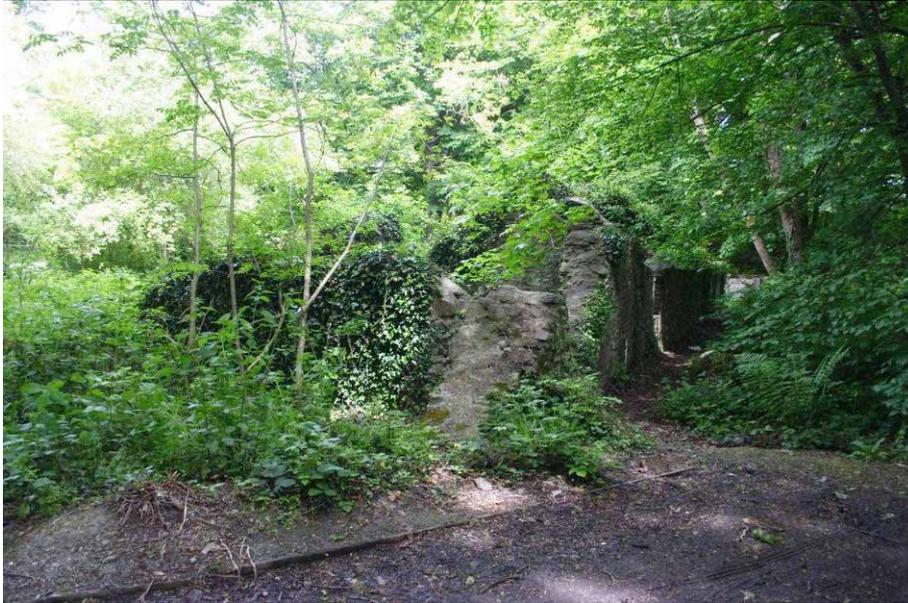
**Photo 35:** Ruins of Llanina Mill.

Abandoned post medieval mill recorded on the regional HER. The structure lies in an area now utilised for car parking and appears to be decaying. Relatively recent consolidation work using concrete appears to have been undertaken which has stabilised the structure. However, ivy has taken hold over much of the structure which is considered likely to cause the fabric to deteriorate as the vegetation will eventually force the masonry apart if left unchecked.

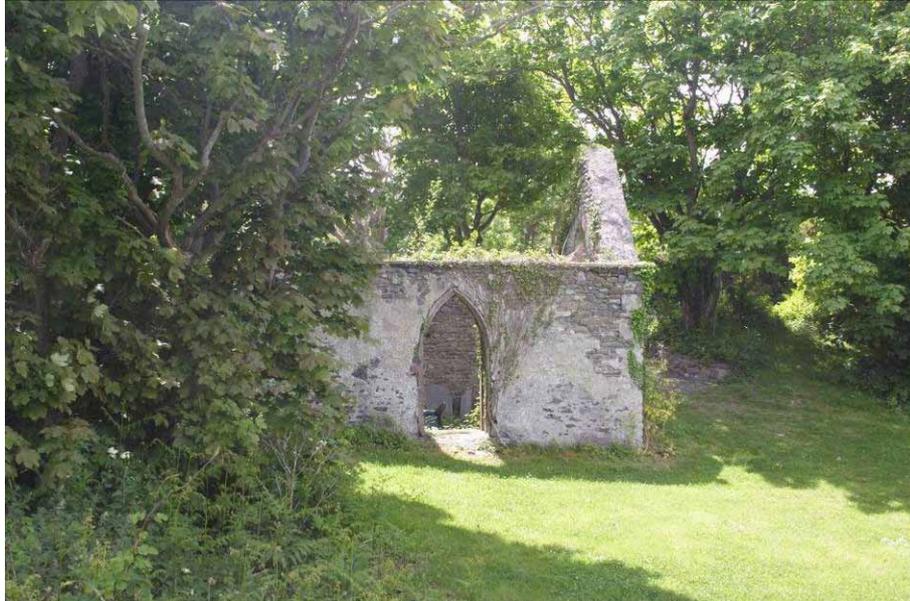
**Photo 36:** Summer house to north of Plas Llanina.

The summer house appears to be stable but is starting to decay with ivy and other vegetation present on the walls. It is also possible that the mortar bonding the walls may be degrading causing structural weakness, whilst the sealing of the

The structure appears to be slightly mislocated on the regional HER, a more accurate NGR would be SN 40453 59816.

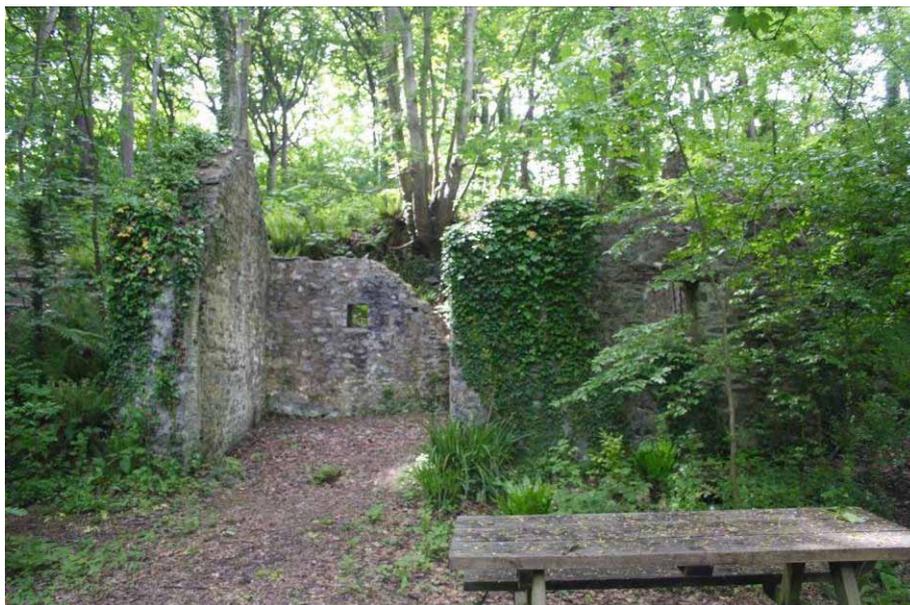
**Photo 37:** Possible former mill house at Llanina.

Possible former stone built mill house associated with Llanina Mill (PRN 29517). The structure is now ruinous but survives to roof height. The rear wall of the structure has partially fallen but now appears to be stable. Areas of cobbled flooring survive beneath the covering of fallen leaves on the ground.

The structure is considered to be decaying and has large areas of ivy covered the stonework which has the potential to eventually destabilise the structure.

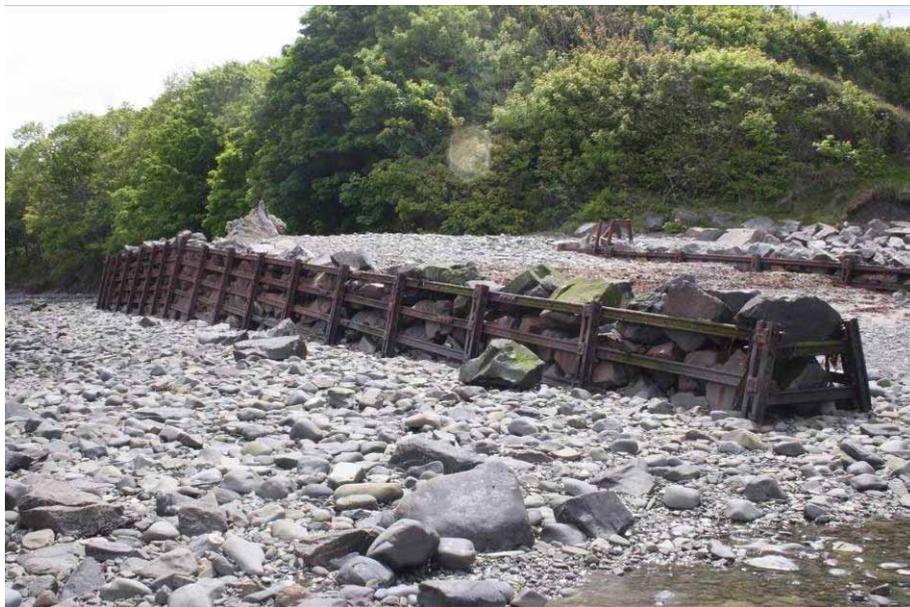
**Photo 38:** Breakwater at Llanina.

Pair of substantial breakwaters constructed of what appear to be former railway lines forming cage like structures filled with large stone. The area between the breakwaters has been filled with beach pebbles by natural processes. The breakwater is considered to be decaying with much of the metalwork corroding.
