# ARFORDIR COASTAL HERITAGE 2010 - 2011

**RHIF YR ADRODDIAD / REPORT NO. 2011/18**  
**RHIF Y PROSIECT / PROJECT RECORD NO. 100612**

**ARFORDIR**  
**COASTAL HERITAGE**  
**2010-2011**

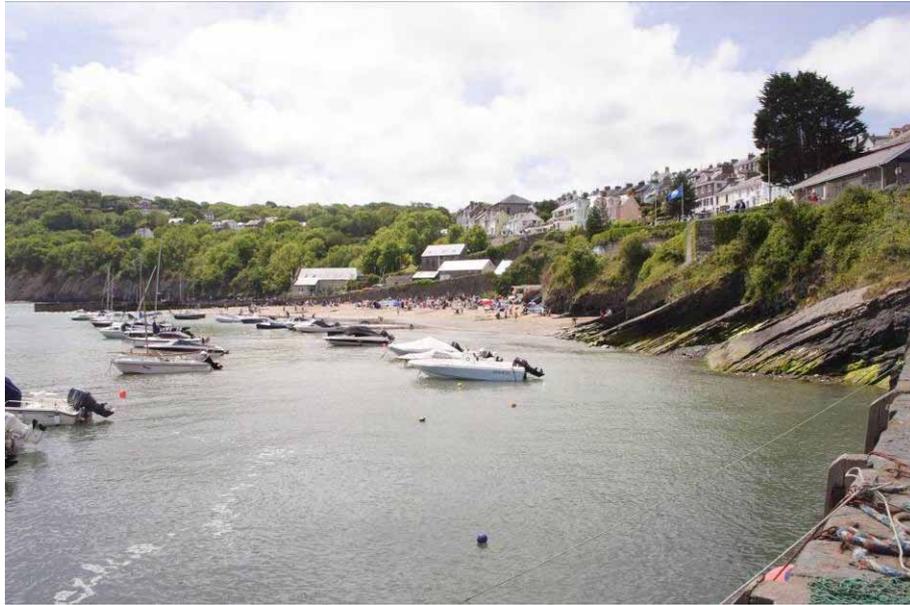
**Photo 39:** New Quay bay from the Harbour.

New Quay was visited as it was categorised as an area under threat of medium to stable coastal erosion. South of the harbour the area appears to be stable with no visible signs of erosion. However, to the north large quantities of large stone have been dumped in an attempt to protect the coastline this has also been undertaken at the seaward end of the harbour wall indicating coastal erosion has been a problem here.

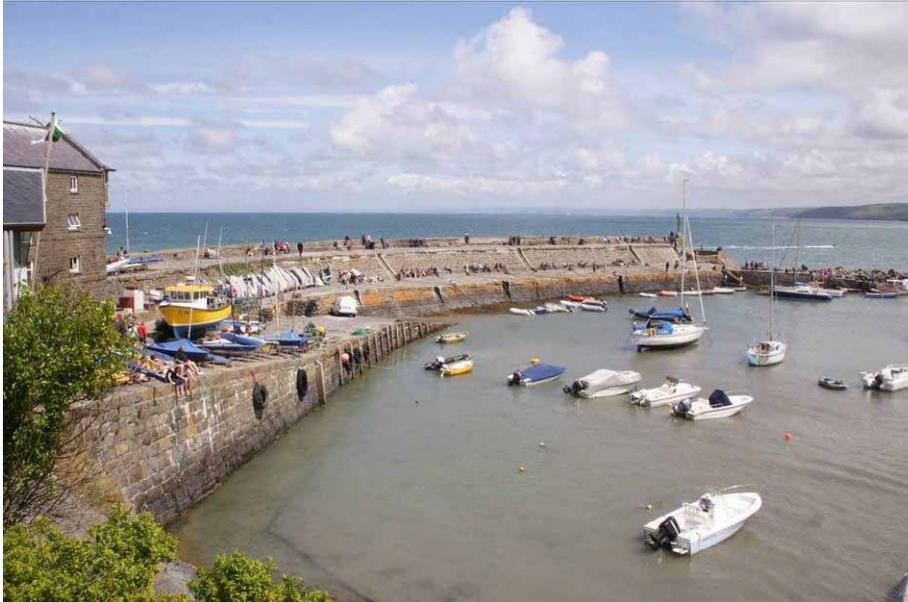
**Photo 40:** Pier and slipway at New Quay from northwest.

Substantial 19<sup>th</sup> century pier constructed of rectangular stone block and incorporating a parallel slipway. Both pier and slipway are in a good state of preservation and do not appear to be immediately under threat from erosion. However, as the pier was partially obscured by water it is unclear if erosion is present beneath the water line and further monitoring would be considered beneficial.

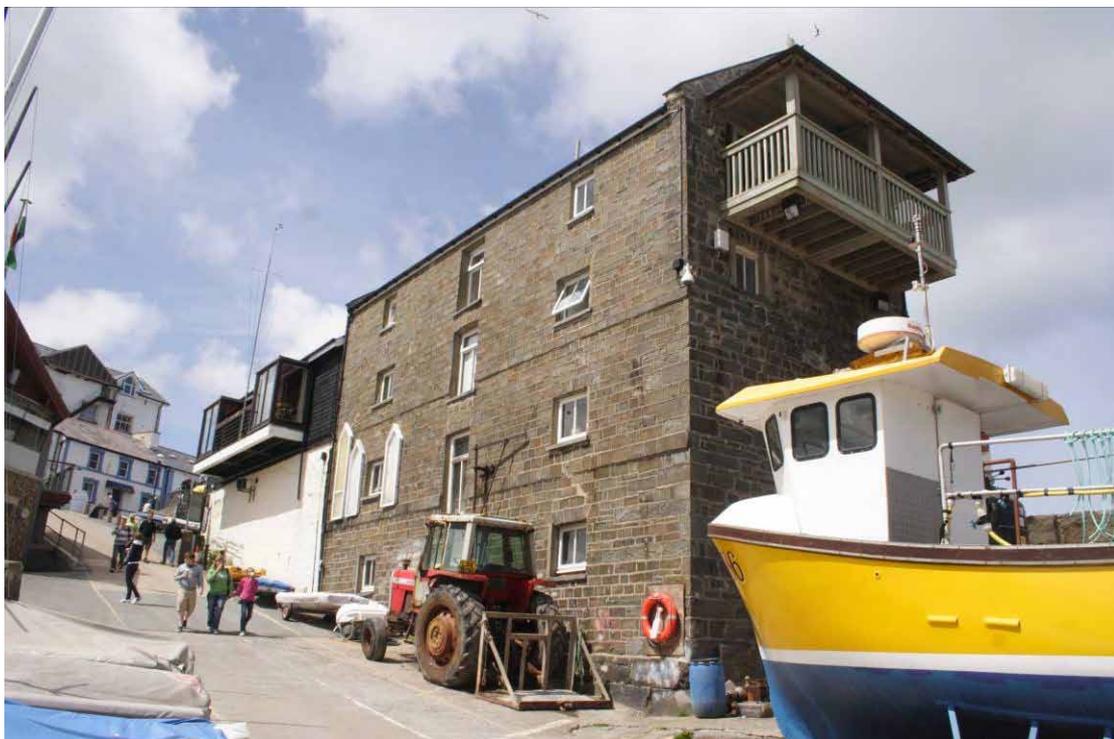
**Photo 41:** Former warehouse now known as the Pier Building.

Grade II listed 19<sup>th</sup> century former warehouse now occupied by the New Quay Yacht Club. The structure, constructed of regularly coursed stone blocks and roofed with slate is in a very good state of repair and appears not to be suffering from erosion, however, a possible threat is its location on a steep access road where it is exposed to possible damage from road vehicles towing boats and trailers to and from the pier area.

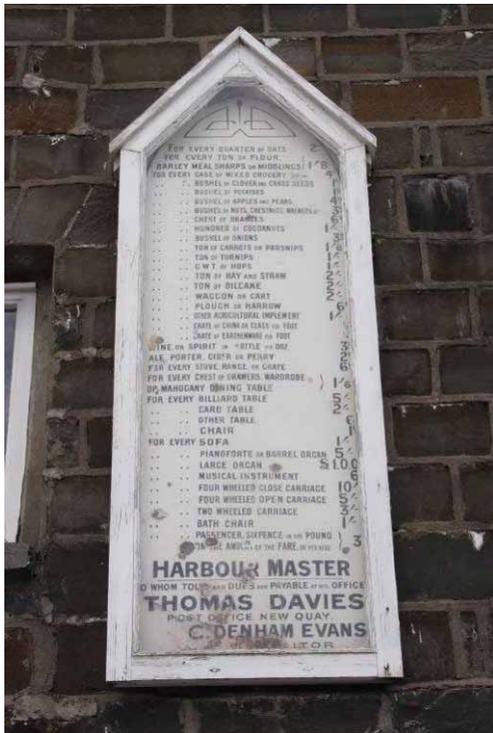
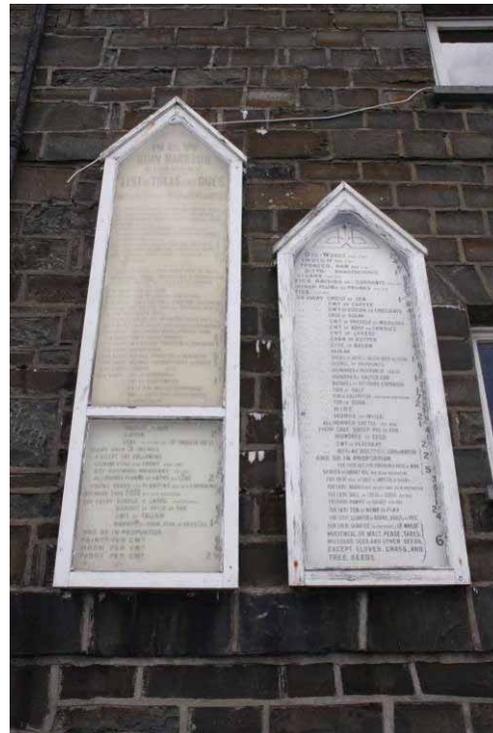
**Photo 42:** Enamel tariff boards fixed to wall of New Quay Yacht Club.

Three late 19<sup>th</sup> – early 20<sup>th</sup> century enamel tariff boards detailing fees payable for all manner of goods landed at New Quay are present on the wall of the structure and are considered to be rare survivors of their type. The signs are housed in timber glass and Perspex casings that provide protection for the signs which have apparently been restored in recent years although corrosion is visible in some places. The casings housing the signs appear to be decaying and in need of maintenance and may possibly be no longer be water tight which may cause water to cause corrosion of the signs if left unchecked. Enamel signs such as those at New Quay are highly collectable can command considerable prices and are considered to be at risk from theft.

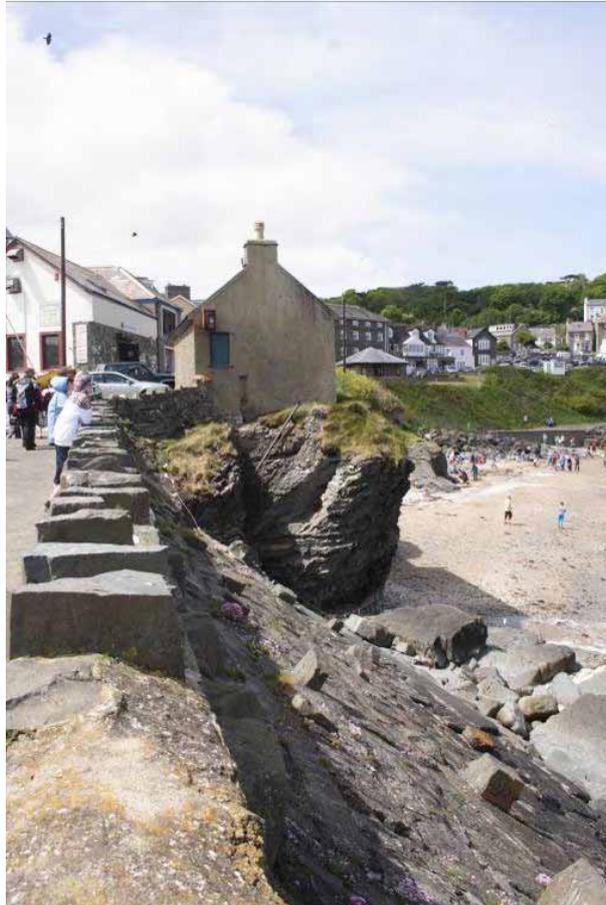
**Photo 43:** Former life saving apparatus house.

Late 19<sup>th</sup> century former life saving apparatus house that currently appears to be abandoned. The structure is concrete rendered with slate roof and is now decaying. The structure is situated on an exposed small rock outcrop overlooking the adjacent beach.

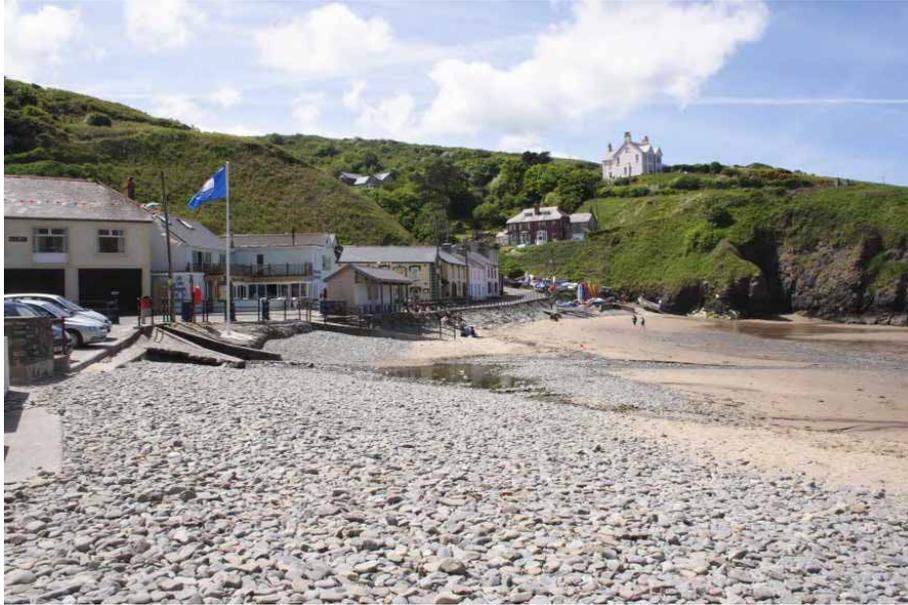
**Photo 44:** Llangranog seafront looking south.

The coastline between Llangranog and Pendinaslochdin to the north was visited as it lies within an area of medium coastal erosion. During the site visit stone sea defences were noted along the sea front of Llangranog suggesting that erosion has previously been a problem at this location but this now appears to have been addressed and the seafront at present is now considered to be stable.

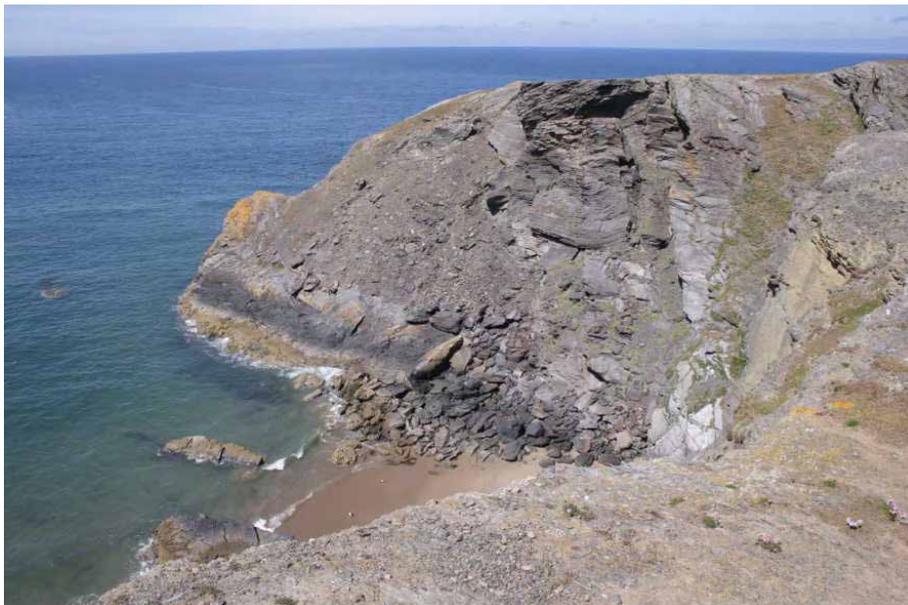
**Photo 45:** Coastline at Ynys Lochtyn facing north.

However to the north of Llangranog erosion appears to be more of a problem with large areas of eroded cliff noted especially around the area of Ynys Lochtyn.

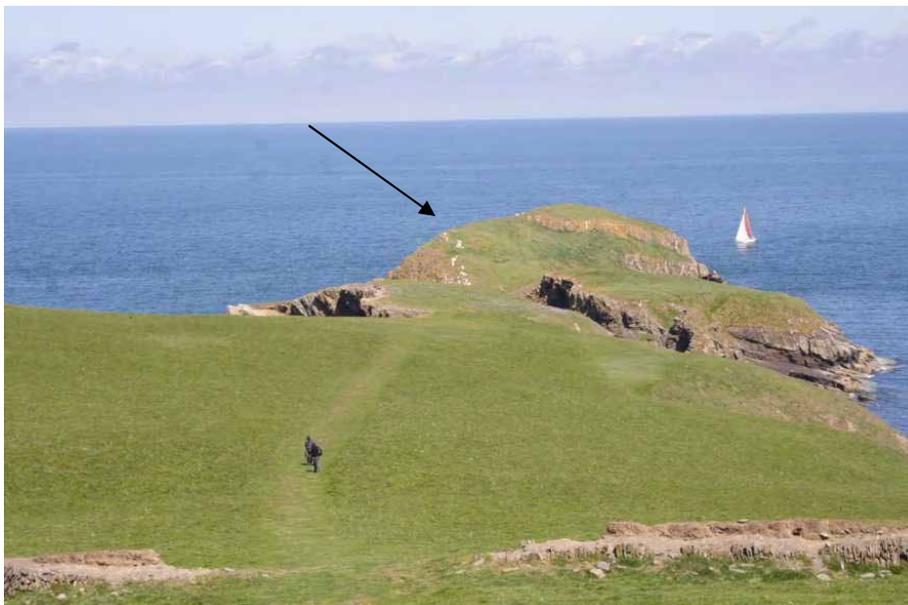
**Photo 47:** Ynys Lochin defended enclosure from southeast.

The scheduled Iron Age defended enclosure has been severely eroded on all sides, with the north end of the promontory completely inaccessible. Previous visits to the site indicate the presence of hut circles and earthwork features that may be of early medieval date (PRN 7531). No evidence of hut circles was

identified during the site visit, however, it was possible to identify a heavily eroded bank running east - west across the promontory. The bank is considered to be eroding as a result of 'footfall' erosion with areas of the turf completely eroded away exposing the soil of the bank. In addition a depression on the western side of the bank suggests that part of it may have been removed.

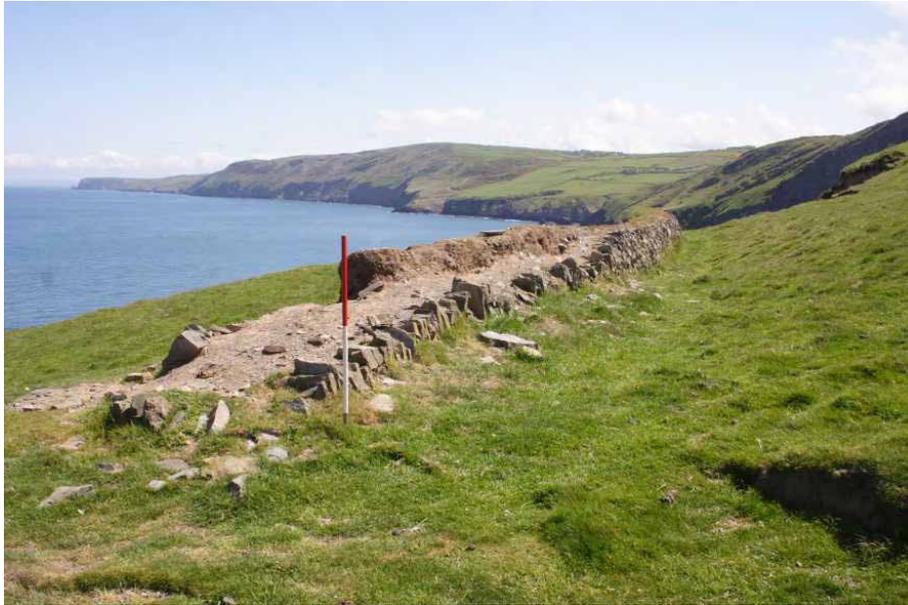
**Photo 50:** Heavily eroded bank at Ynys Lochtin.

Suggested former outer defensive bank of Ynys Lochtin defended enclosure. The bank, revetted with stone, is being severely eroded by both animal and human 'footfall' and is considered to be threatened with complete destruction if the situation is not addressed. The central portion of the bank has almost completely been destroyed and the whole structure appears to be surrounded by grassed over stone. A slight trace of a ditch survives on the south side of the wall. It is considered that consolidation work is urgently needed to prevent further erosion taking place. An updated description of this site has been made as part of the Defended Enclosures project, which is in the process of being updated to the HER. In that report this ditch is not considered to be of high archaeological significance, relating to a post medieval field boundary.

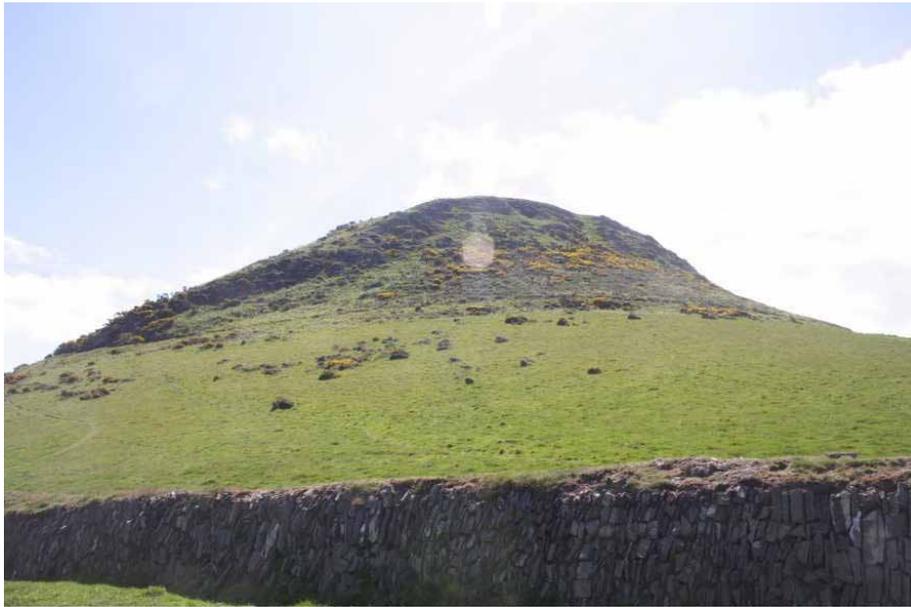
**Photo 51:** Pendinaslochdin hillfort from north

A broadly circular enclosure set on a steep hilltop at the south end of Ynys Lochtin promontory the site was not accessed. However, it was possible to view that coastal erosion is threatening both the west side where the cliff top now stands at a distance of c.10m from the base of the hill, whilst on the northeast the cliff top is currently c.17m. Erosion is more apparent on the western side and is evidenced by recent collapses in the cliff. Further monitoring is considered important for this area to assess the rate at which the cliffs are eroding.

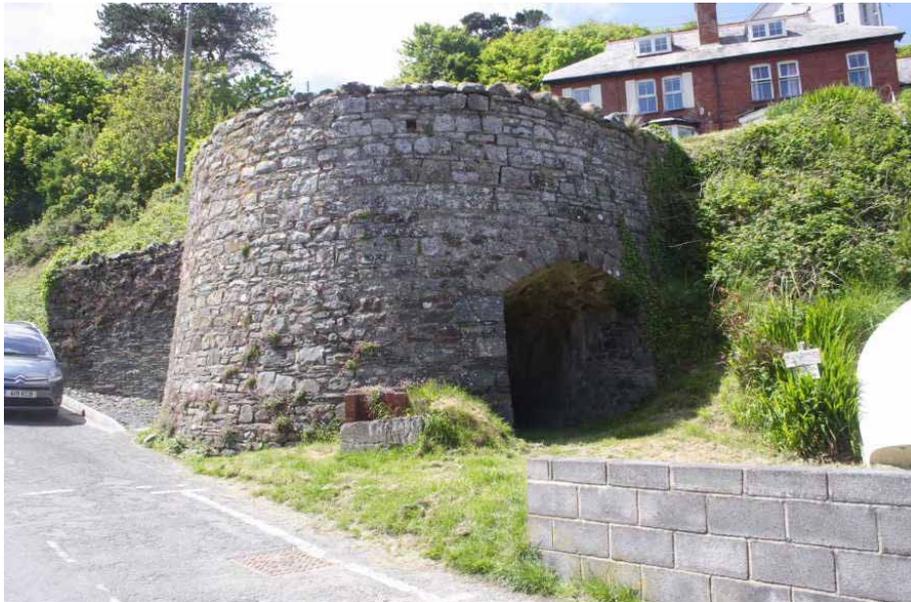
**Photo 52:** Lime kiln at Llangranog beach from northeast.

Substantial stone pot kiln with two draw holes piercing the northeast and southwest walls. The southwest draw hole retains a partially broken stone lintel

bearing the date 1887. The structure appears to be stable with very little evidence for decay.

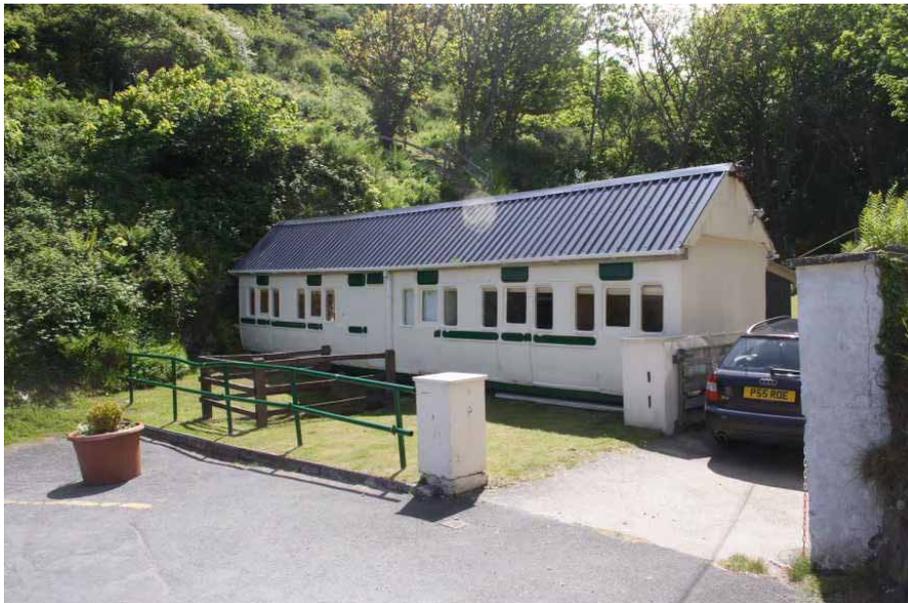
**Photo 54:** 19<sup>th</sup> century converted railway coach at Llangranog.

Former GWR five compartment luggage composite coach surviving as body only and now utilised as a dwelling with corrugated metal sheeting pitched roof.

The carriage appears to be in a good state of repair with a recently renewed roof and the windows still retaining 'No Smoking' signs that probably date from the early 20<sup>th</sup> century. However, a stream runs beneath the centre of the carriage which may cause the carriage to subside if left unchecked.

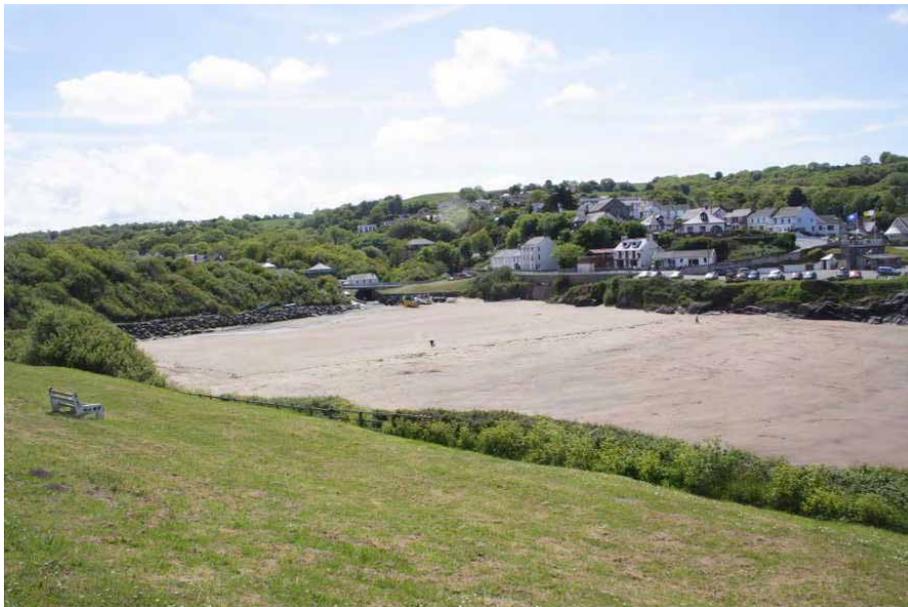
**Photo 55:** Traeth Dyffryn, Aberporth.

Whilst Aberporth is located in an area considered to be of stable coastal erosion a visit was made to reassess the area. It was found that the coastline in the area remains stable with very little evidence for erosion.

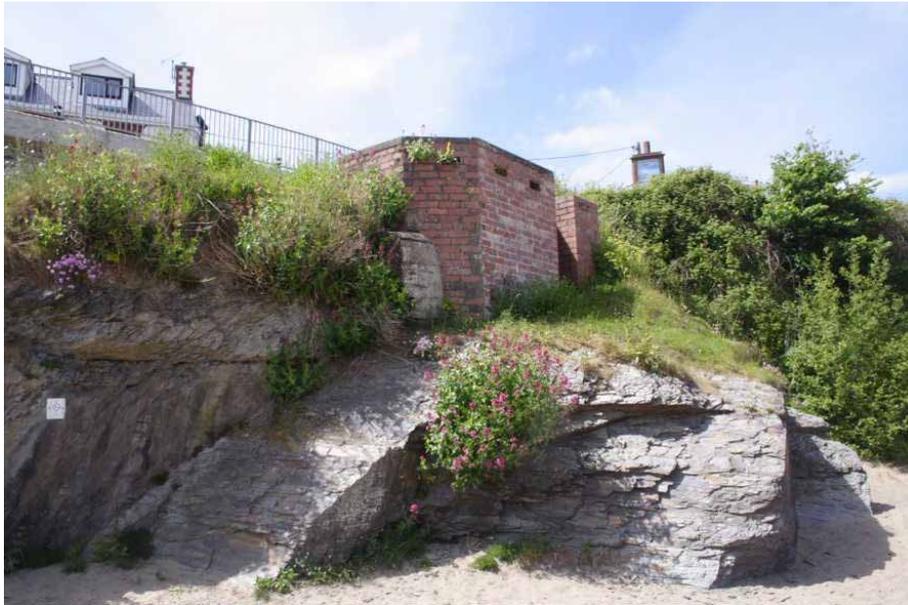
**Photo 56:** Pill box/ observation post at Aberporth Beach.

Red brick and concrete pill box / observation post located overlooking Treath Dyffryn and set on a rock outcrop. The south east corner of the structure is set an angle is pierced by a single opening. The south wall is pierced by two further openings. Access to the structure is through a door in the north wall which is protected by a brick screening wall.

On the regional HER the structures NGR is given as SN 2585 5148 which places it to the west of its actual location. A more accurate grid reference would be SN 25863 51482. The structure appears to be stable at present but decay is beginning to set in.

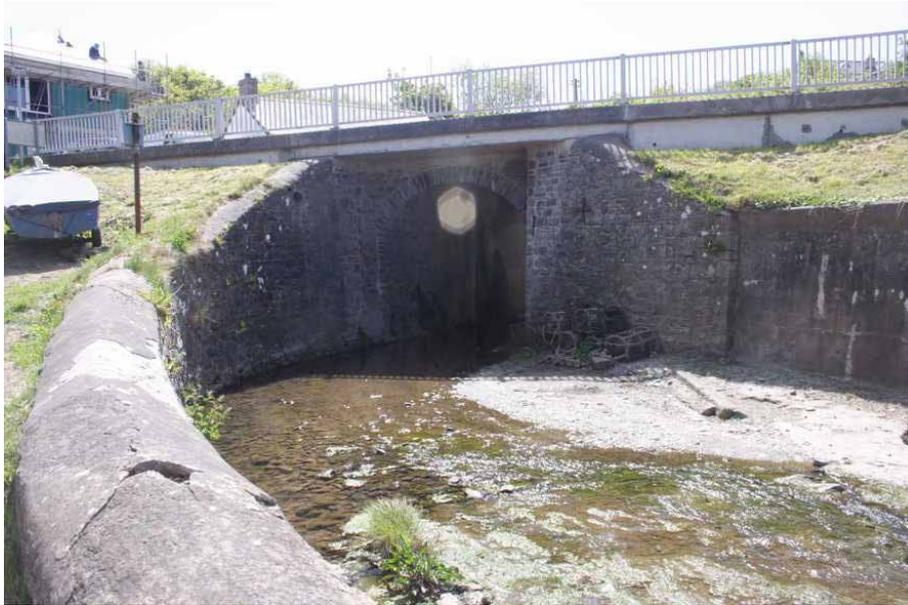
**Photo 57:** Ffordd y Odyn bridge, Aberporth.

Single arched stone bridge over stream that carries road now known as Ffordd y Odyn. The bridge appears to have been constructed sometime between the late 19<sup>th</sup> and early 20<sup>th</sup> centuries. The road above the bridge has been strengthened recently and any parapet that once existed has now gone.

The bridge appears to be in a good state of preservation with little or no signs of decay. Some relatively recent repointing work has been undertaken on the northwest corner of the bridge. A tie bar is also visible to the right which may suggest previous weakness in the bridge structure.

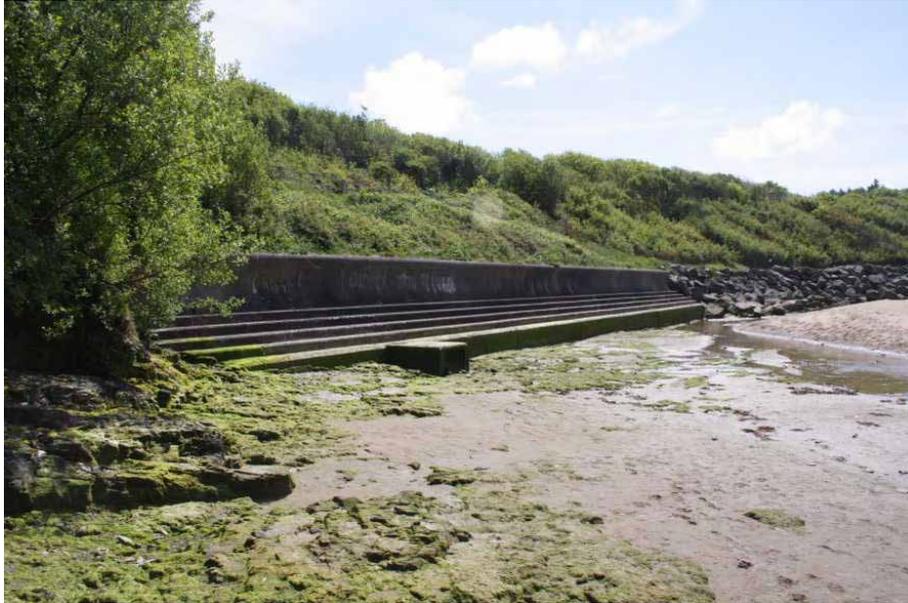
**Photo 58:** Concrete and stone sea defences at Traeth Dyffryn beach, Aberporth.

The sea defences are free from erosion and decay at present but this is considered likely to change over time.

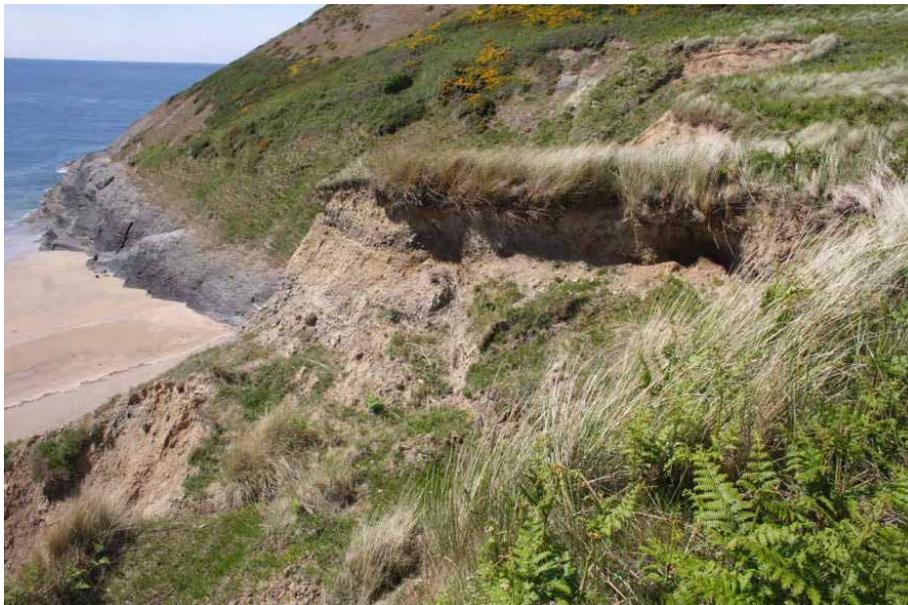
**Photo 59:** Eroded cliff edge at Mwnt showing exposed soil.

Mwnt was visited as it lies in an area considered to be threatened by a medium level of coastal erosion. Coastal erosion in the form of cliff collapses of quite recent date were identified which were concentrated in the central area of the bay.

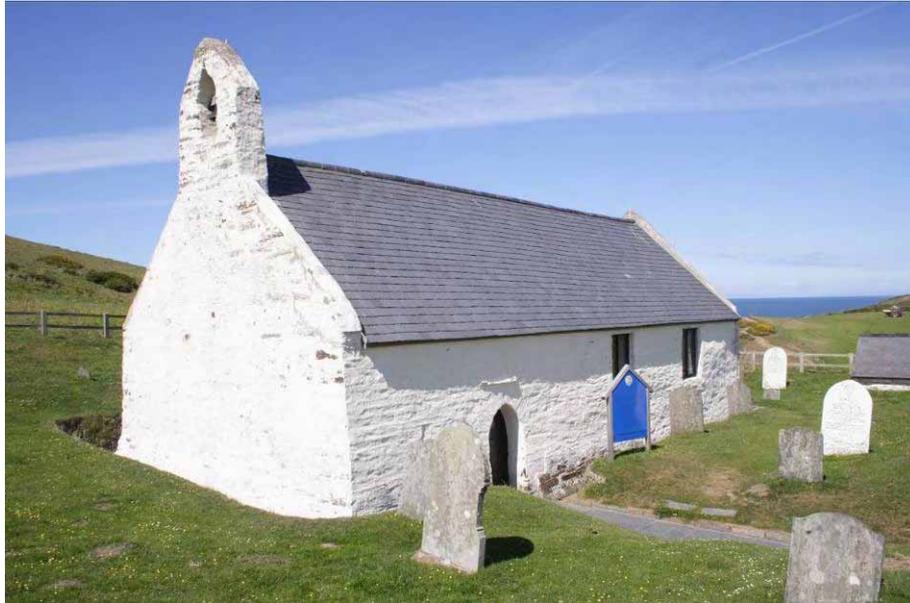
**Photo 60:** Holy Cross Church Mwnt

Medieval church recently restored and currently limewashed. The church appears to be in a very good state of repair with the only visible sign of erosion being the loss of some of the limewash on the west gable end. The church is recorded on the regional HER as a parish church but is now a chapelry of Y Ferwig Parish.

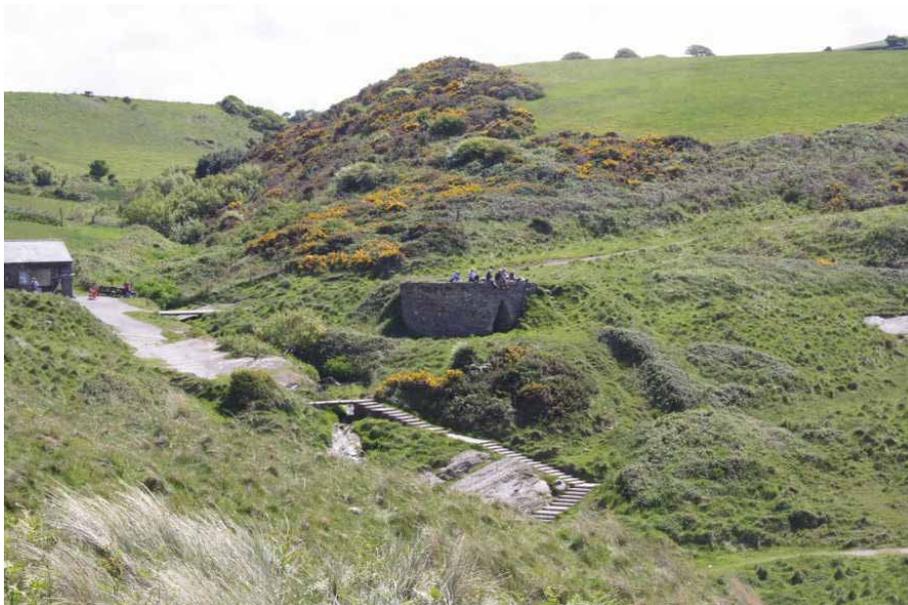
**Photo 61:** Lime kiln at Mwnt.

Substantial stone built pot kiln with single draw hole piercing the north side. The kiln appears to be partially terraced into the hillside and is in a good state of preservation.

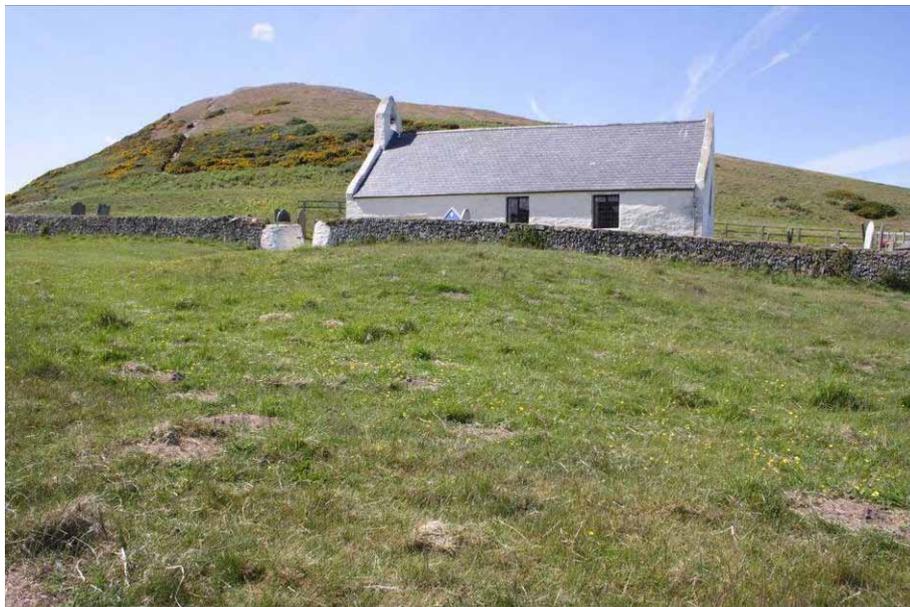
**Photo 62:** Round barrow adjacent to Mwnt Church.

Circular grassed over round barrow c.15m in diameter surviving to a height of c.1m. The barrow has been partially overlain by the adjoining churchyard on its northwest side, whilst on the southwest a footpath cuts through the barrow. Animal burrowing was noted on the barrow which has the potential to disturb underlying archaeological deposits. Antiquarian accounts refer to 'burials' in a mound near the church being exposed by shifting sands. These burials are traditionally attributed to a medieval battle.
