BEILI DYFFRYN, CARMARTHENSHIRE

Archaeological Investigation of a possible Medieval Long House and survey of a Neolithic Chambered Tomb

RHIF YR ADRODDIAD / REPORT NO. 2010/11
RHIF Y PROSIECT / PROJECT RECORD NO. 99630

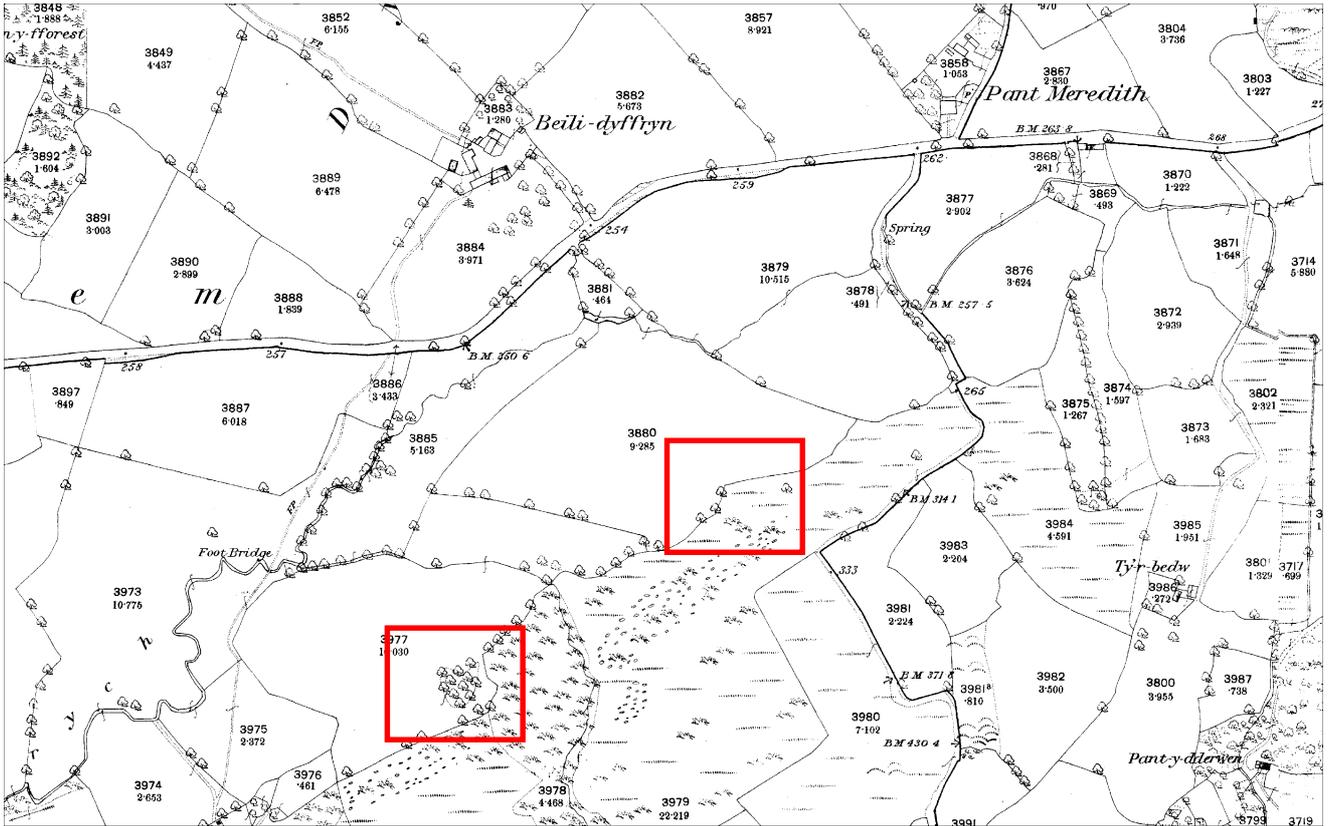
2.1.4 Map evidence from the 1880s and 1906 (Figures 3 and 4) show that the neither the medieval longhouse or chambered tomb are labelled, although clues to their location are visible. The site of the medieval longhouse is indicated by the slight kink in the boundary wall along the southern edge of the field in which it lies. This kink corresponds to that which still exists today.

Figure 3: Extract of the 1886 1:2500 1st Edition Ordnance Survey map showing longhouse location central and chambered tomb to bottom left.

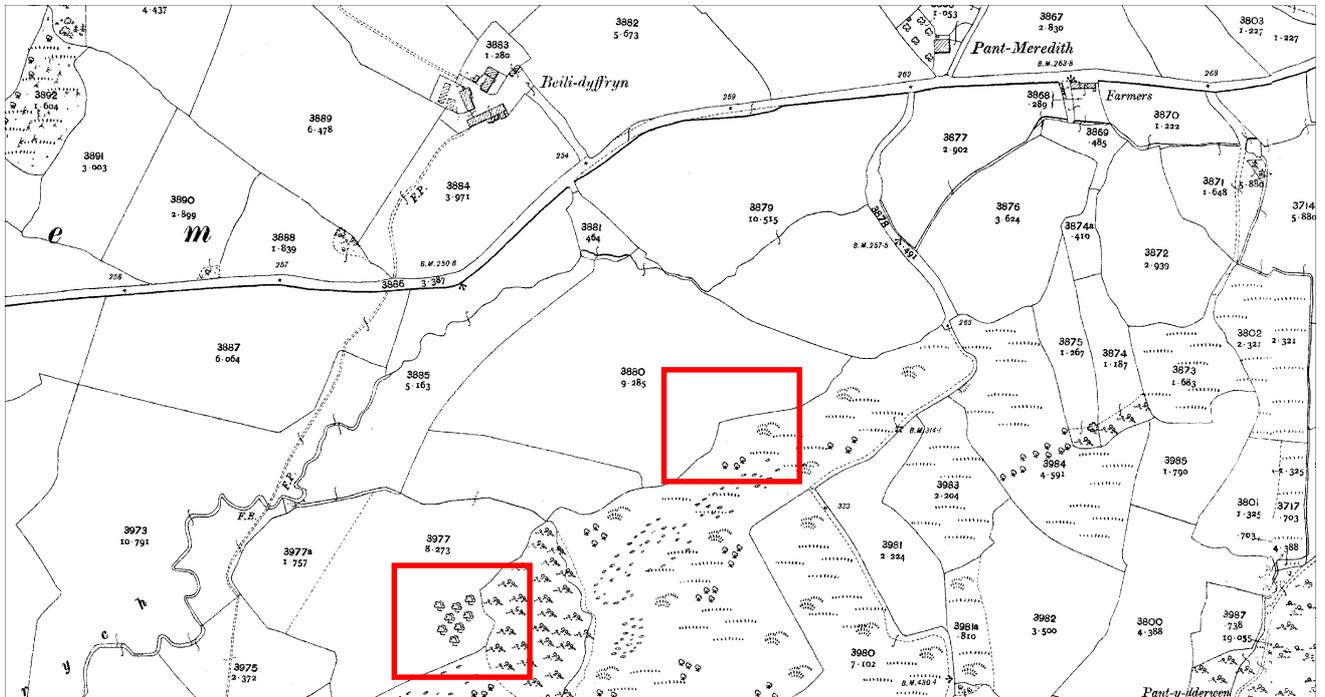
2.1.5 The Neolithic chambered tomb, known as Cae'r Ganfa or Cil y Ganfa indicated by a small patch of woodland. In general neither map alters significantly from the existing ordnance survey map as illustrated above (Figure 2).

Figure 4: Extract of the 1906 1:2500 2nd Edition Ordnance Survey map showing longhouse location central and chambered tomb to bottom left

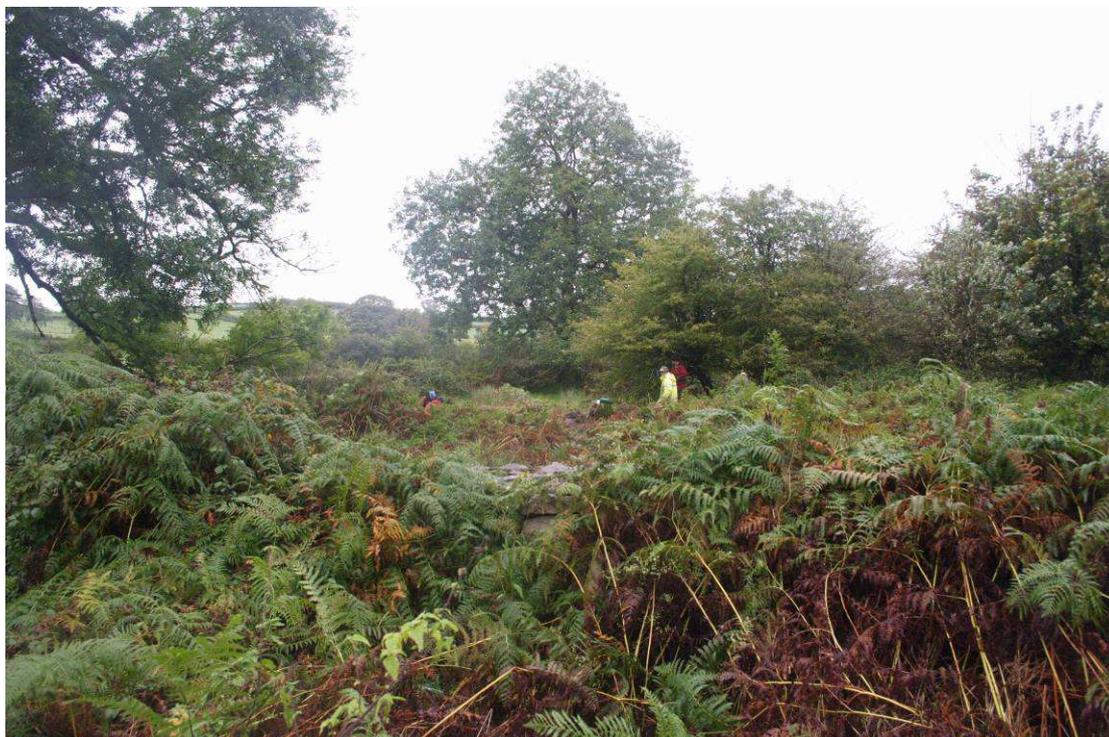
3.2.1 The site of the long-house was very overgrown with bracken and brambles, and some small trees (blackthorn/hawthorn) covering the southern half of the structure. The first day was spent clearing the northern end of the building of vegetation cover (no trees were removed during the works).

Photo 1: Initial site clearance of the medieval long house

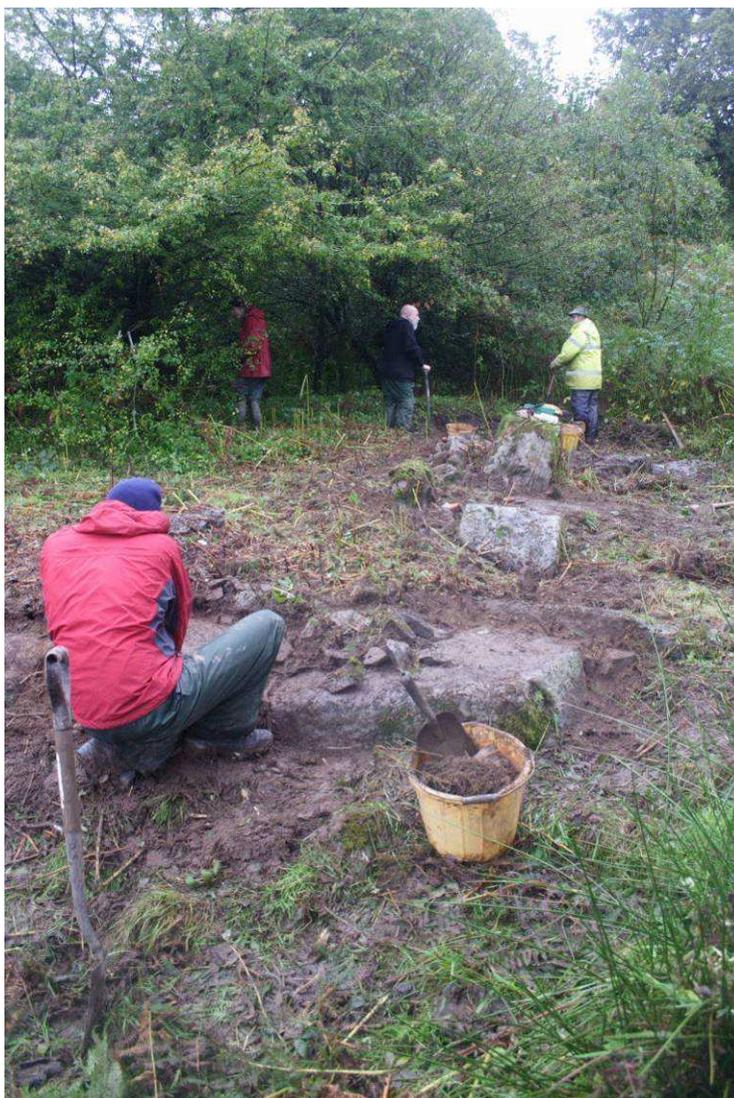
3.2.2 The building was substantially more overgrown than when it was first surveyed in 1993, at which time almost all of the walls of the building were visible. The structure was aligned roughly northwest-southeast along its long axis. Two rooms could be identified within the building, with the possibility of a third at the southeastern end of the structure formed by the end wall of the building and natural outcropping rock. Following clearance of the structure during these works the northwestern room was clearly defined with a dividing wall between the two rooms. The second room was not so clearly visible being very overgrown, although further limited clearance demonstrated its alignment.

Photo 2: Further clearance work revealing the northwestern end of the building

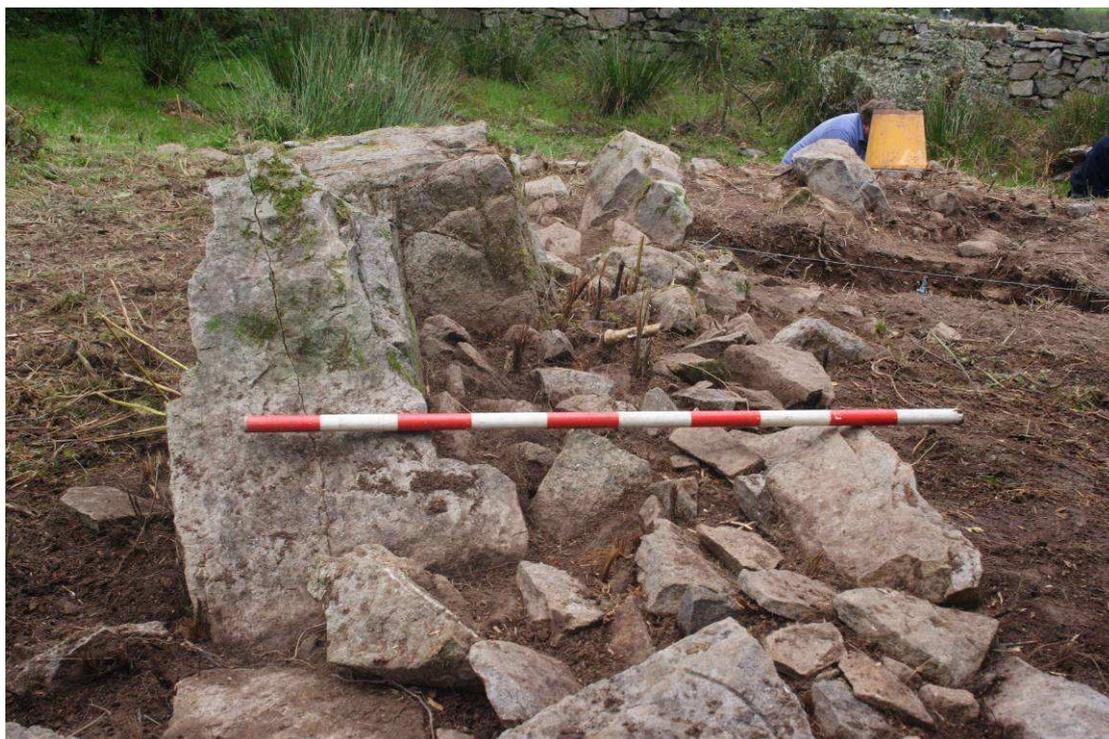
3.2.3 The exposed walls of the building showed no clear evidence of bonding material, implying either they were originally dry-stone or that they were clay bonded which had substantially washed away. The stone used in the structure were locally sourced from the outcrops on the slopes of Carn-Goch. The size of the stones varied from small angular blocks to very large slabs and boulders which were mostly used as the footings for the structure, especially along the northern end of the building. The northwestern end had evidently been built on a raised platform, which reduced towards the south as the natural ground level begins to rise.

Figure 3: View south along western wall of building (205) showing variations in size of stones used in construction

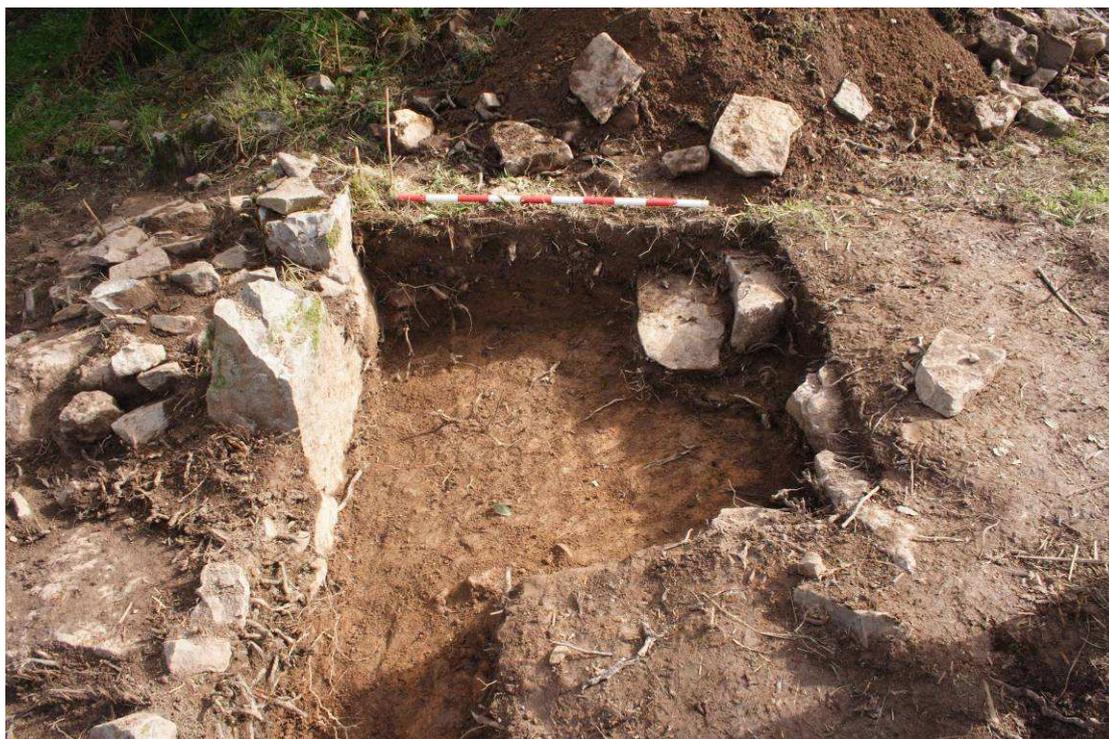
3.2.4 Three trenches were excavated within the northwestern end of the building, one in the northeast corner of the building, a second along the western wall of the building in the northern part of the room and a third on the eastern side of the building adjacent to the dividing wall between the two rooms. The trenches in the northern part of the room demonstrated a c.0.15 – 0.25m depth of topsoil and rubble, which had evidently accumulated within the abandoned building. The lack of many larger stones within this area suggests that the majority of stone had been removed for use elsewhere in antiquity. Below the topsoil a more fine sandy clay soil was encountered, of a light brown colour, with far fewer stones within, which was tentatively identified as a floor layer. In both trenches a few small thin flat stones were revealed all at a very similar level) which are likely to have been the remnants of a slab floor, although it had been much disturbed. The lower sandy clay soil was removed indicating a depth of between 0.12 and 0.22m before a similar sandy clay soil was exposed that was slightly more compact and lighter (yellowish brown) than that above. It is considered that this material was that used to create the raised platform on which this end of the building sits. Some small sherds of pottery were recovered from the layer beneath the topsoil, possibly Dyfed gravel tempered ware, of later medieval/post-medieval date.

Photo 4: Trench 3 in northeastern corner facing south, showing eastern wall (305) and two stones possibly relating to earlier flagged floor (304)

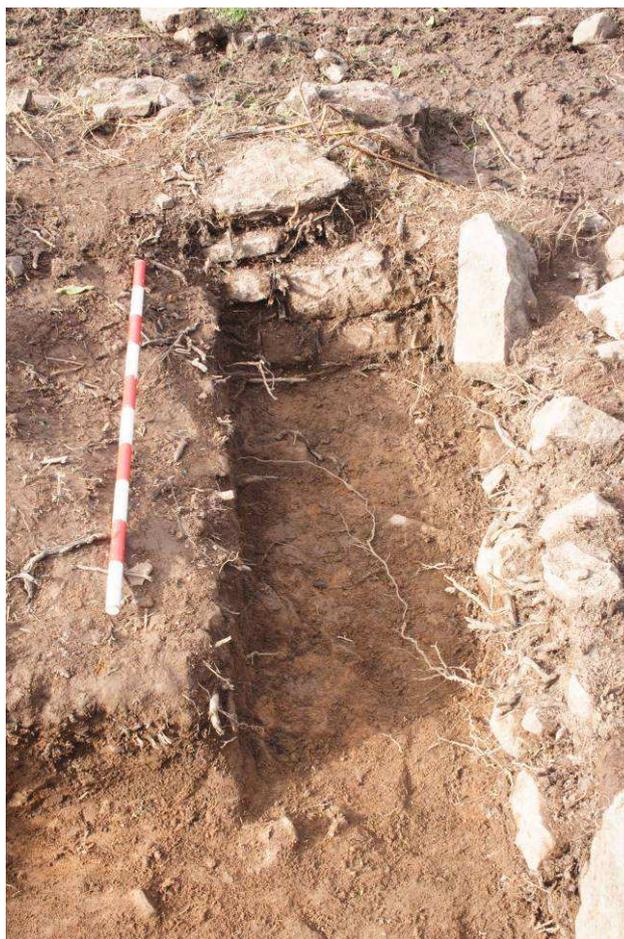
3.2.5 Within the trench in the northeastern corner a small section of the northern internal wall was exposed. On the internal face would appear to have been crudely faced and coursed using smaller more regular shaped stone. This contrasted with the visible external face of the wall in this area, which was comprised of substantial stone blocks, and far less visible coursing or facing (although this may have been due to collapse and removal of stone). The eastern face of the internal wall was also far more irregular comprising larger stones mixed with smaller ones.

Photo 5: Trench 3 in northeastern corner facing north showing internal face of north wall of building (306), with eastern wall along side (305)

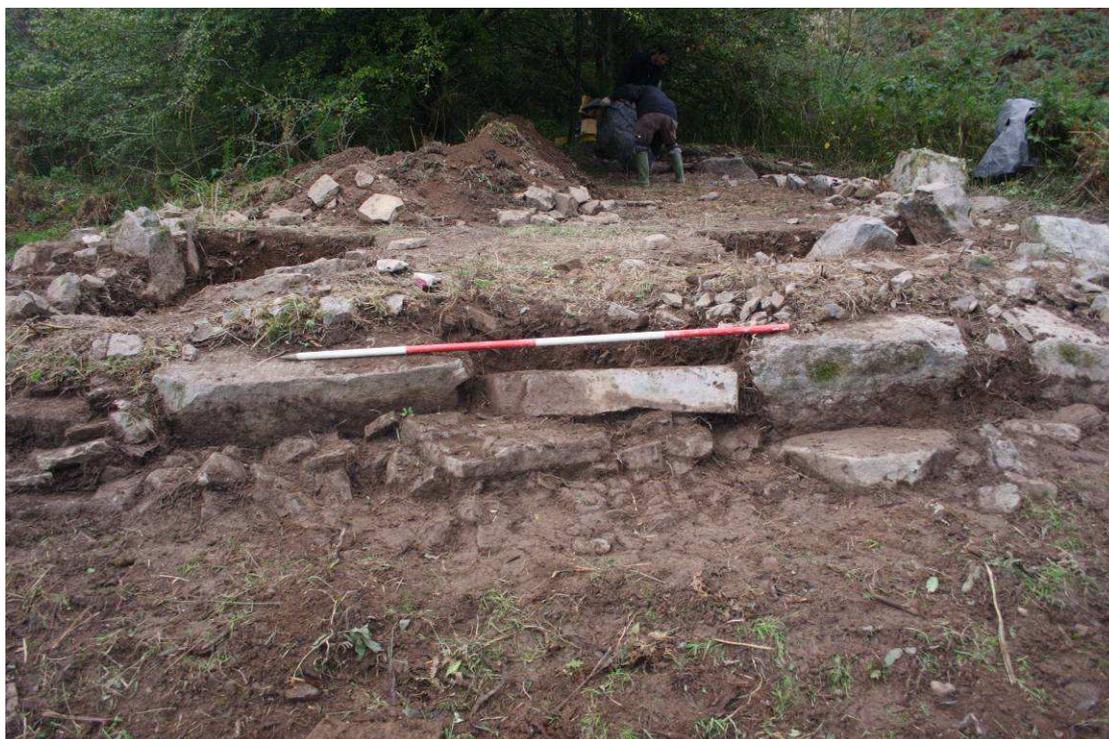
Photo 6: External face of northern wall of structure (306) showing substantial blocks used in its construction

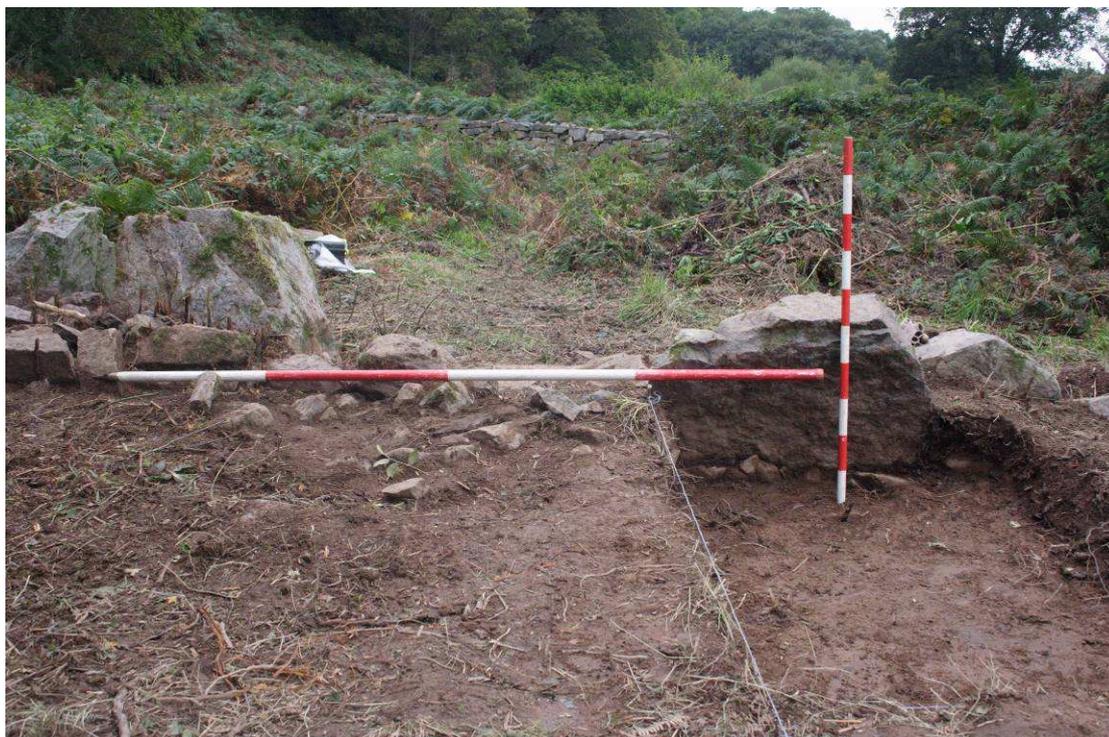
3.2.6 The trench on the western side of the building exposed part of the face of the western wall, which mostly comprised a single substantial stone with smaller stones around.

Photo 7: Trench 3 along western wall of building, facing west, showing part of trench and a length of the wall

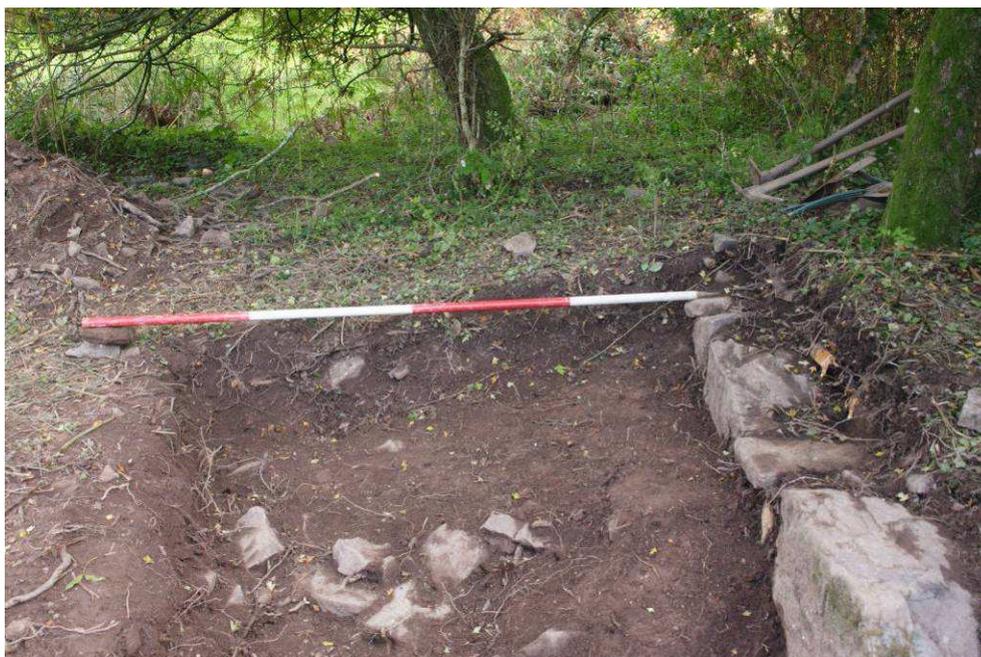
3.2.7 The trench adjacent to the dividing wall in the centre of the building revealed an entrance to the building accessing from the western side. Stones were also placed projecting out from the entrance possibly indicating a porch structure / windbreak or alternatively wall used to herd livestock into the building. No floor level was identified within this area, the main stratigraphic sequence comprising a c.0.25m deep layer of topsoil and rubble lying on top an orangey brown sandy clay, which containing lots of root activity and was not as free of stones as that excavated to the north. On the southern side of the trench, adjacent to the dividing wall, an area of ash and burnt sand was present within a subsoil under a thinner depth of topsoil. It is considered most likely that this is a dump of material derived from cleaning out a fire. It is not clear whether the ash derived from the use of the structure, or a later episode of burning following abandonment of the structure. The location of the material within the building would suggest that the latter hypothesis is more likely.

3.2.8 The dividing wall along the south of the trench was constructed of fairly regular long blocks of stone, implying a fairly neat face to the wall. Only a small part of the wall was exposed, and only to a single course in height.

Photo 8: Trench 1 adjacent to dividing wall, facing east

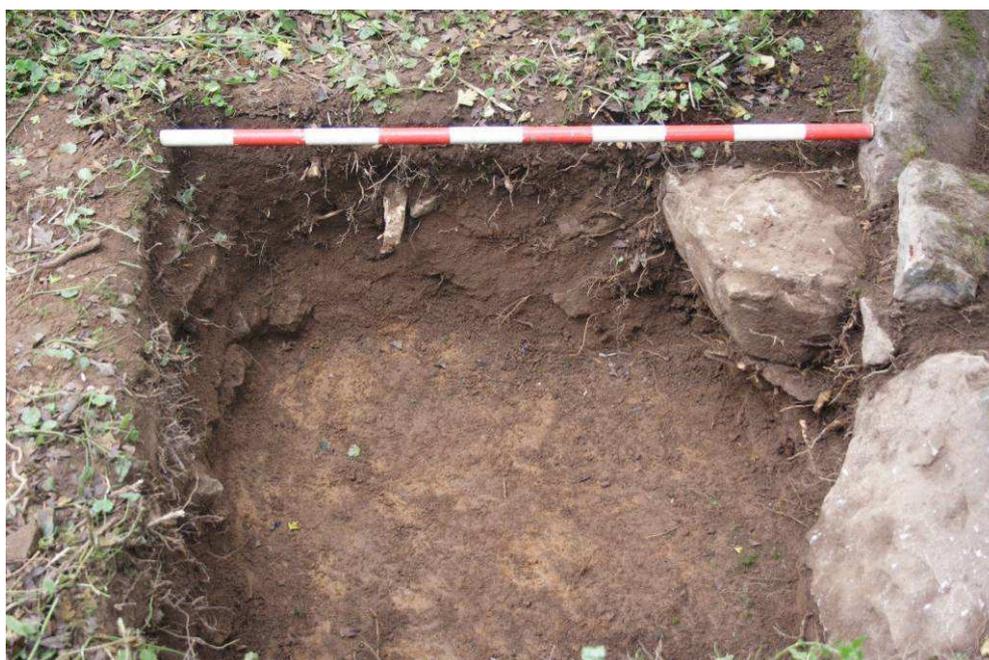
3.2.9 A fourth small trench was located within the southern room of the building adjacent to the eastern wall. This trench revealed a topsoil depth of around 0.45m containing far more rubble than had been seen in the other trenches. Below the topsoil a sandy clay was revealed of light brown colour, which may have been natural subsoil or a similar layer of material associated with the construction of the raised platform on which the building sits. No evidence of flooring was seen. The topsoil within this trench contained a number of artefacts probably dating from the 19th century onwards. No earlier finds were recorded. The eastern wall of the building in this part of the site was very irregular in its construction with no clear facing or coursing (although was constructed of mostly medium sized stones).

Photo 9: Trench located in southern room showing part of eastern wall (502), facing north

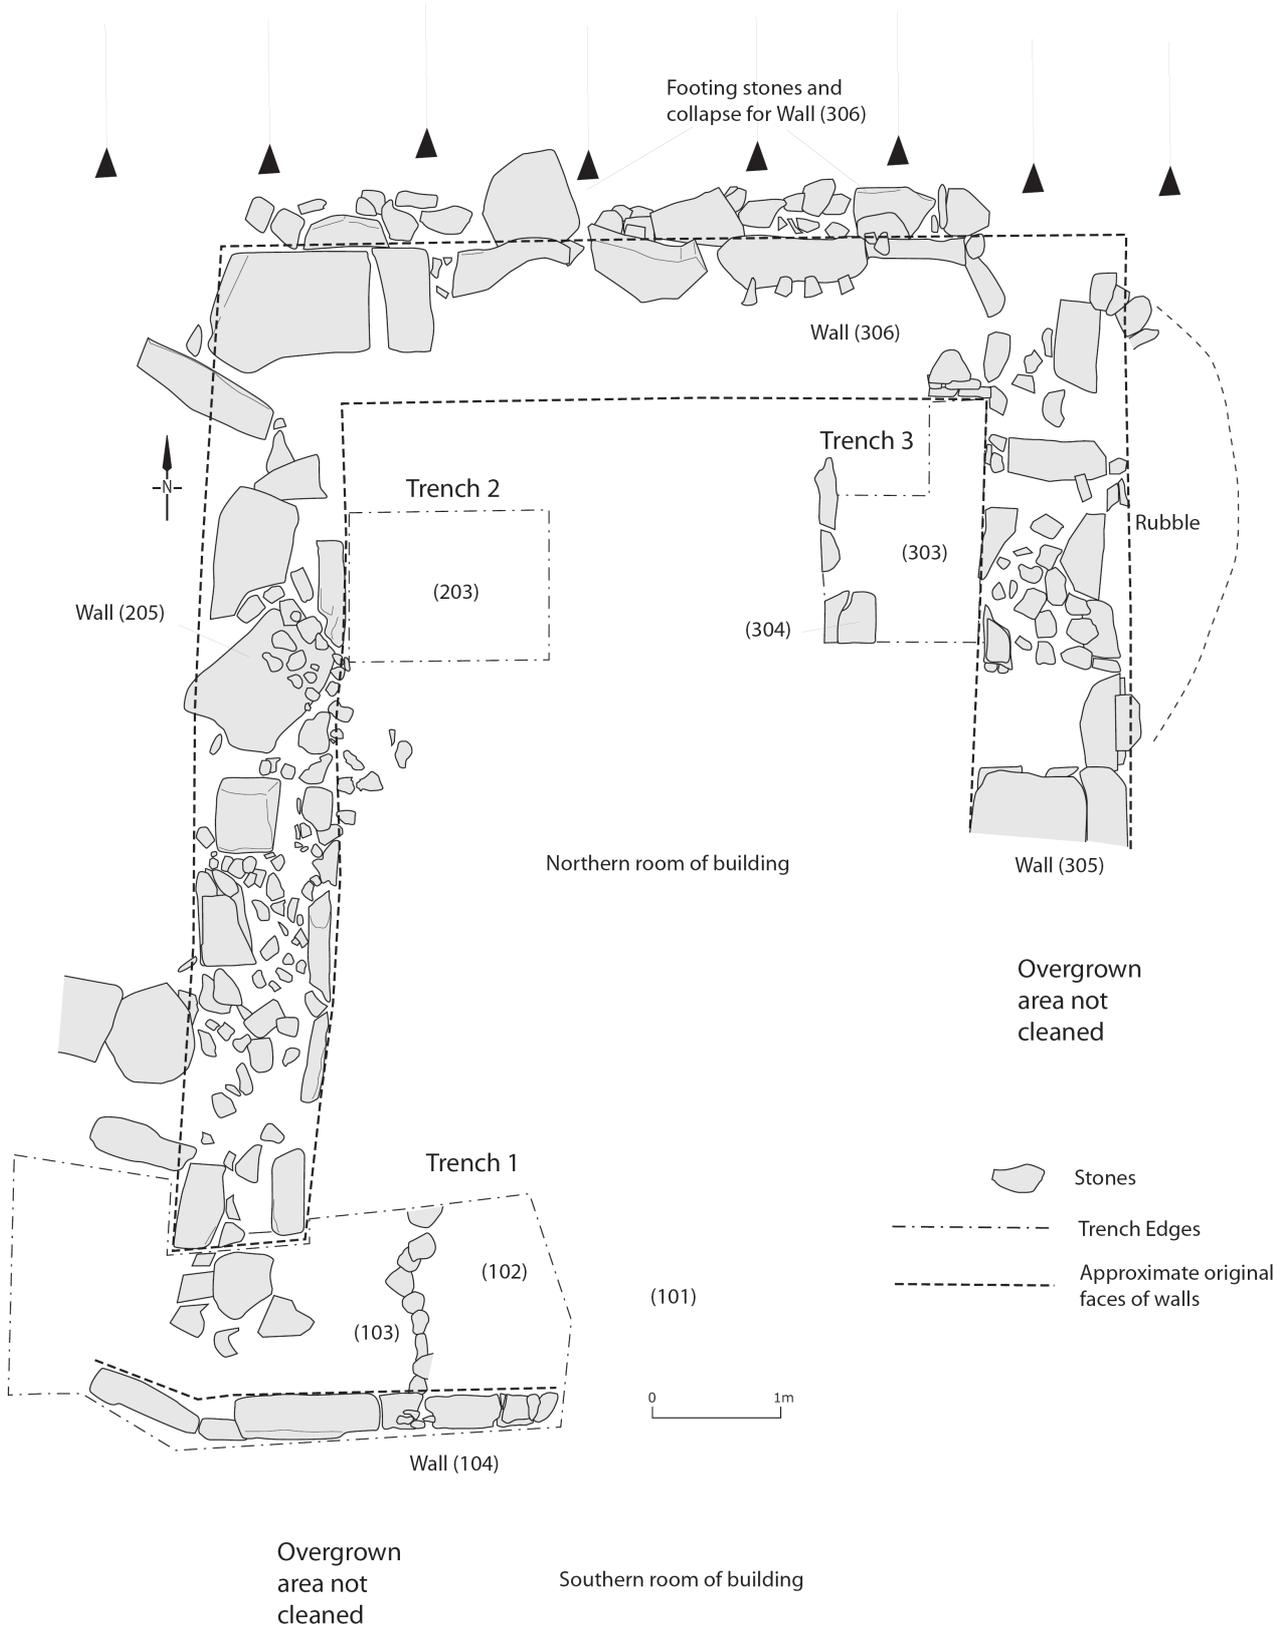
Figure 5: Plan of Northern end of building, showing Trenches 1, 2 and 3

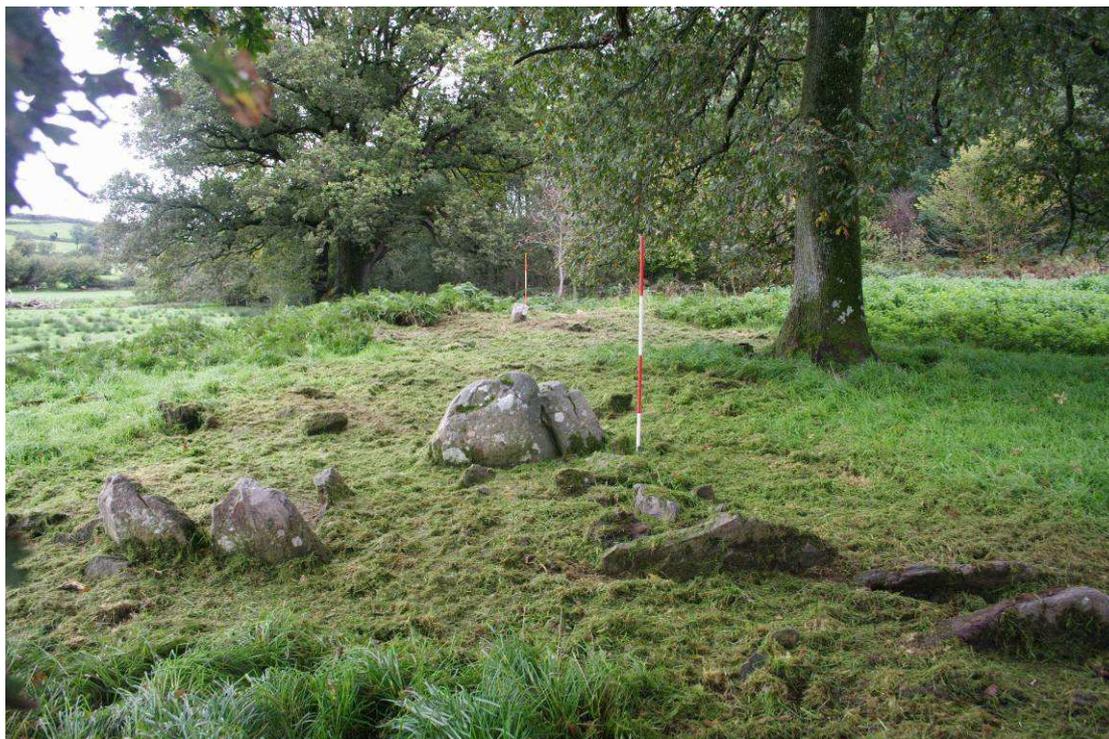
3.3.2 The first group of stones (Stone Group 1) lies at the western end, with an incomplete parallel arrangement aligned roughly northnorthwest-southsoutheast, the western line 1.3m in length, the eastern line 5.5m in length. The alignments were c.0.8m apart. A gap is present in the eastern alignment, of c.1.5m width, with a perpendicular stone running from the northern edge of the gap to the east, towards a substantial upright boulder. The boulder was 1.2m in width facing the gap in the eastern alignment.

Photo 10: Stone Group 1 facing eastnortheast, with scale adjacent to substantial boulder (second group of stones to rear marked by distant scale)

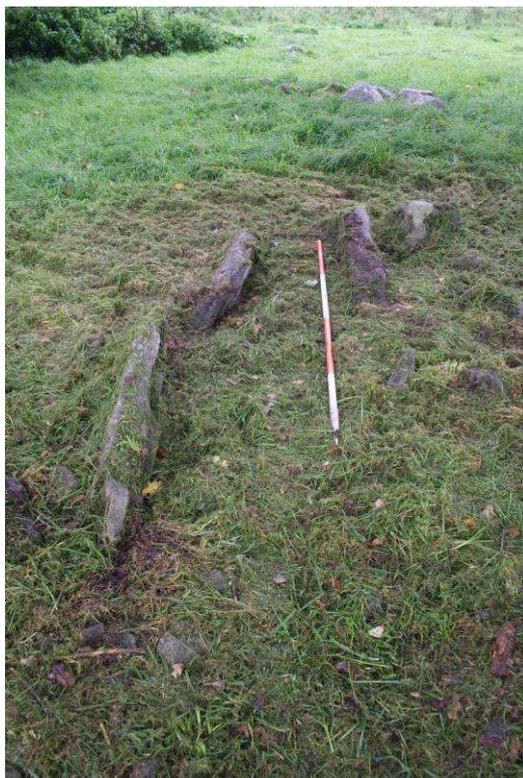
Photo 11: Parallel alignments of stone in western Stone Group 1, facing southsouthwest

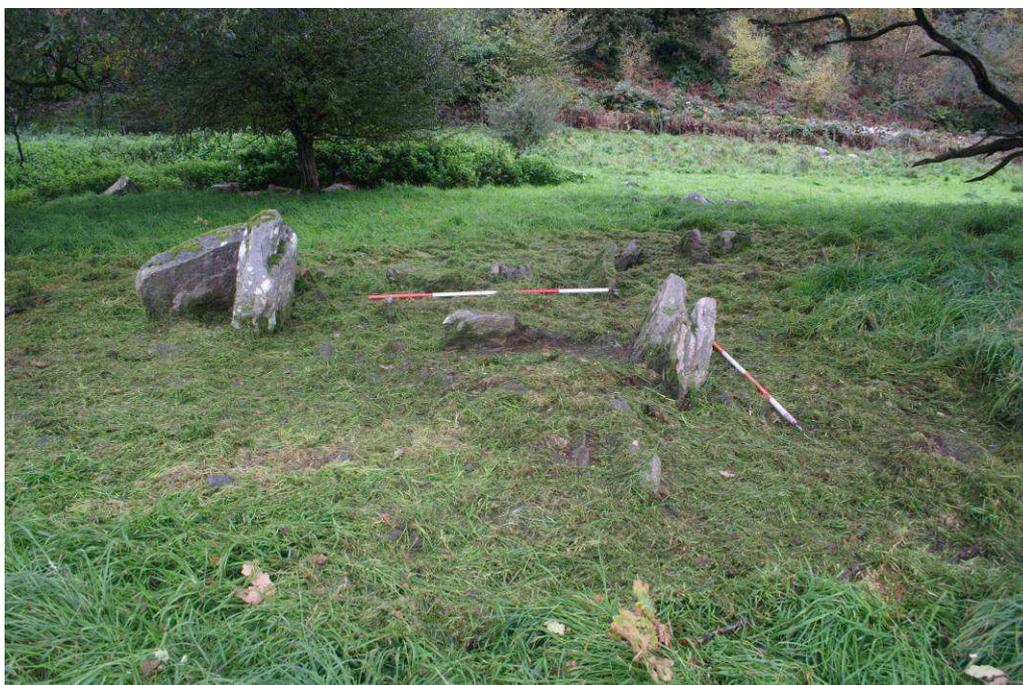
Photo 12: Stone Group 1 facing northnorthwest

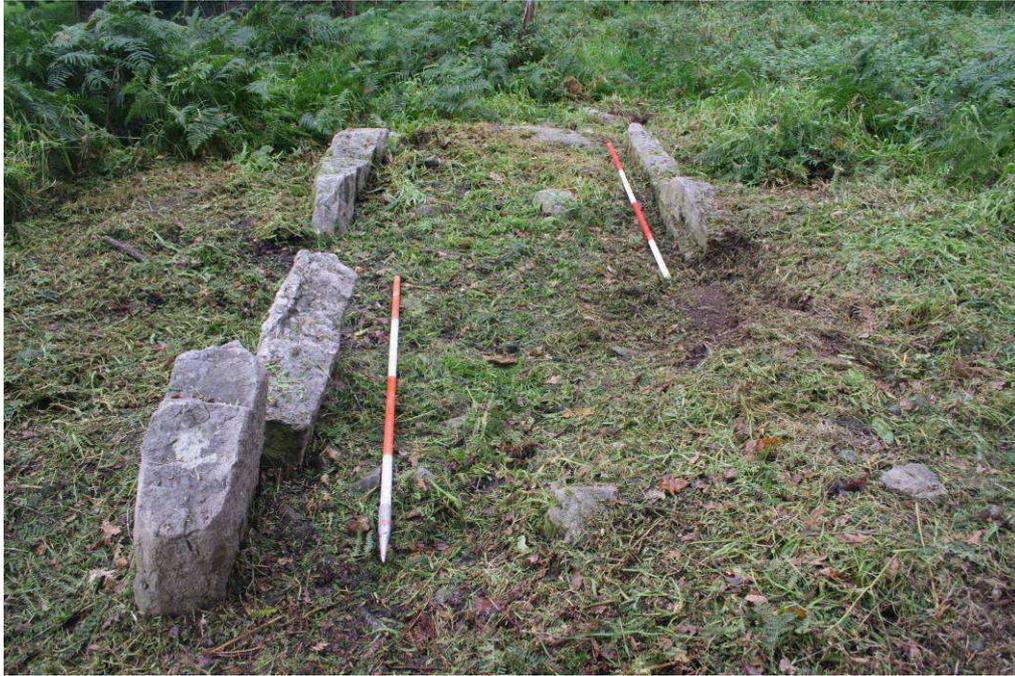
3.3.4 The second group of stones (Stone Group 2) lies at the eastern end of the mound and comprises a rectangular arrangement of long narrow stones forming an apparent chamber. The western end of the chamber was partially damaged where a former field bank crossed across the top of the mound. The chamber measured around 4.2m x 1.5m in width, aligned roughly eastnortheast to

westsouthwest. The rectangular chamber is aligned very closely with the gap in the eastern alignment of stones in the western group.

Photo 13: Stone Group 2 forming rectangular chamber, facing eastnortheast

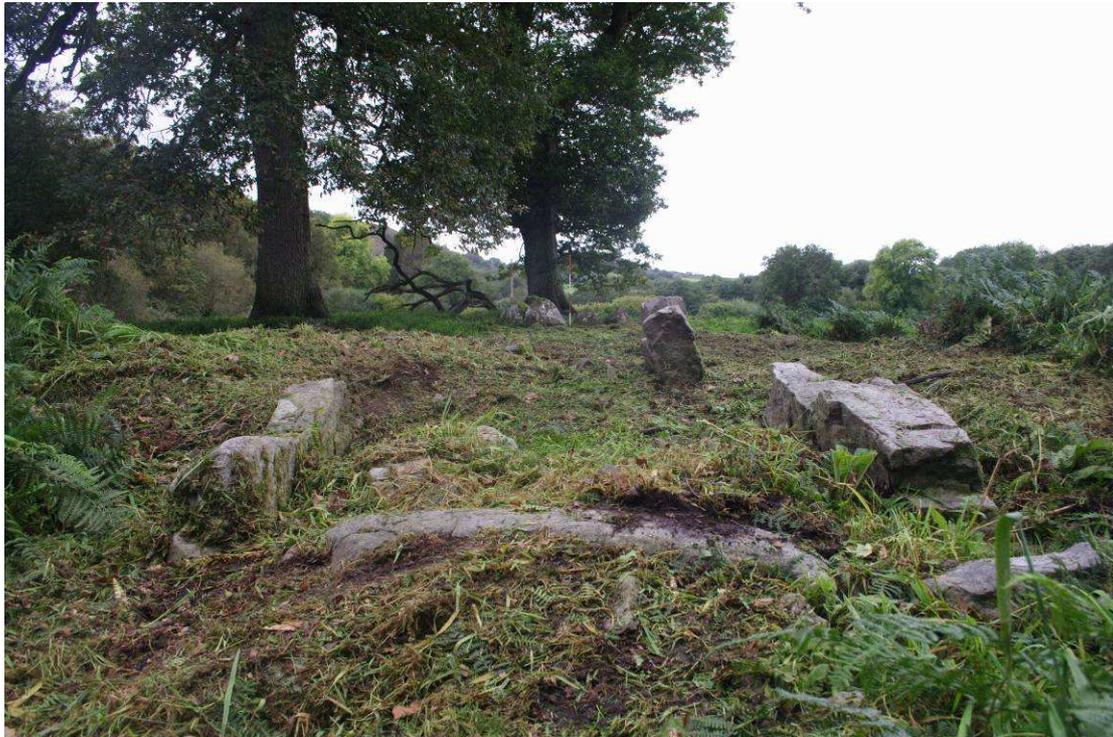
Photo 13: Stone Group 2 forming rectangular chamber, facing westsouthwest with western group of stones visible in distance (marked with scales)

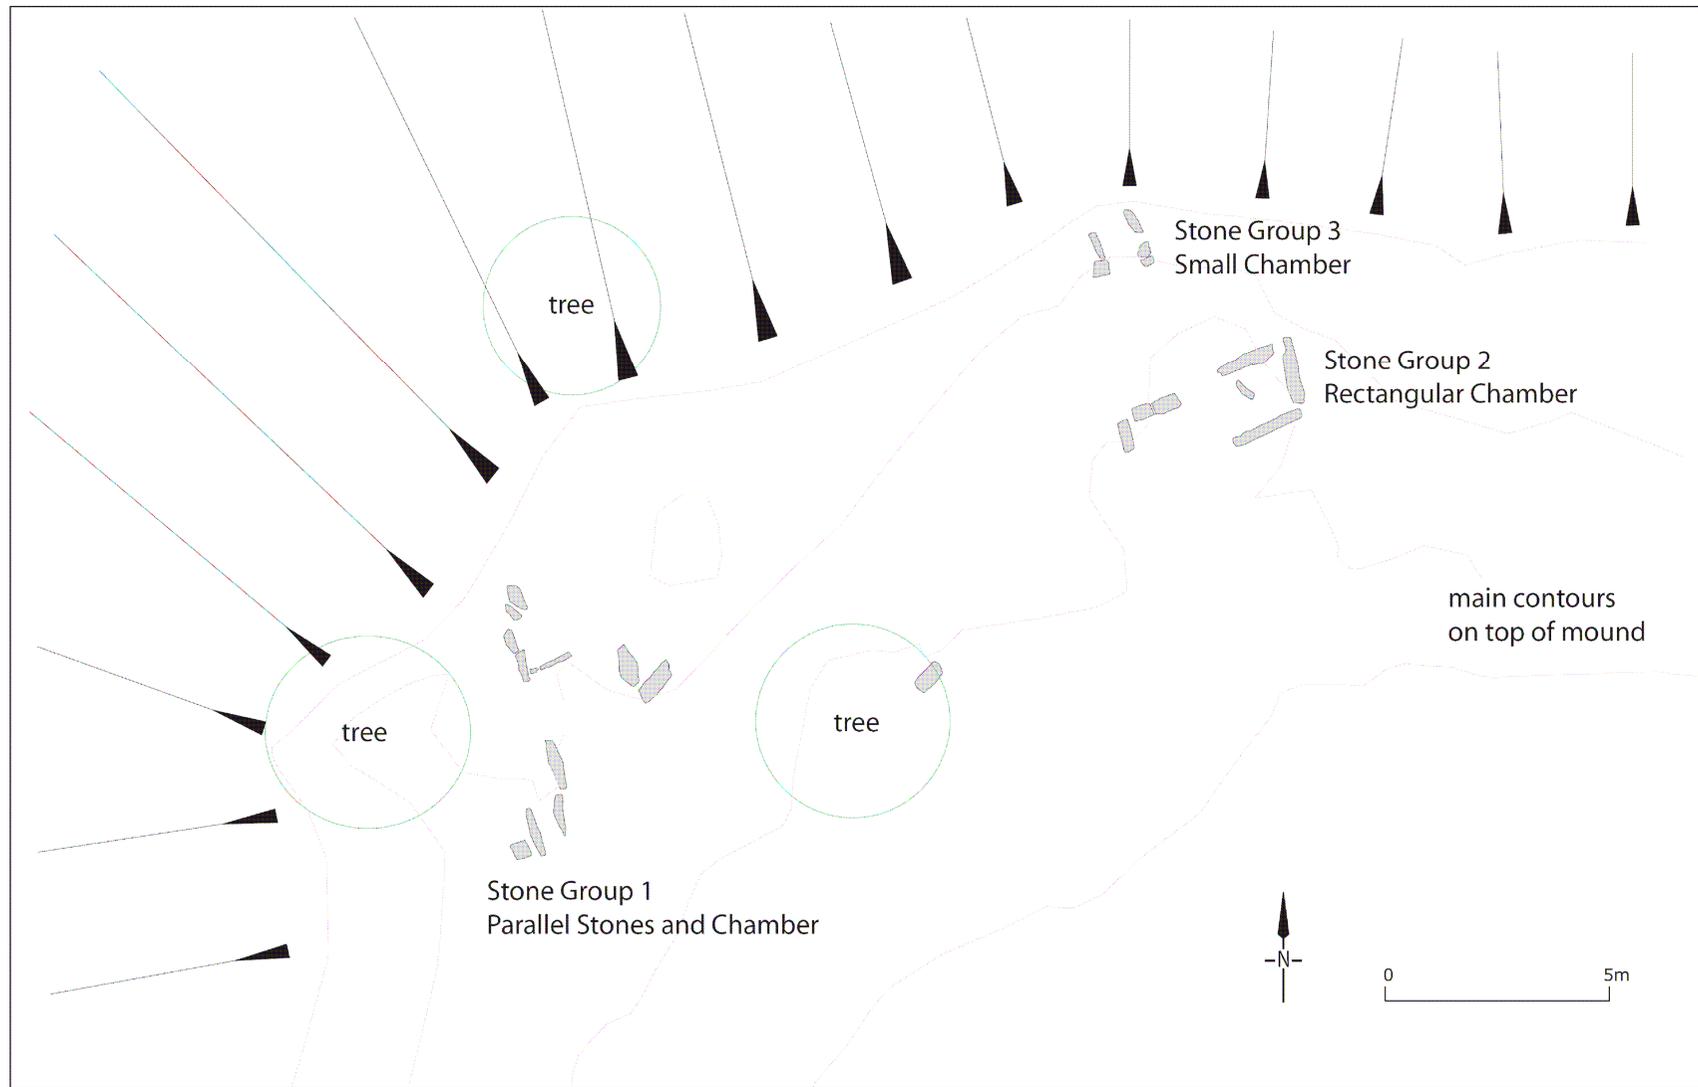
3.3.5 The third group of stones (Stone Group 3) lies 3.5m to the northnorthwest of the rectangular chamber comprising two parallel lines of stones, both around 1.4 – 1.5m in length, a metre apart. The stones are aligned perpendicular to the chamber, northnorthwest to southsoutheast.

Figure 6: Chambered Tomb Cae'r Ganfa or Cil y Ganfa, showing stone groups (NGR SN 6950 2502)

4.6 The chambered tomb potentially has three main groups of stones, comprising a group at the western end, Stone Group 1, which has parallel rows of stones and potentially an entranceway into a chamber behind. Stone Group 2 comprises a rectangular arrangement of narrow stones forming a large chamber. Stone Group 3 implies a small chamber to the north of Stone Group 2. There is still a potential for other chambers to be present within the mound, covered by vegetation or still sealed beneath the mound material. The potential is that the tomb is very well preserved and would be considered to be of high archaeological importance.
