**GOTHIC ARCADE, HAFOD,
CEREDIGION:
ARCHAEOLOGICAL WATCHING
BRIEF 2016
(NGR SN77437355)**

RHIF YR ADRODDIAD / REPORT NO. 2016/36
RHIF Y DIGWYDDIAD / EVENT RECORD NO. 109373

**GOTHIC ARCADE, HAFOD, CEREDIGION:
ARCHAEOLOGICAL WATCHING BRIEF 2016**

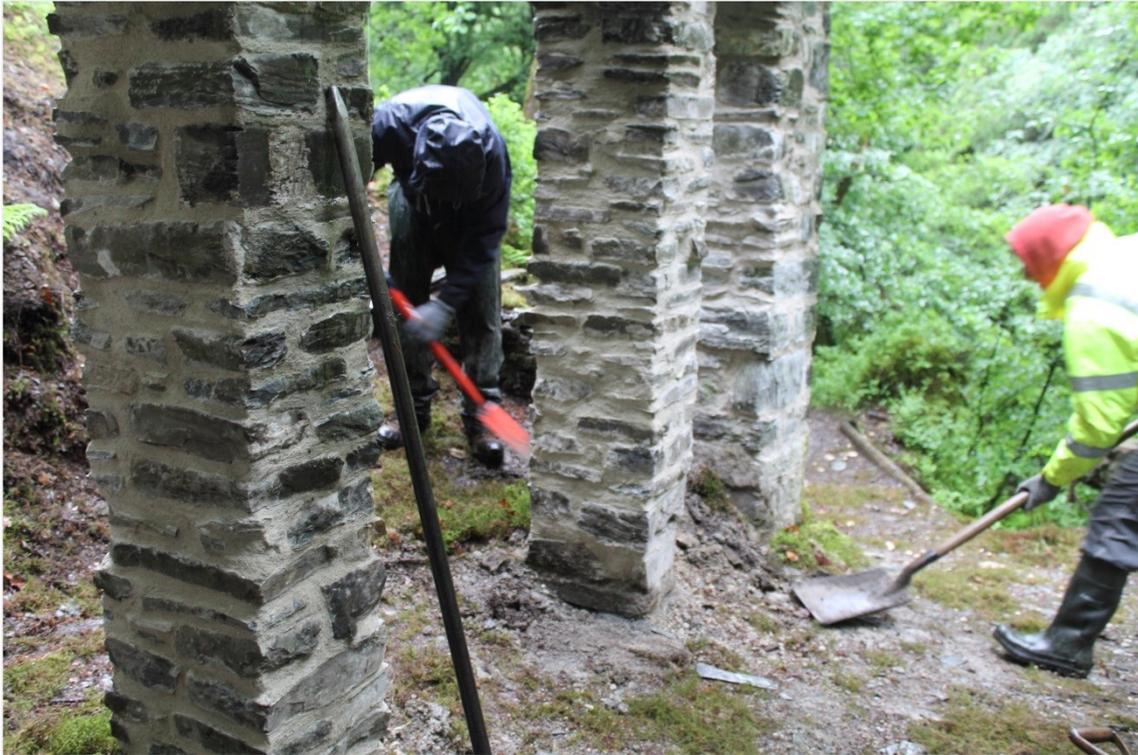
Photo 3: Removing the moss at the beginning of the excavation – looking northwest.

- 4.1.3 After a thick layer of sphagnum moss was removed (Photo 3) a loose dark silty soil containing a large number of small and medium stones and rotting leaf mould was revealed (Photo 4). The deposit would appear to have been a result of soil subsiding into the internal area of the arcade from the steeply sloping bank to the rear.

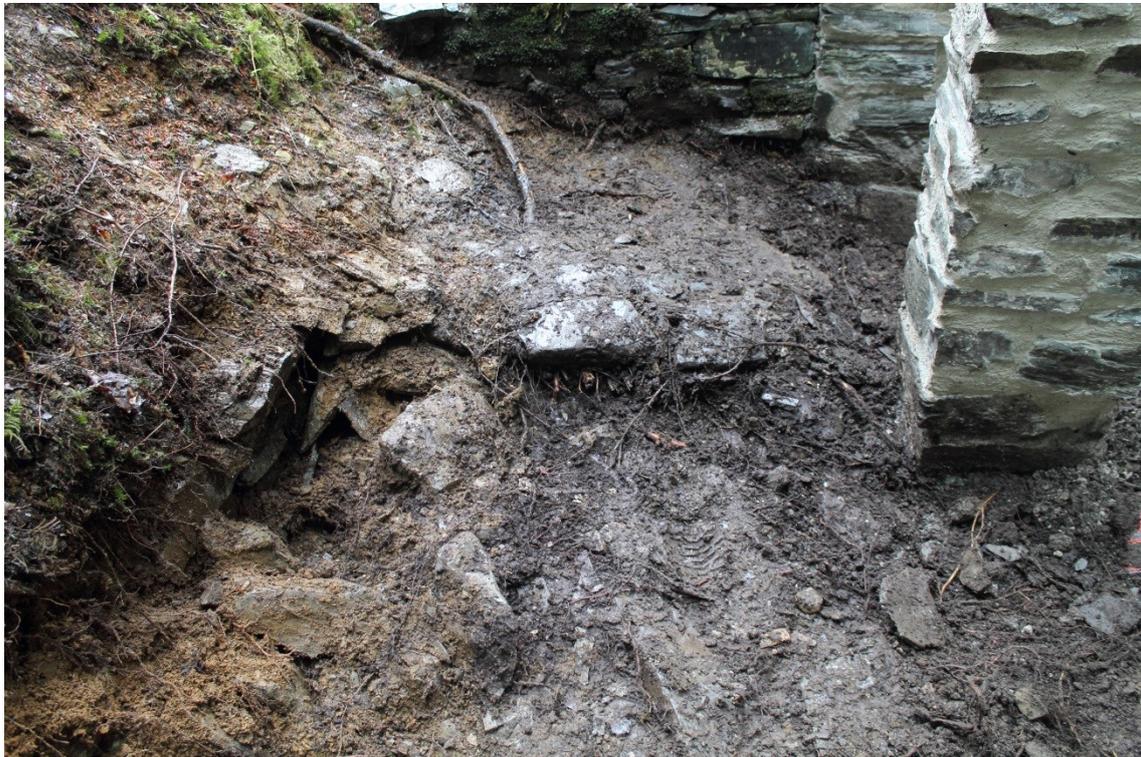
Photo 4: The loose dark silty soil lying above the collapsed stone of the retaining wall – looking northwest.

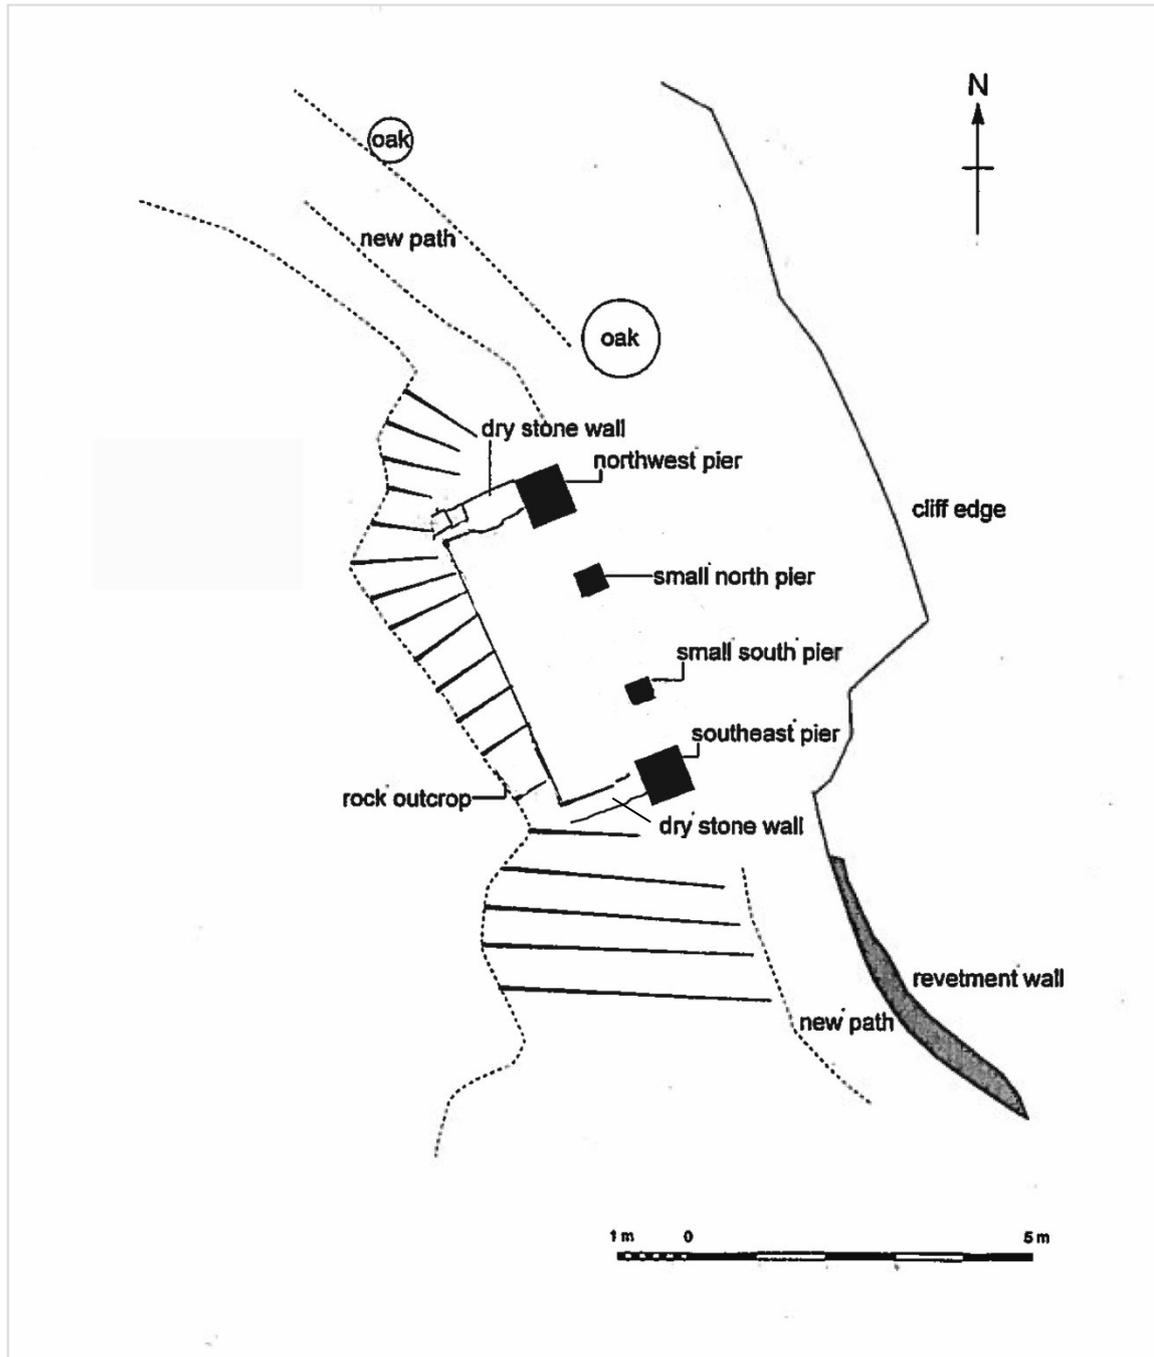
- 4.1.6 Surviving remnants of the dry stone walling could still be seen in situ. Composed in part of large slabs, the wall appeared quite crudely built. The walling ran from each of the larger piers back into the artificially cut slope creating a rectangular area behind the stone piers, measuring approximately 3.9m by 1.4m (Figure 5).

Figure 5: The site plan of the Gothic Arcade as recorded in 2003 amended to show the position of the rear retaining wall.

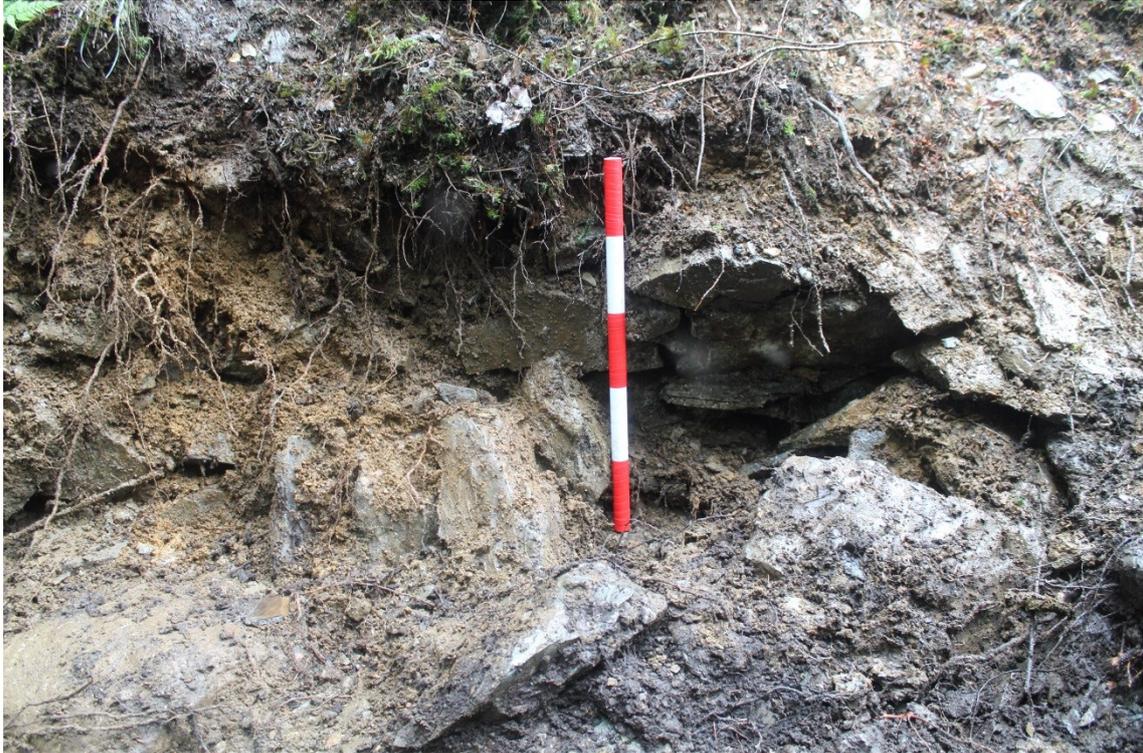
- 4.1.5 Careful removal of this stone deposit showed this material was a result of the collapse of a dry stone revetment wall that had been built at the rear of the arcade into the east facing slope..

Photo 5: A remnant of the rear retaining wall emerging during excavation of the stone rubble – looking southwest. 0.5m scale

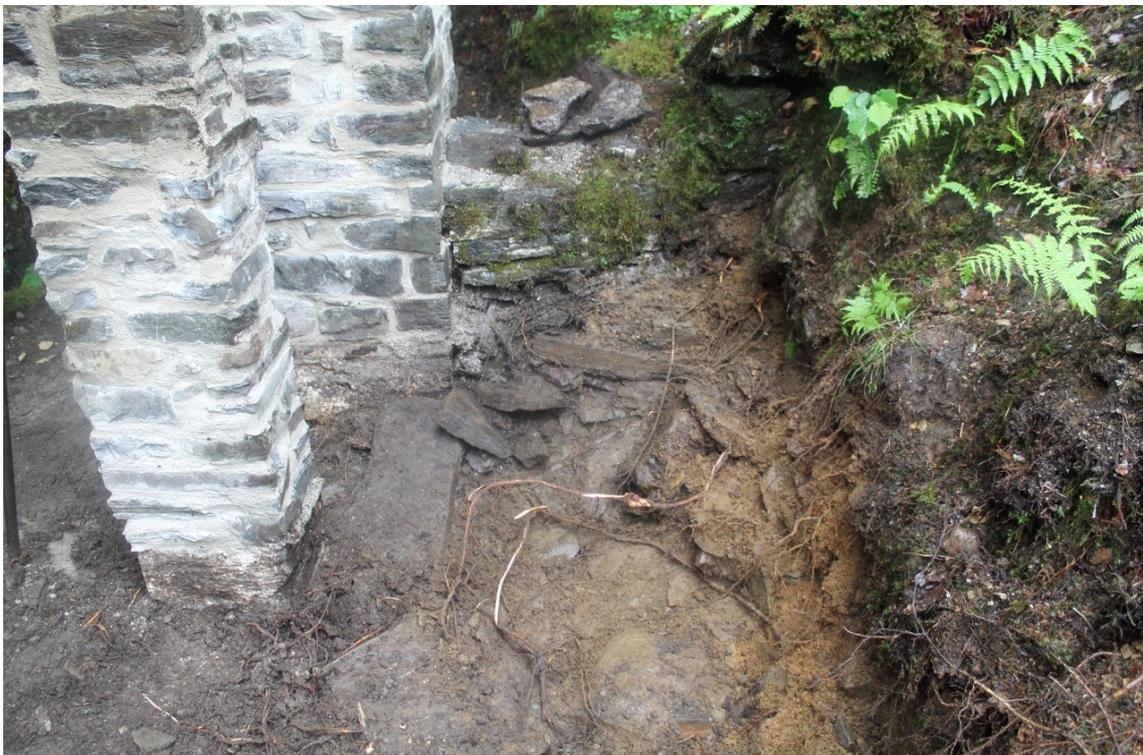
- 4.1.7 The retaining wall survived to a maximum height of 1.30m at its south west corner but elsewhere it had collapsed with the surviving wall having an average height of 0.60-0.70m (Photos 5 to 10). The wall was not tied into the stone piers.

Photo 6: The southwest corner of the retaining wall during excavation of the stone rubble – looking roughly southeast.

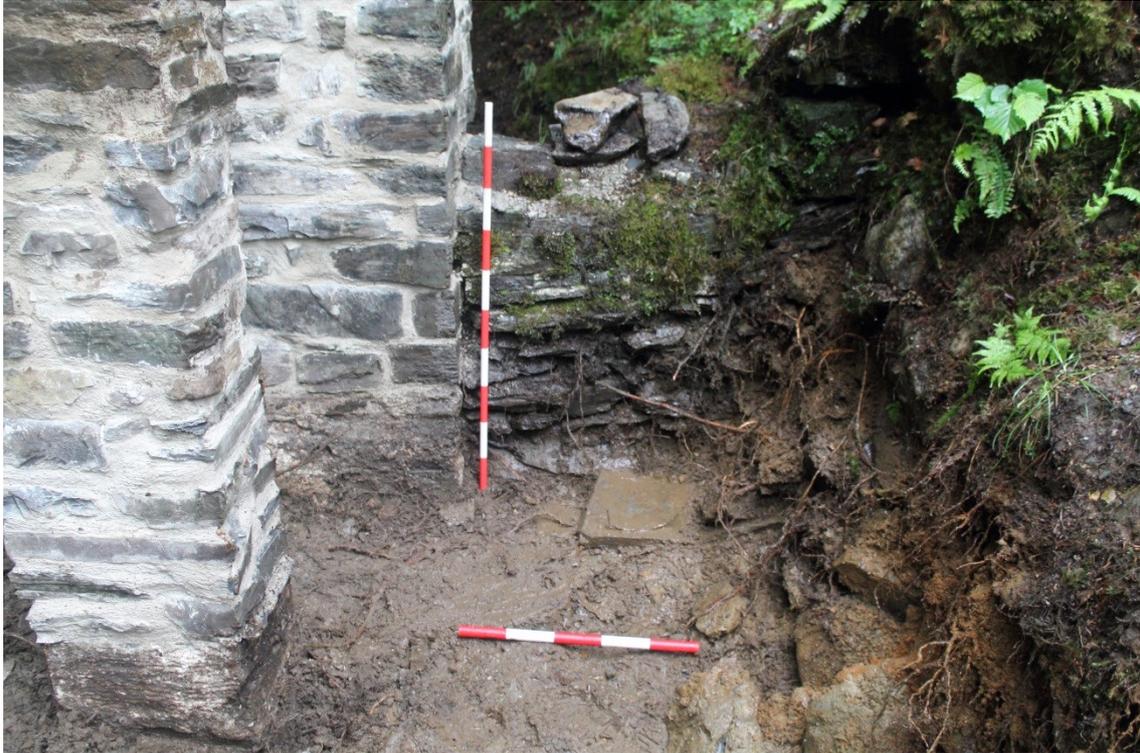
Photo 7: The southwest corner of the retaining wall at the end of the excavation of the stone rubble – looking roughly southeast. 1m & 0.5m scales

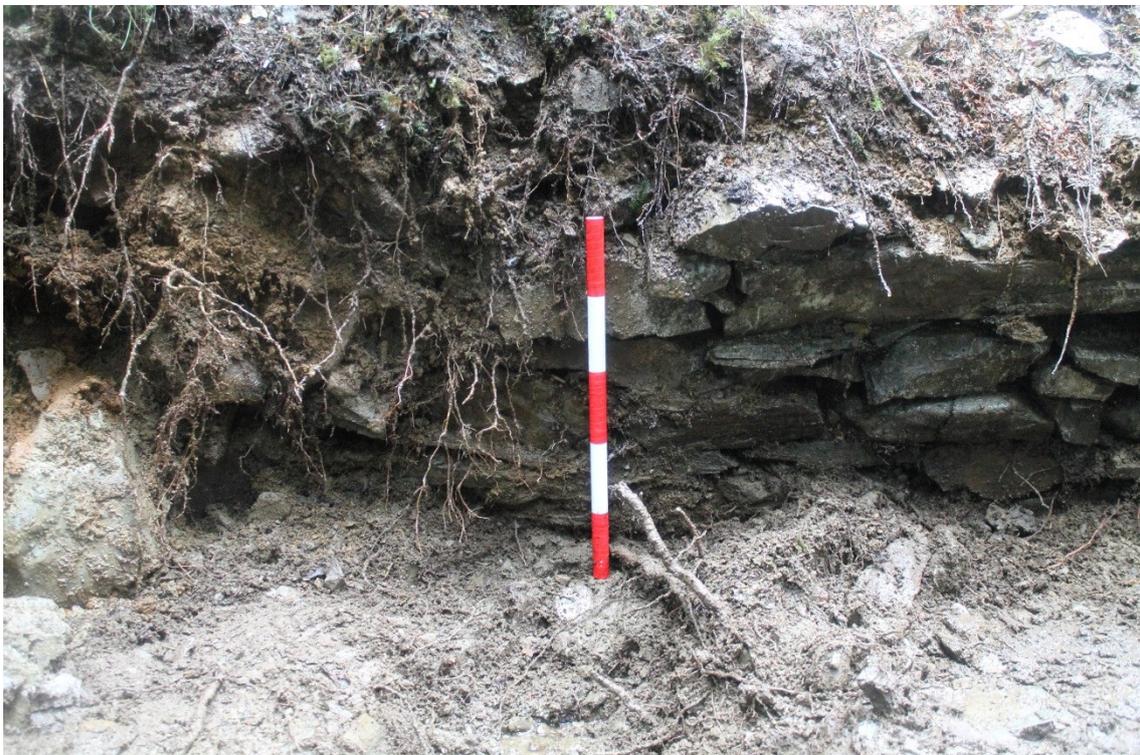
Photo 8: The surviving remnant of the rear retaining wall – looking southwest. 0.5m scale

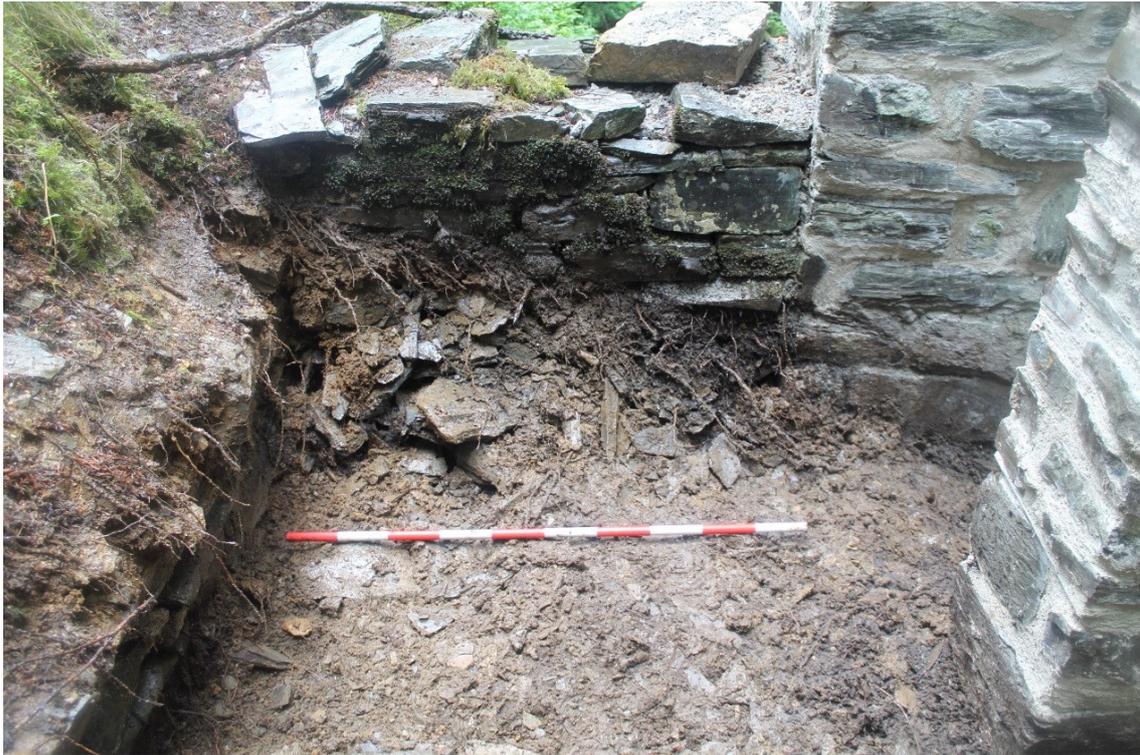
Photo 9: The northwest corner of the retaining wall at the end of the excavation – looking northwest. Note how the bottom section of the wall has collapsed inwards. 1m scale

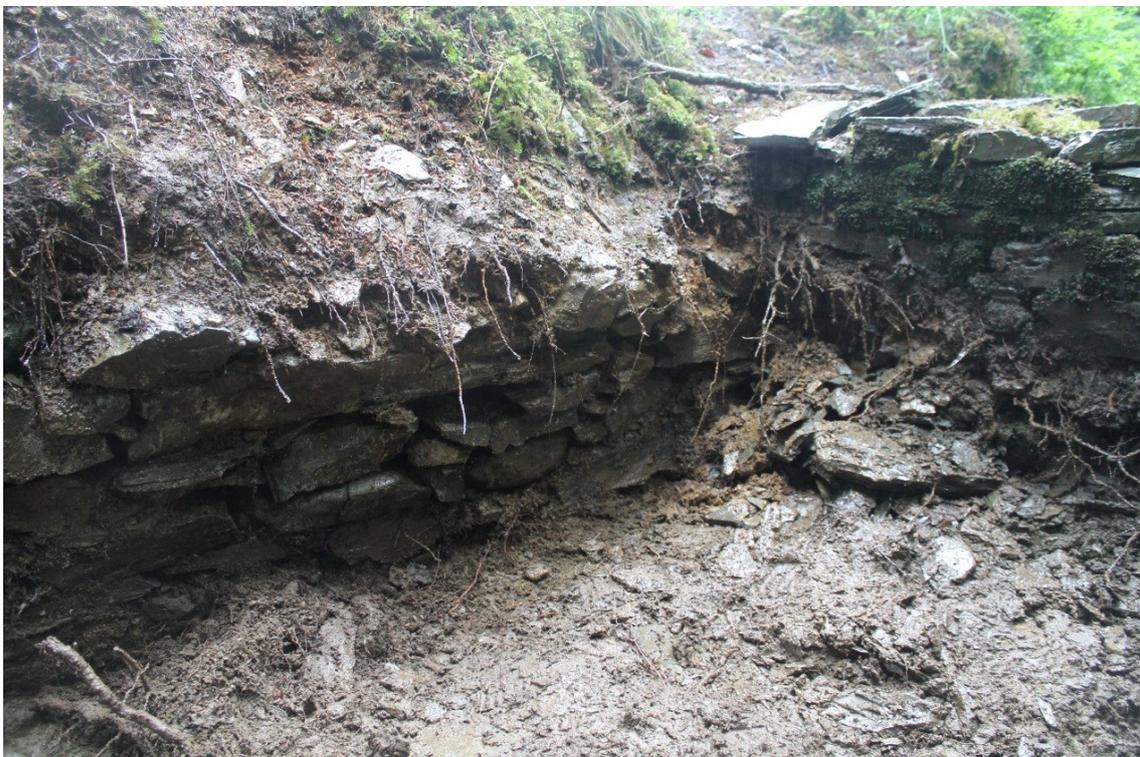
Photo 10: The northwest corner retaining wall at the end of the excavation showing the basic nature of the wall construction – looking roughly west

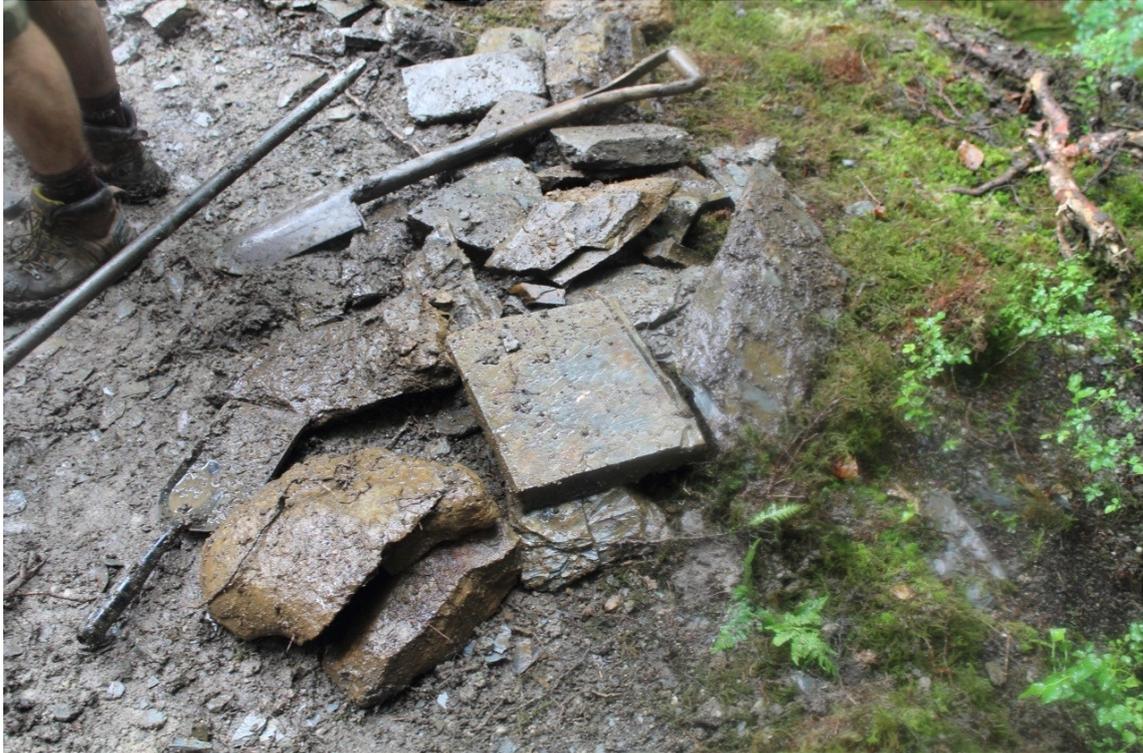
Photo 11: A selection of the roughly worked stone slabs used to construct the wall.

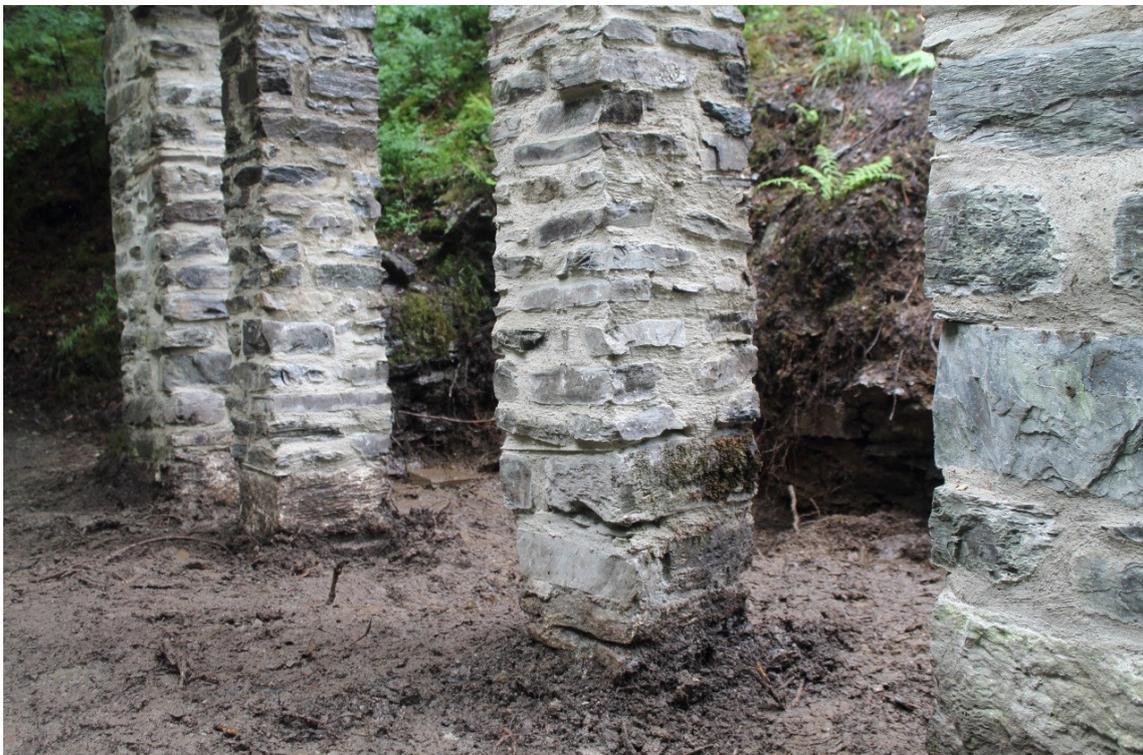
- 4.1.8 At the bottom of the stone rubble a number of large rectangular stones were revealed that could have possibly been coping stones for the top of the retaining wall (Photo 11). At this point the excavation was halted as the level of the outside path had been reached (Photos 12 and 13). No evidence of any internal floor surfaces was revealed during the excavation and although the excavation ceased at this point, it did appear that bedrock had all but been reached. It is probable that there the floor of the arcade was just exposed bedrock.

Photo 12: The cleared Gothic Arcade at the end of the excavation – looking south.

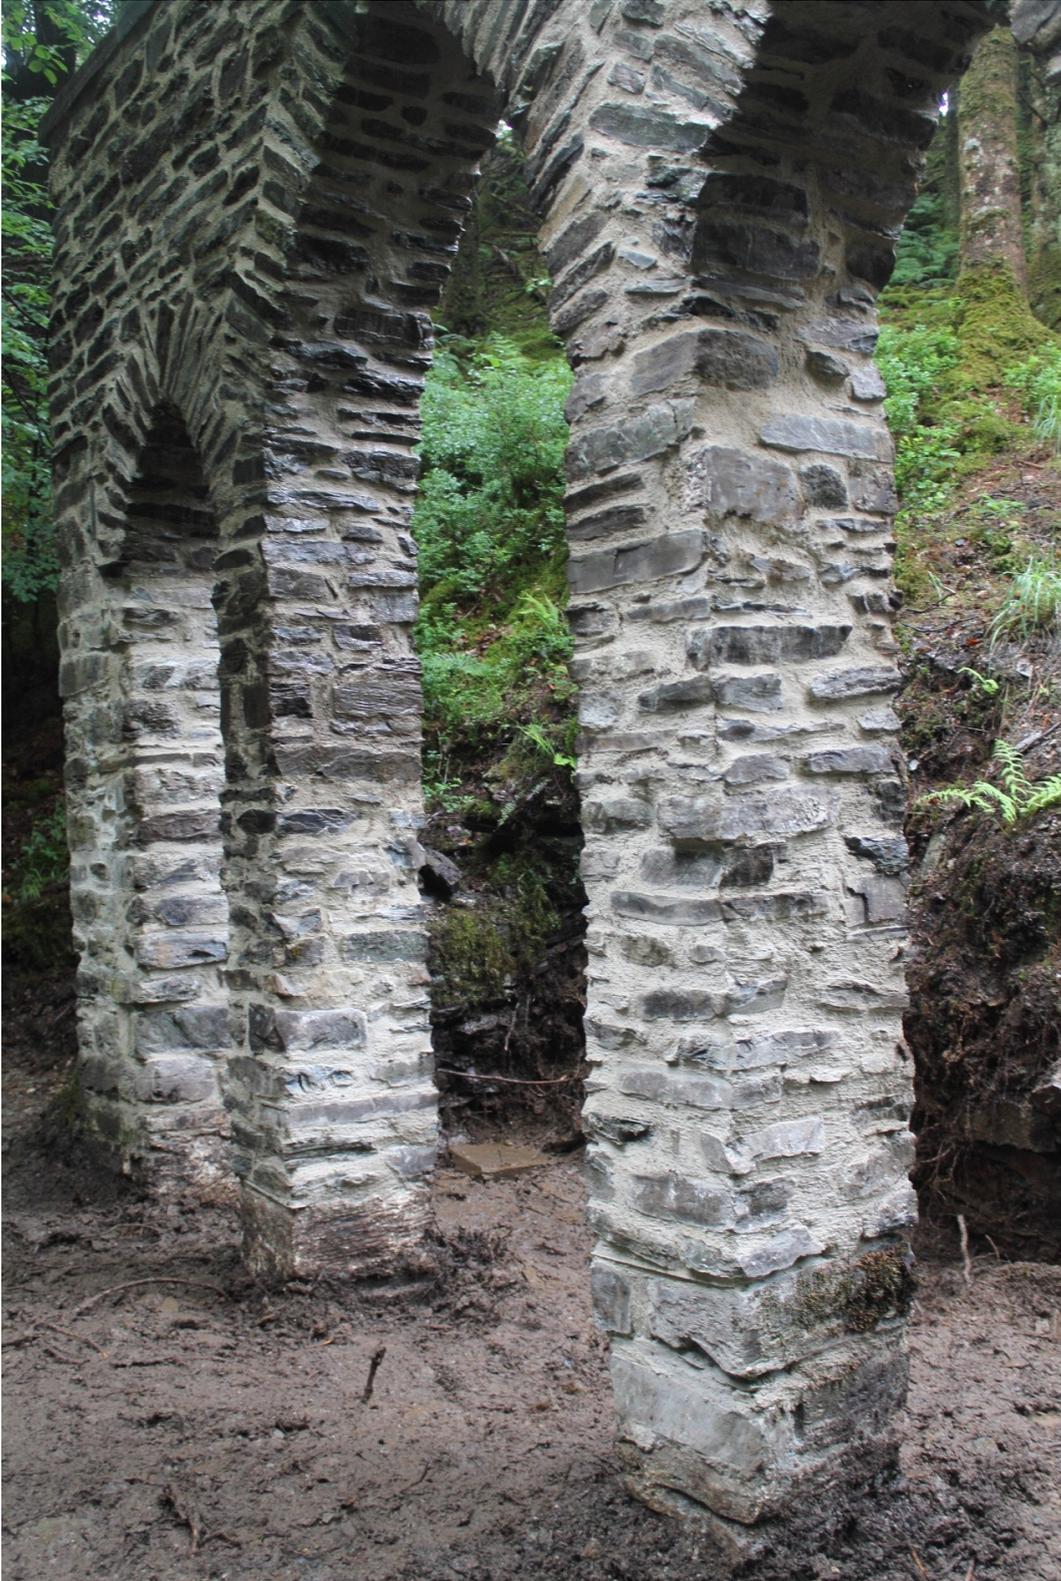
Photo 13: The cleared Gothic Arcade at the end of the excavation – looking south.

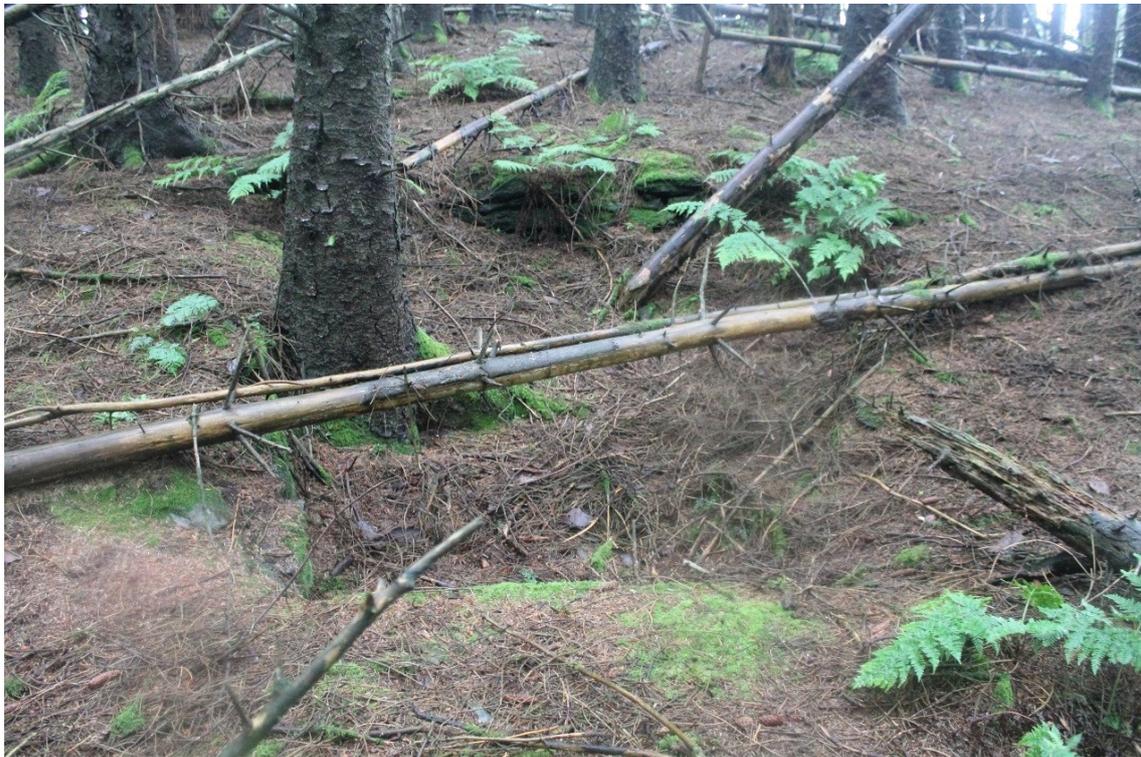
- 4.2.3 The corn drier is 'teardrop' shaped and aligned N-S with the flue at the southern narrow end of the 'teardrop'. It is somewhat terraced into the hill slope. The earthwork is visible as a slightly raised sub-circular outer bank surrounding a similarly shaped depression in the ground (Photo 14). At the southern end is a 1.7m wide x 3.2m long flue that is still extant and constructed from mudstone (Photo 15). The sub circular depression measures from the northern inner edge to the northern edge of the flue 3.60m with a maximum width of 2.30m (inner edge to inner edge). The large flue allows for the circulation of warm area below a platform on which corn was placed to dry.

Photo 14: The sub-circular depression within the surrounding earthwork bank of corn drier (PRN 109380).

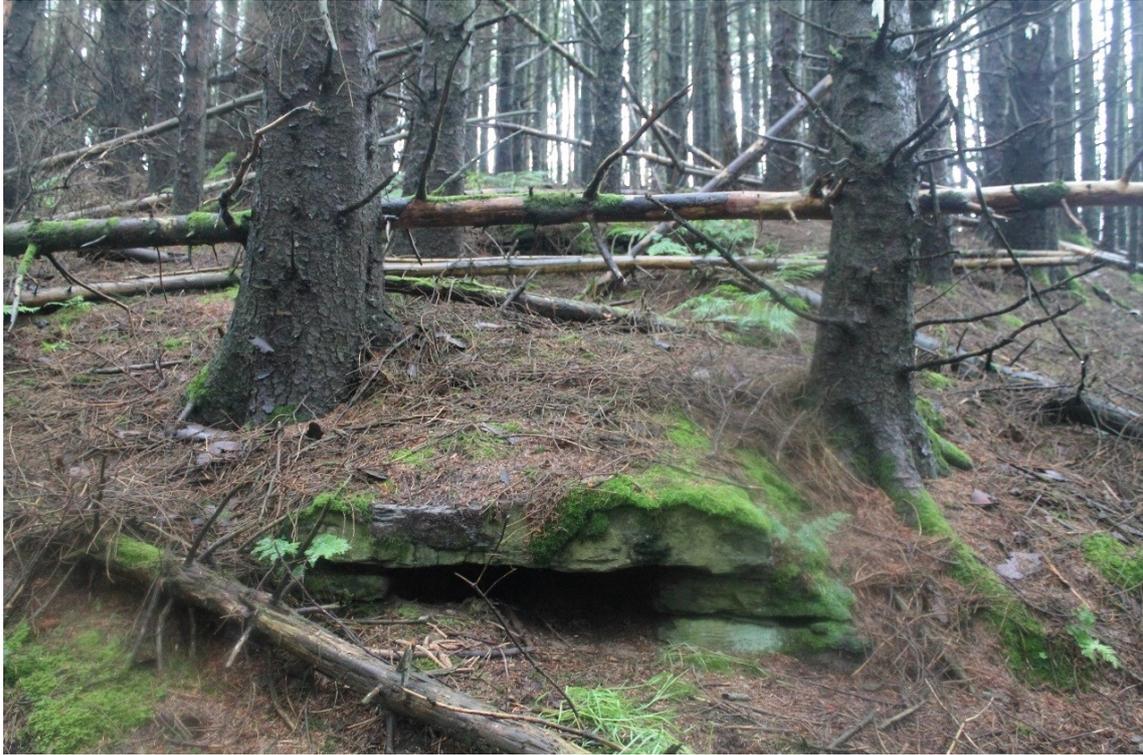
Photo 15: The south facing stone built flue of corn drier (PRN 109380).
