PONT NEWYDD, HAFOD, CEREDIGION: ARCHAEOLOGICAL EVALUATION AND WATCHING BRIEF 2017

Prepared by DAT Archaeological Services
For: Natural Resources Wales

RHIF YR ADRODDIAD / REPORT NO. 2017/21
RHIF Y PROSIECT / PROJECT RECORD NO. 110436

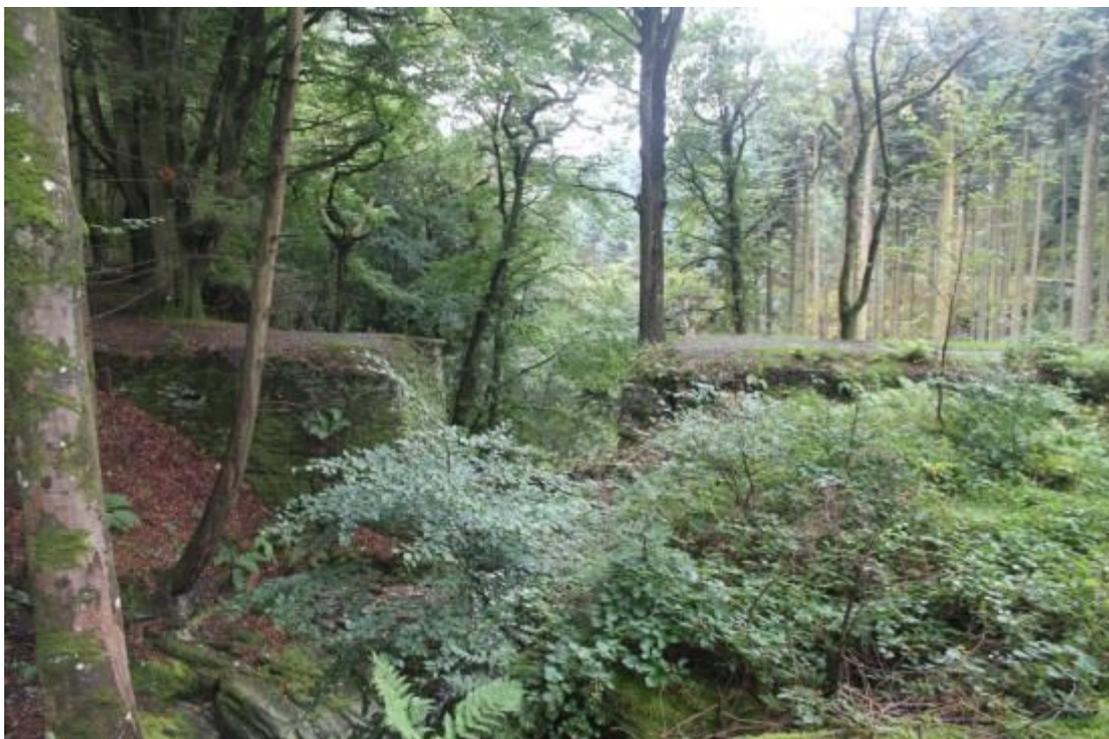
Photo 1: The northeast side of the remaining bridge abutments of Pont Newydd, facing south

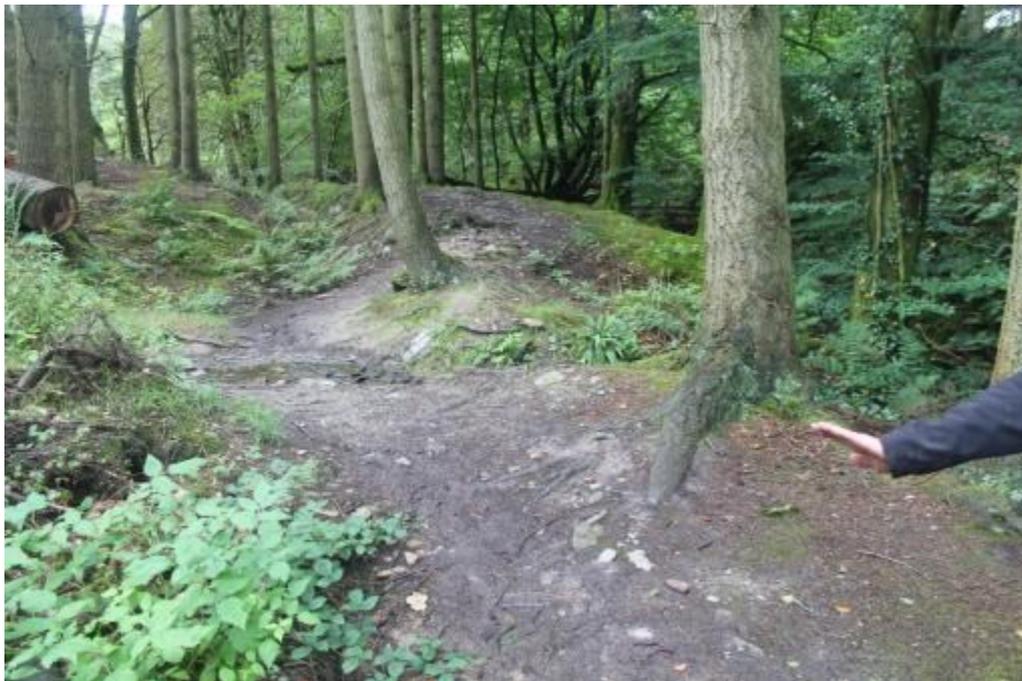
Photo 3: Looking northeast along the northern section of the leat

- 2.1.3 The leat under investigation runs parallel to Nant Peiran to its northwest for about 80m, and is cut through by the northwest bridge abutment (Figure 3; Photos 3-5). At the north end of the leat a bank appears to have been built to stop it in-taking water from further upstream (Photo 6). At its southern end it still opens into Nant Peiran at the top of a steep rock face above the main natural waterfalls, although little water now empties from it (Photo 7). At the start of the project the leat was overgrown with trees and scrub and had a modern gravel pathway inserted across its width, supported on stone walls (Photo 5).

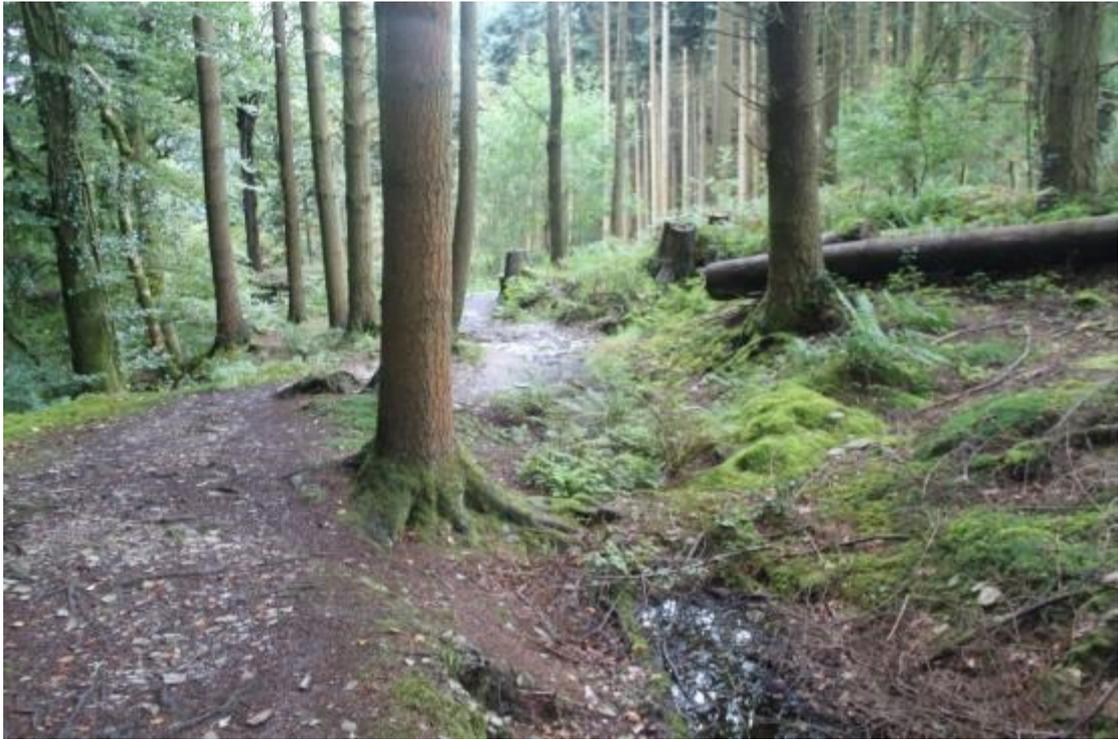
Photo 4: Looking southeast along the northern section of the leat

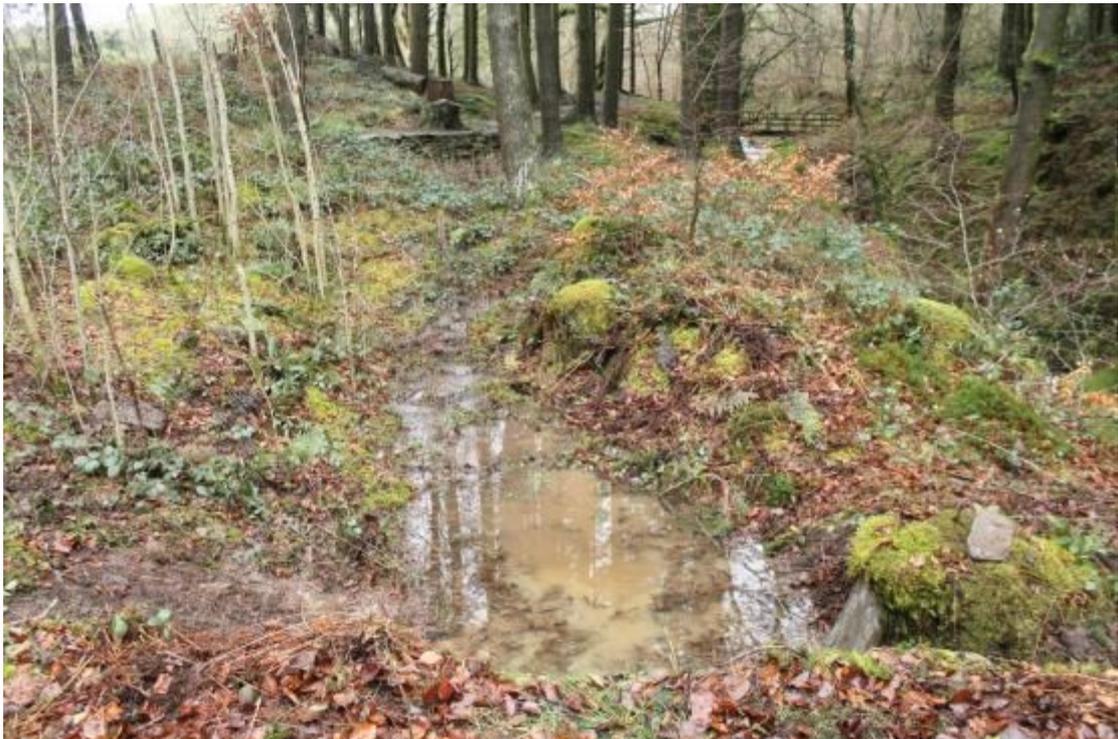
Photo 5: Looking northeast along the northern section of the leat from the bridge, with modern gravel pathway across the leat in the distance

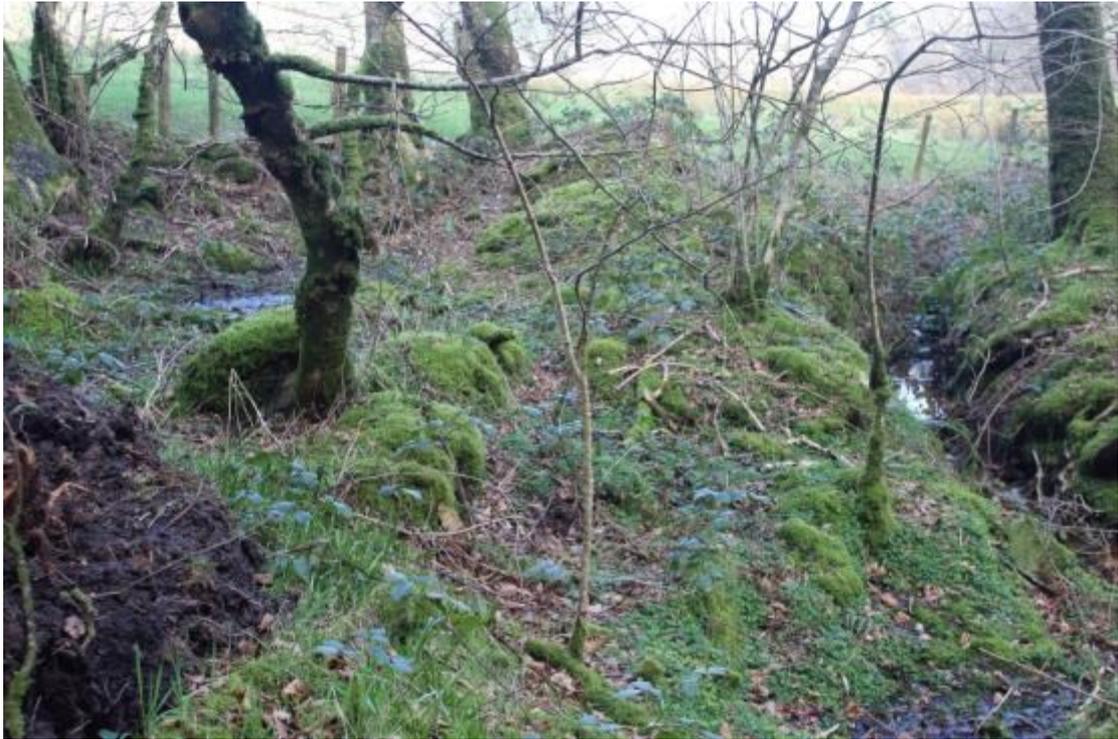
Photo 6: Facing north. At the north end of the leat a bank appears to have been built to stop it in-taking water from further upstream.

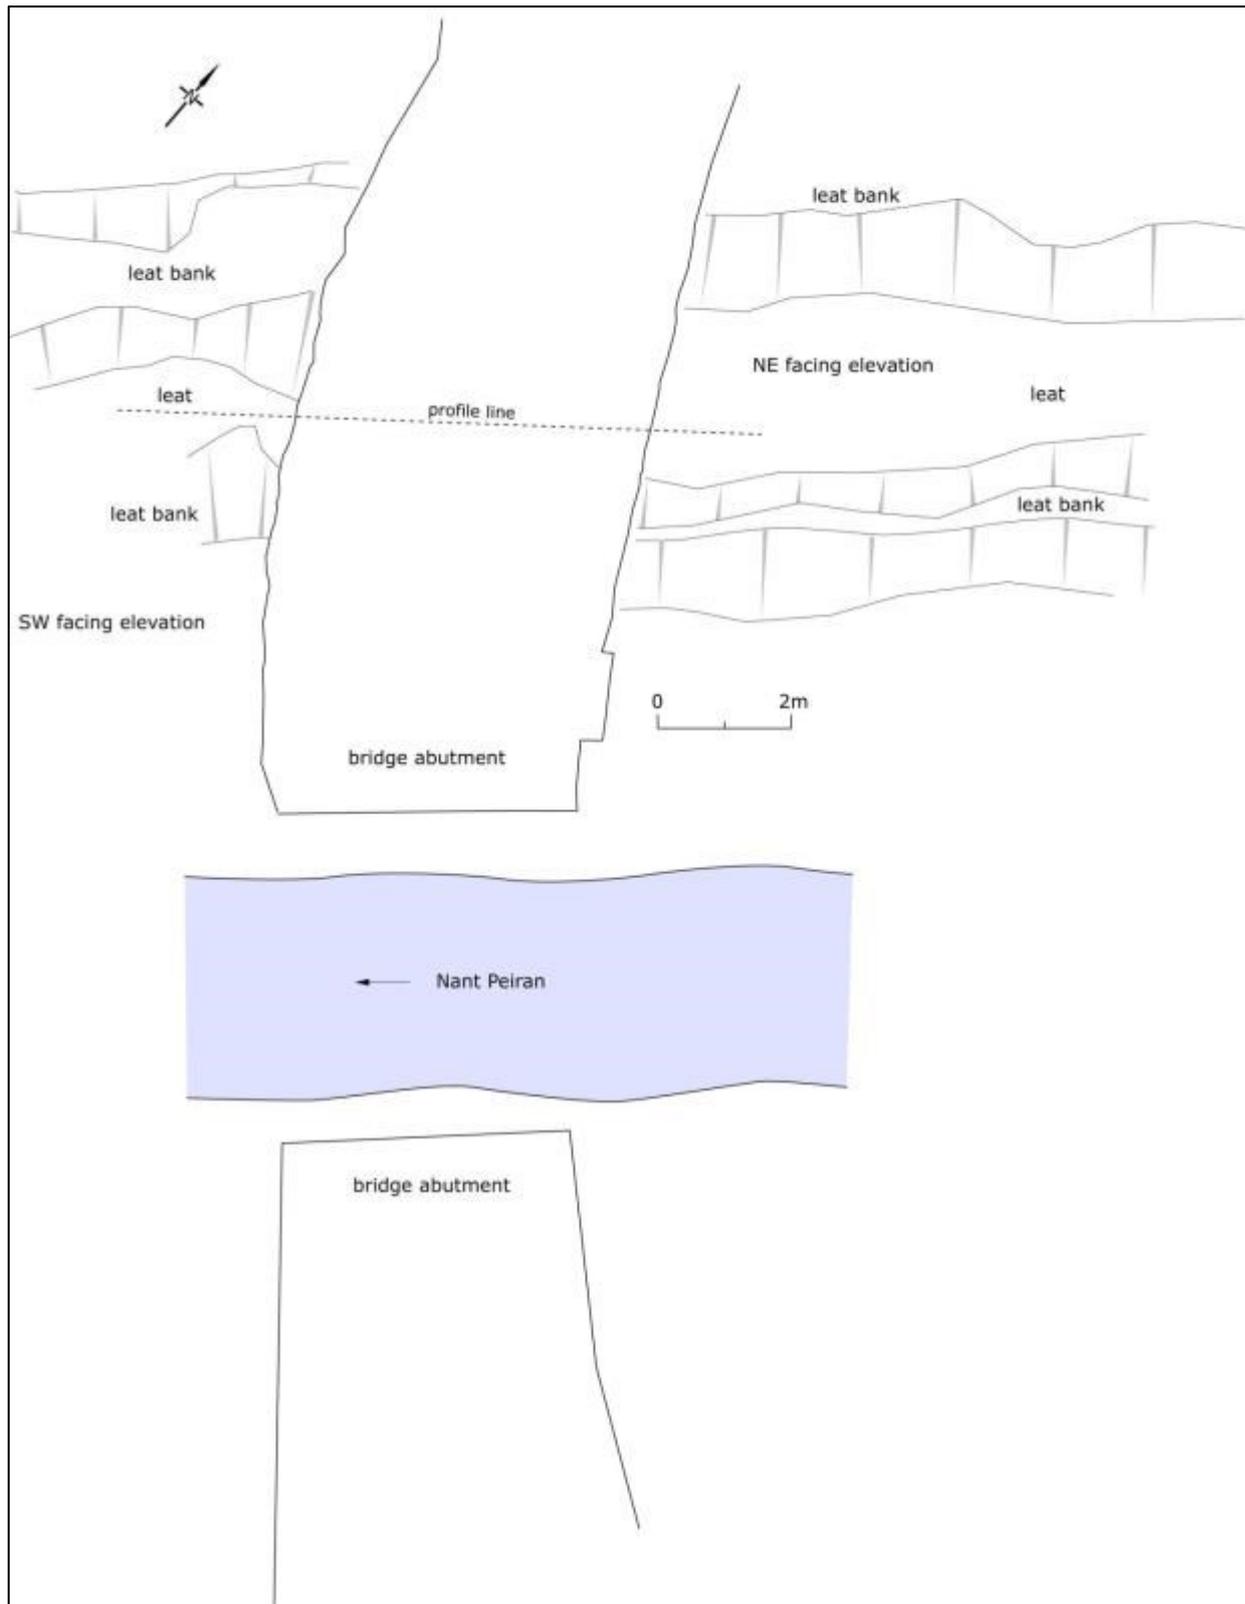
Figure 8: Plan drawing of the bridge abutments, and the leat in the vicinity of the northern bridge abutment where excavations were carried out. The profile is shown in Figure 9.

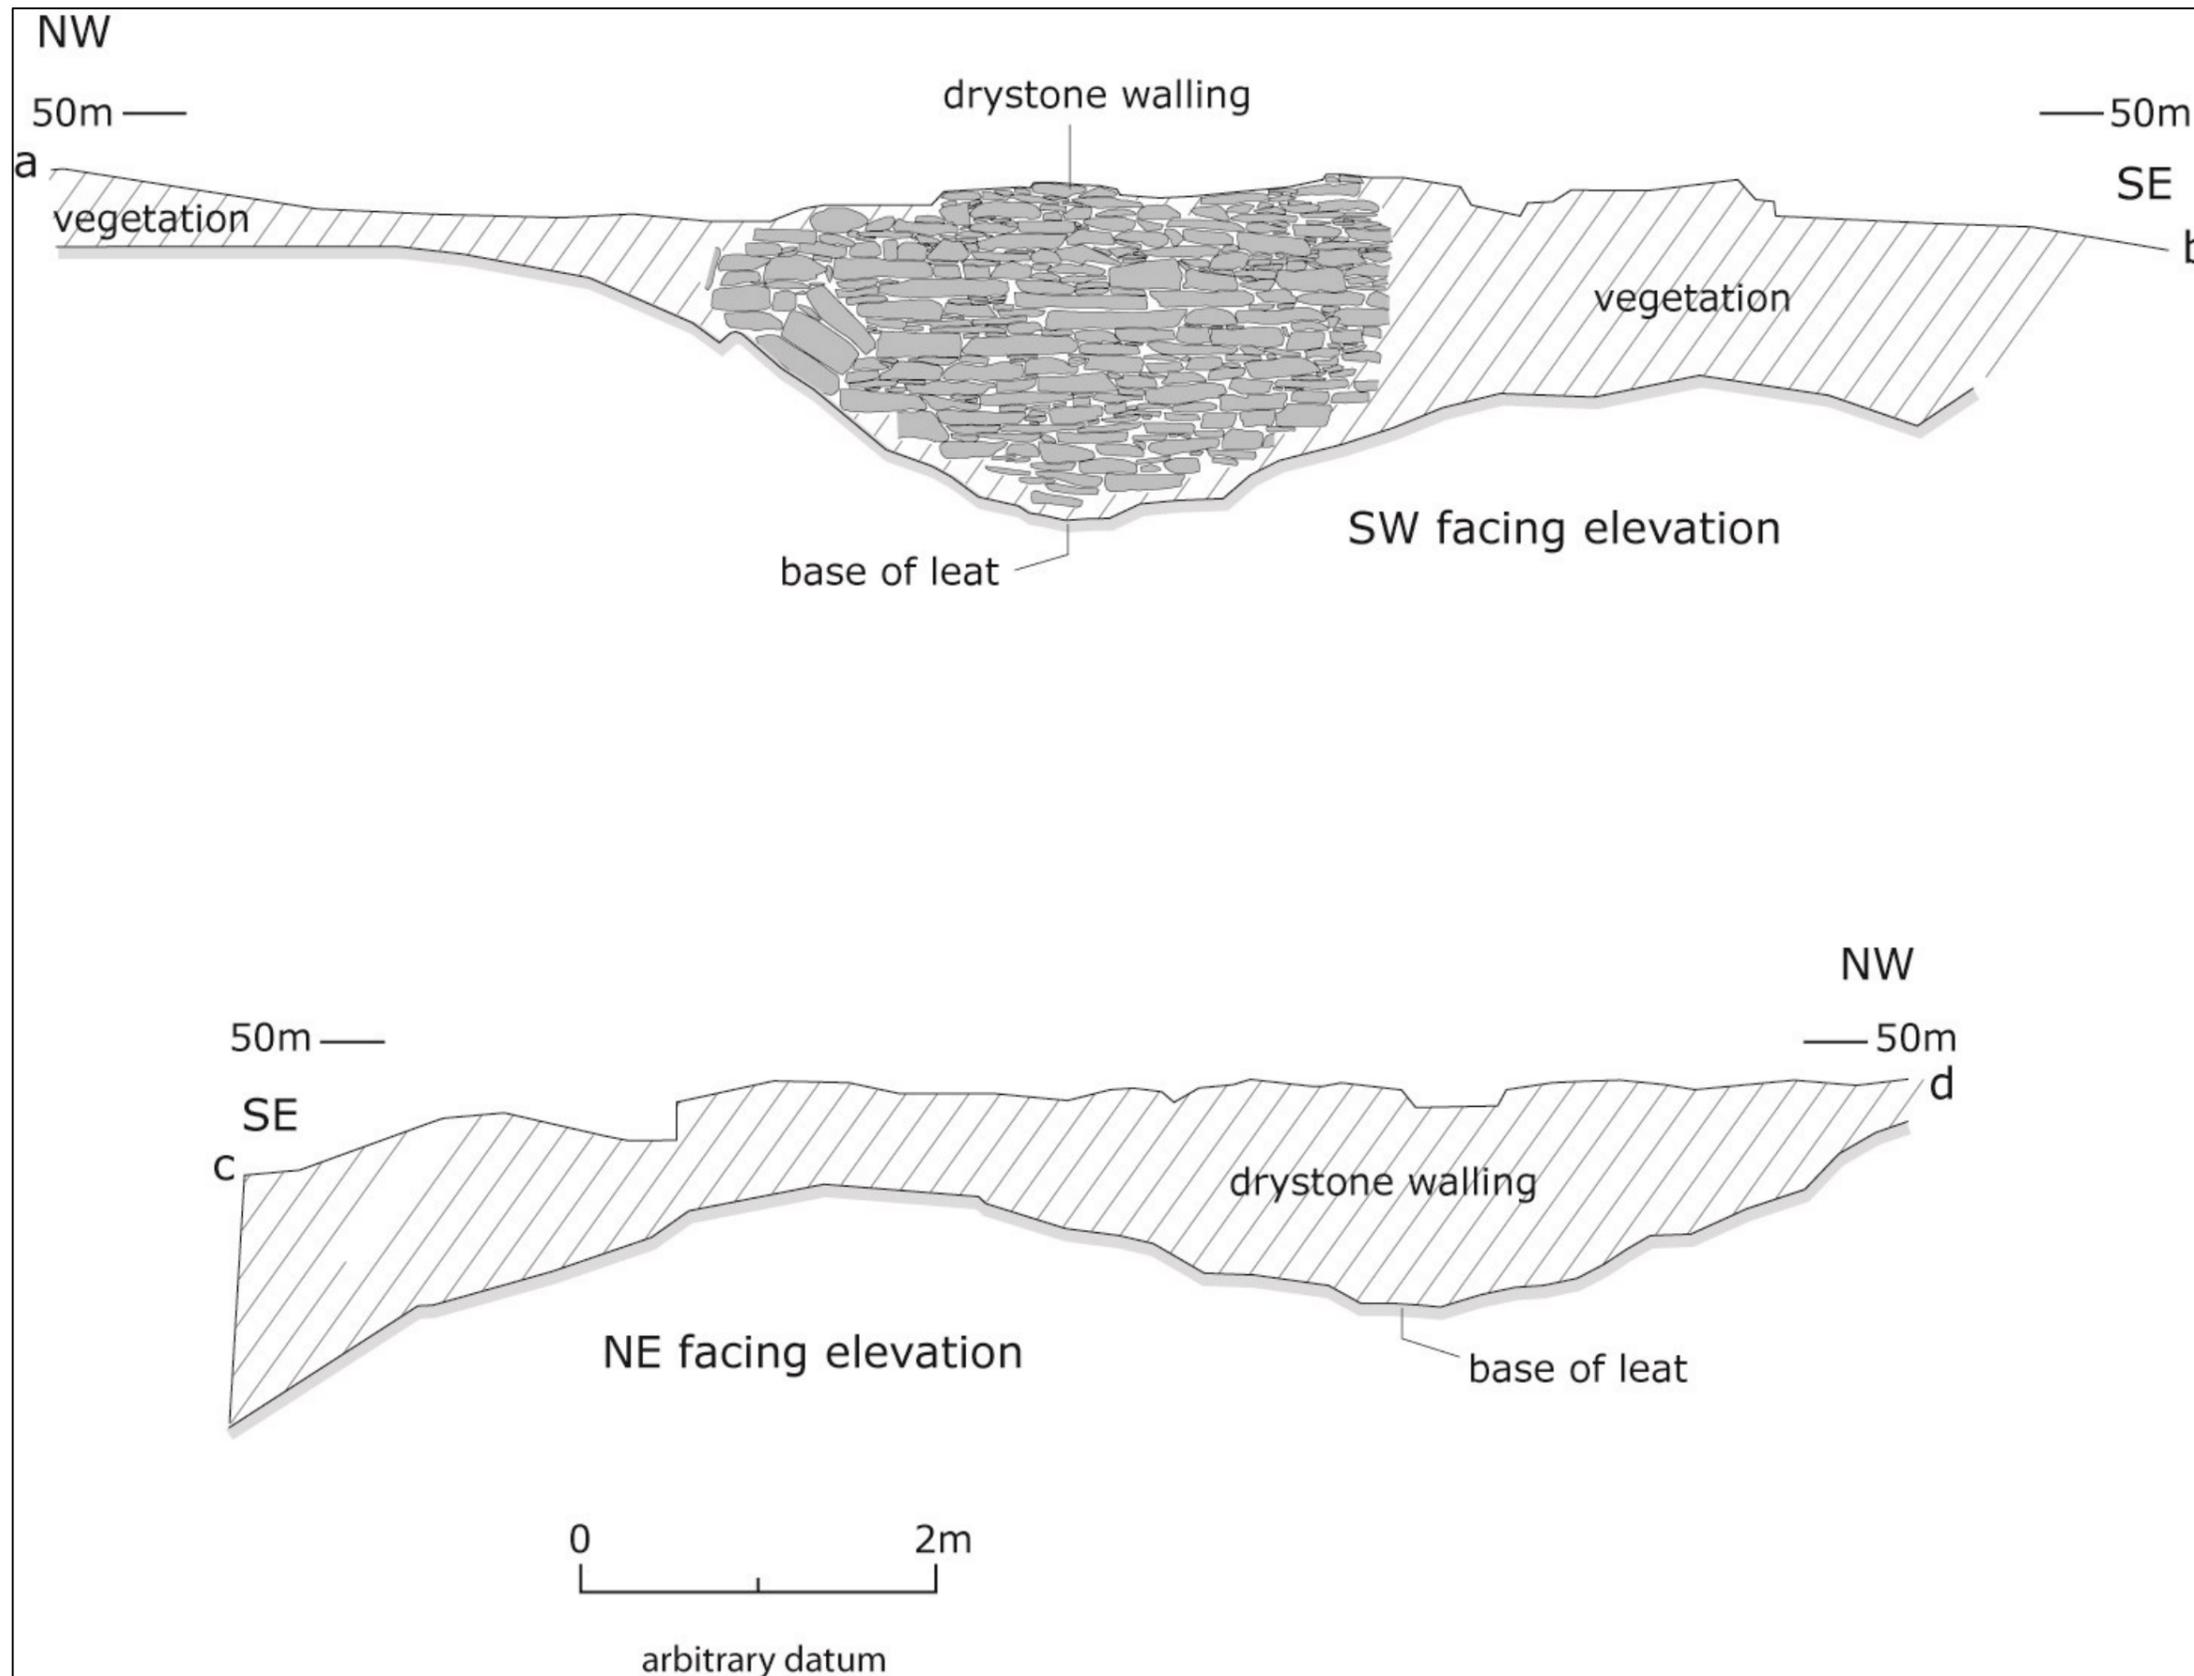
- 4.7 The elevation of the southwestern façade of the bridge abutment was recorded (Figure 9).
- 4.8 On the northwestern side of the bridge abutment elevation, three stones were noted which did not fit with the horizontal laying of its rubble stone construction (Figure 9; Photo 11). The stones had the appearance of what could be interpreted as the start of a springing arch laid directly on the western bank of the leat. No further evidence for a former arch could be seen on either side of the abutment and so it is considered unlikely to be the remains of a former arch over the leat. It is considered more likely to be the remains of a patched repair to the bridge abutment.

Figure 9: The southwest- and northeast-facing elevations of the northern bridge abutment

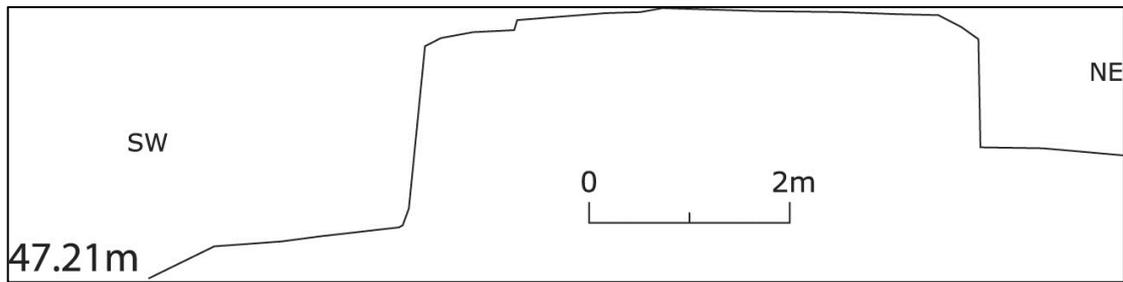
Figure 10: Profile of the northern bridge abutment (see Figure 8 for location)

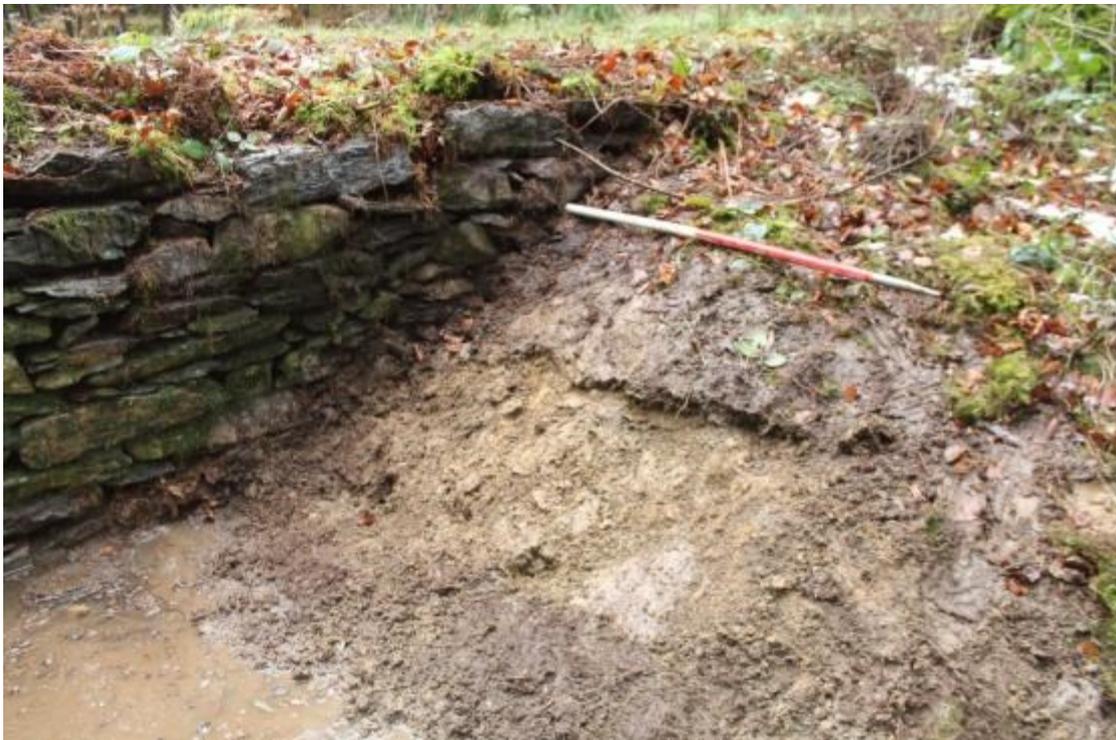
Photo 8: Facing west. Post-excavation shot of the west bank of the leat on the northeastern side of the bridge abutment, with a 1m scale.

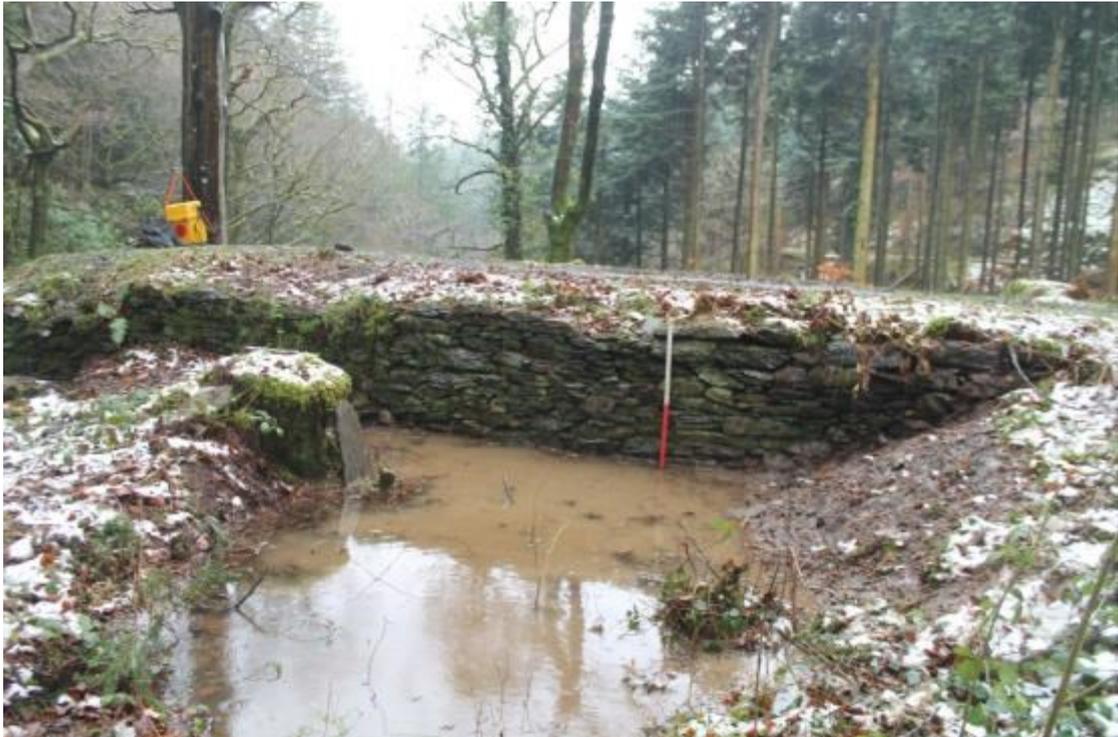
- 4.2 As the alluvial deposits were removed it became possible to visualise the original profile of the channel, although the maximum depth was difficult to determine because of the pooling water (Photo 9). No signs of a culvert were observed in the exposed face of the bridge abutment, and removal of mud did not appear to unblock any hidden channel to drain the pool.

Photo 9: The northeast face of the northern bridge abutment after moss removal and after excavation of the leat, with a 1m scale

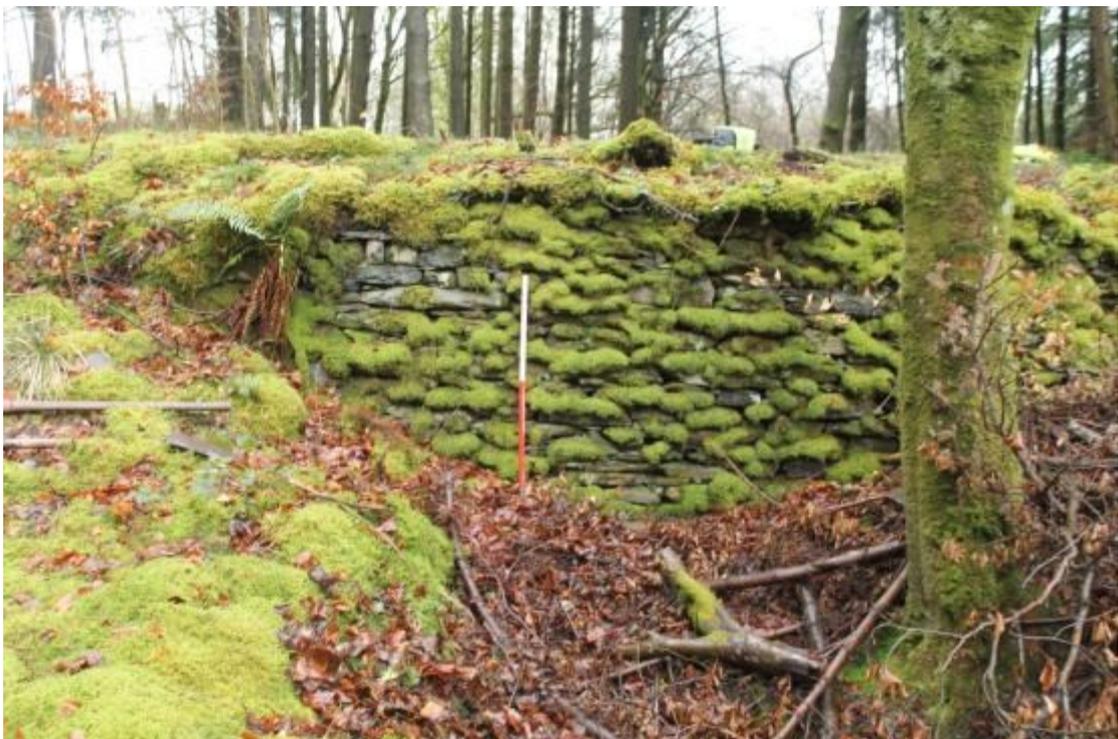
- 4.5 As on the northeast side the wall was mossy and this and other vegetation needed clearing (Photo 10).
- 4.6 As alluvium deposits were removed a gravelly layer was encountered and presumed the base of the original channel. There was no sign of a culvert through the abutment. Photo 11 shows the area after excavation.

Photo 10: The leat and the southwest side of the northern bridge abutment before cleaning and excavation, with a 1m scale

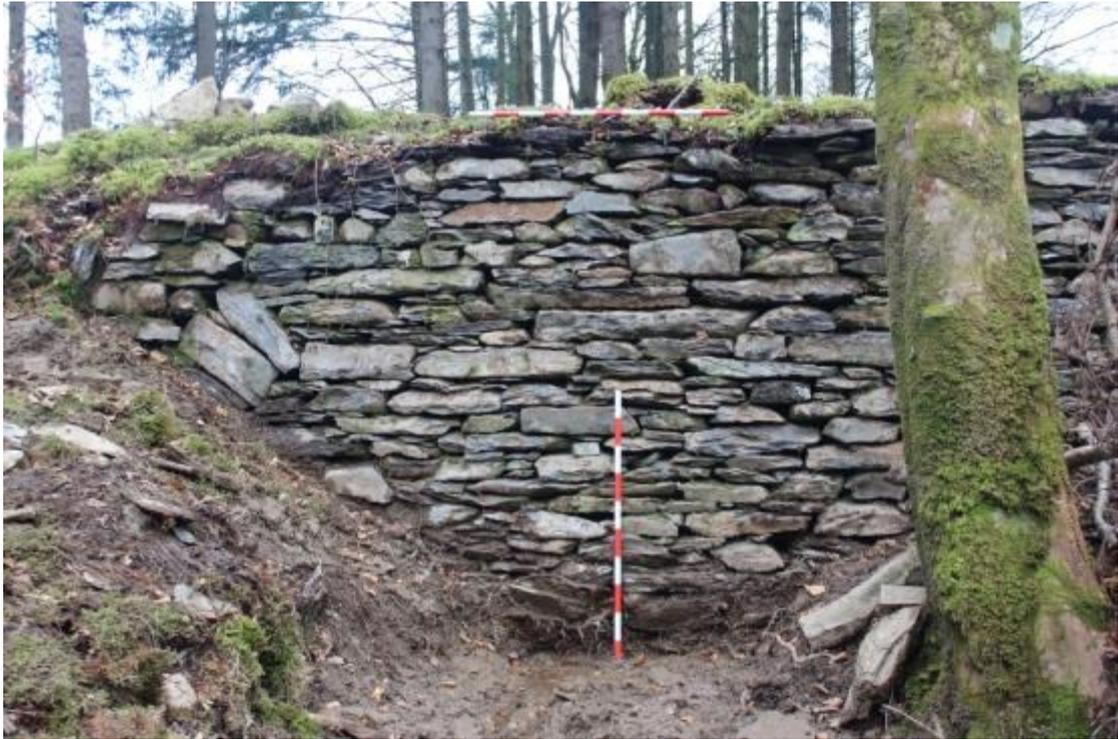
Photo 11: The east and the southwest side of the northern bridge abutment after cleaning and excavation, with 1m scale

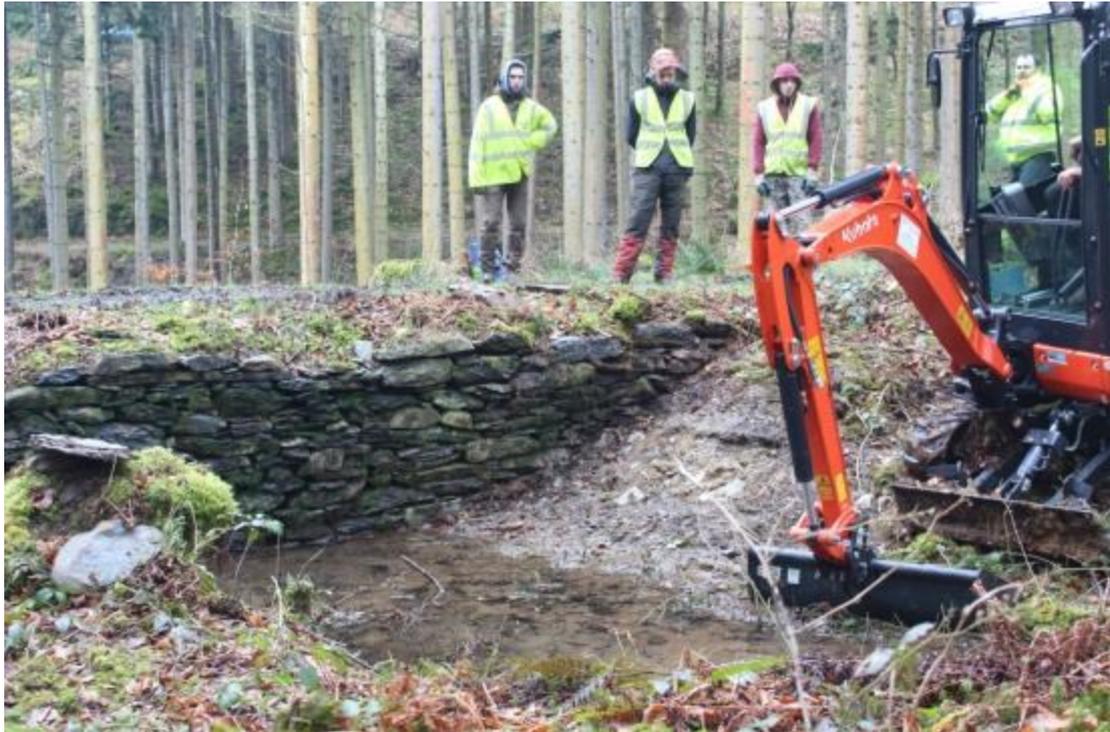
Photo 12: Excavation of the alluvial deposits in the leat by machine, facing west-southwest

- 5.1 Further clearing of vegetation was required before machine excavation of the leat could take place. This was carried out by volunteers of the Hafod Trust. Photo 12 shows excavation getting underway just north of the bridge abutment. A large amount of mud was excavated and the spoil deposited temporarily just west of the leat. The machine operator found it easy to tell when he had reached the base of the leat, even though he could not see through the muddy water, because it was hard rock. The leat proved to be approximately 1.2m deep (Photo 13). The profile of its base could not be seen but it was determined to be U-shaped beneath the water. Two similar pieces of ironwork (Photo 14) were found during excavation adjacent to the bridge abutment, identified as parts of the bridge before its collapse/removal. They were similar to links observed to be part of the chain bridge at Hafod (Garfi 1997).

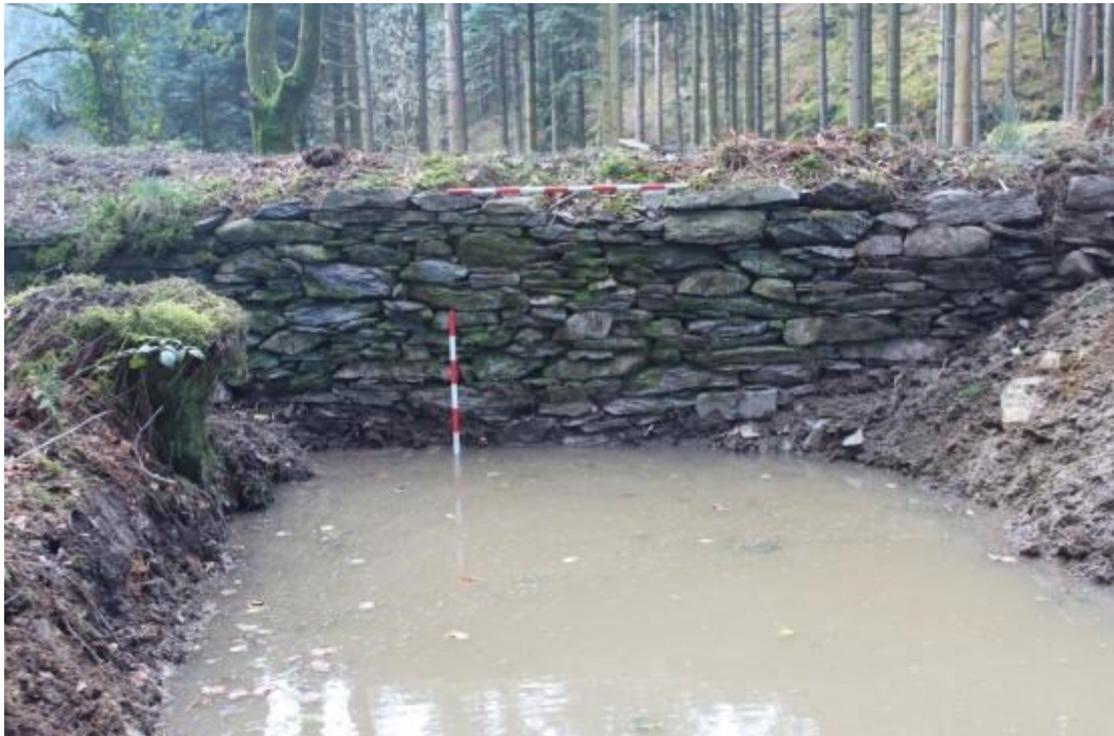
Photo 13: After excavation of the leat just northeast of the bridge abutment

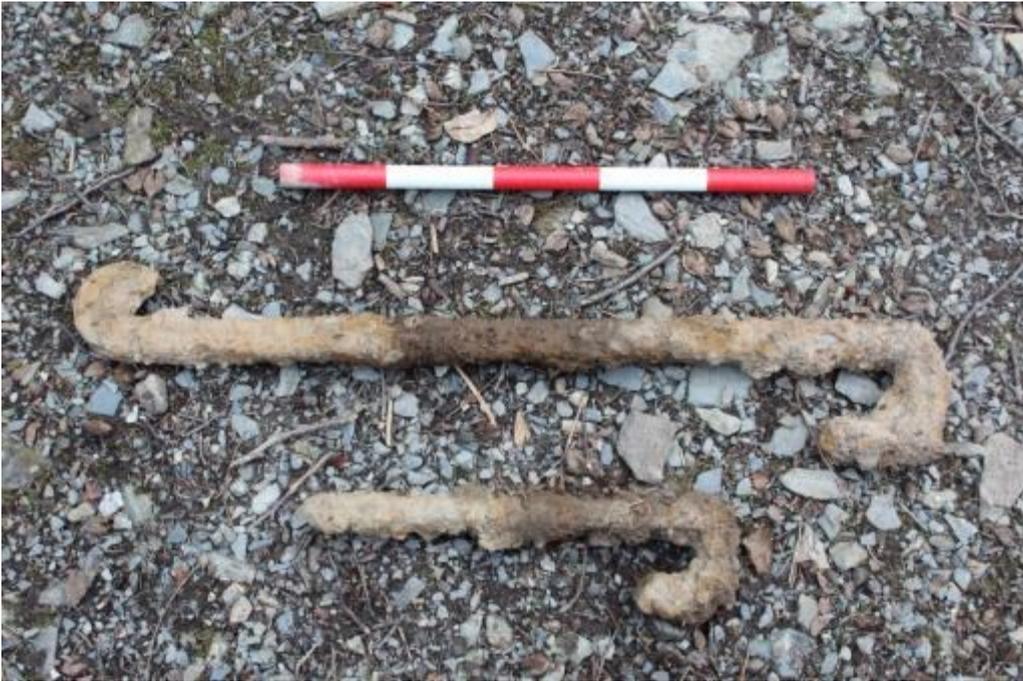
Photo 14: Ironwork found during excavation adjacent to the bridge abutment, previously part of the bridge, with a 0.5m scale

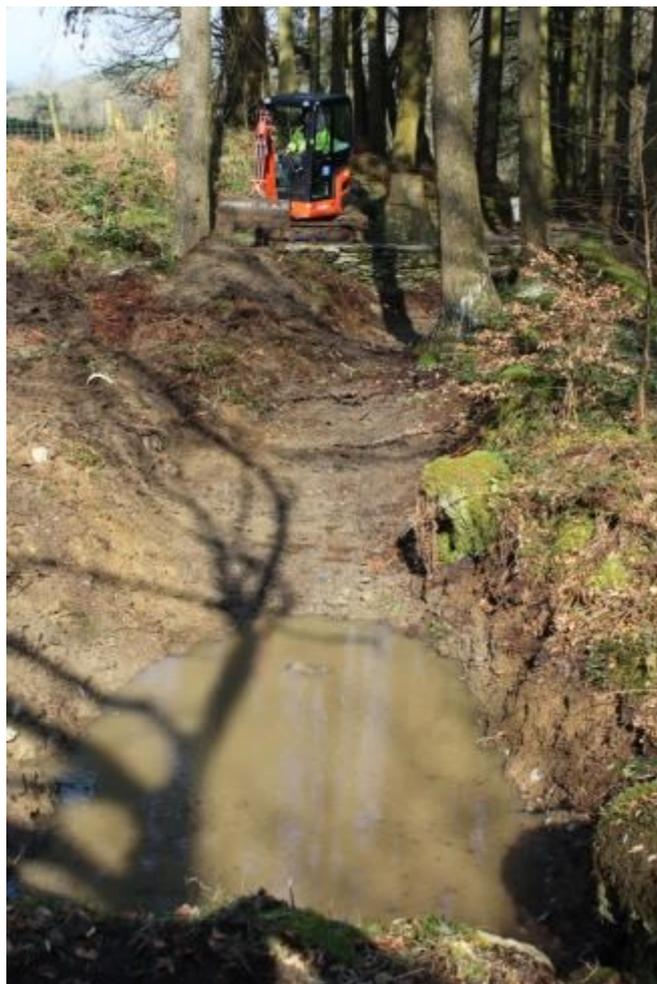
Photo 15: Looking northeast along the section of the leat just north of the northern bridge abutment after partial excavation by machine

- 5.2 Excavation continued along the leat northeast of the bridge abutment (Photo 15) until the modern wall built for a pathway to cross the leat was encountered (Photo 16). Pending further plans for the leat, it was decided to leave the wall and pathway intact for the time being. A tree also hampered complete excavation of the leat in this area.

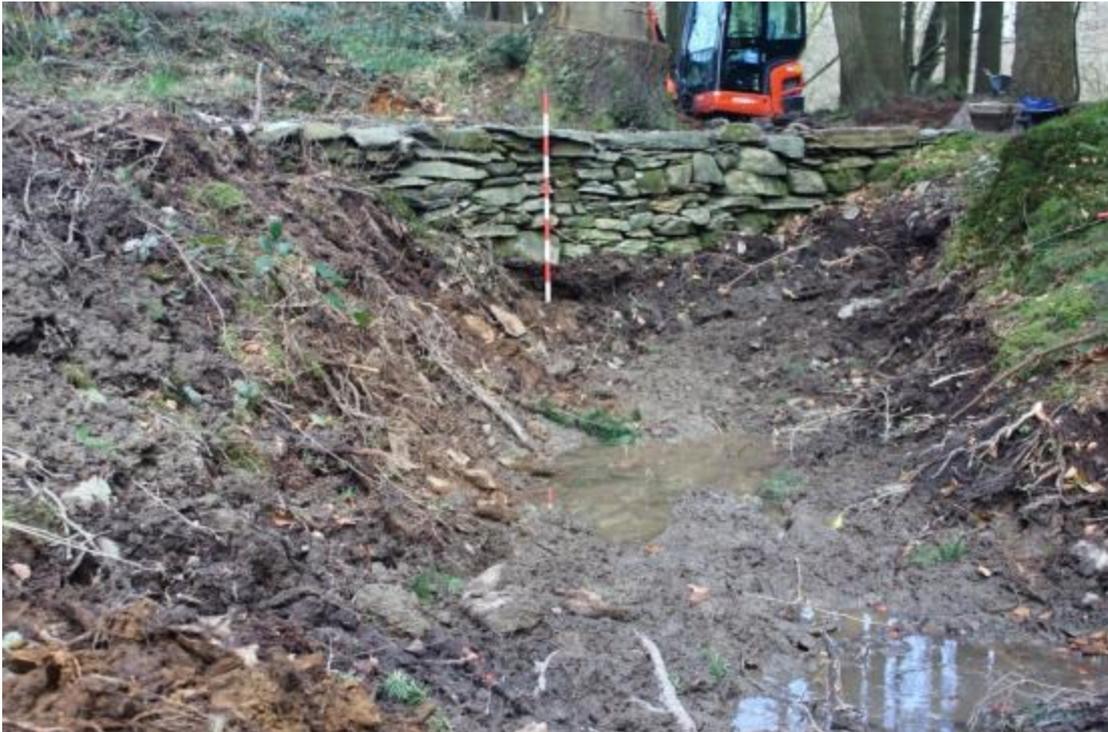
Photo 16: The leat and the modern-built pathway over it, with a 1m scale, after excavation

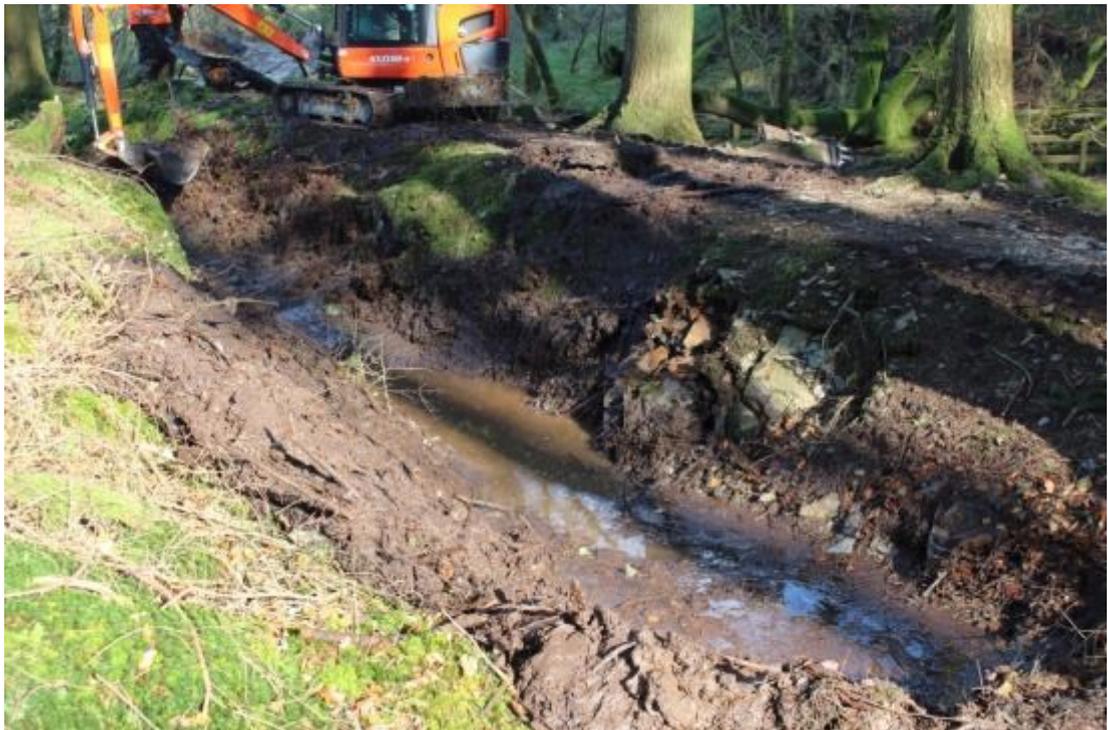
Photo 17: Looking north-northeast across the northern part of the leat during excavation

- 5.3 Northeast of the path, excavation continued along the rest of the leat (Photos 17 – 19). The leat became gradually shallower towards its northern end, where it was 0.9m deep. Excavation stopped before the very northern end was reached in order to preserve the deposits relating to the leat and the possible building of a bank there to end its use. Trees again prevented full excavation of the leat along this section. It was suggested that the trees would be removed in the future and that the excavation of the leat might then be completed.

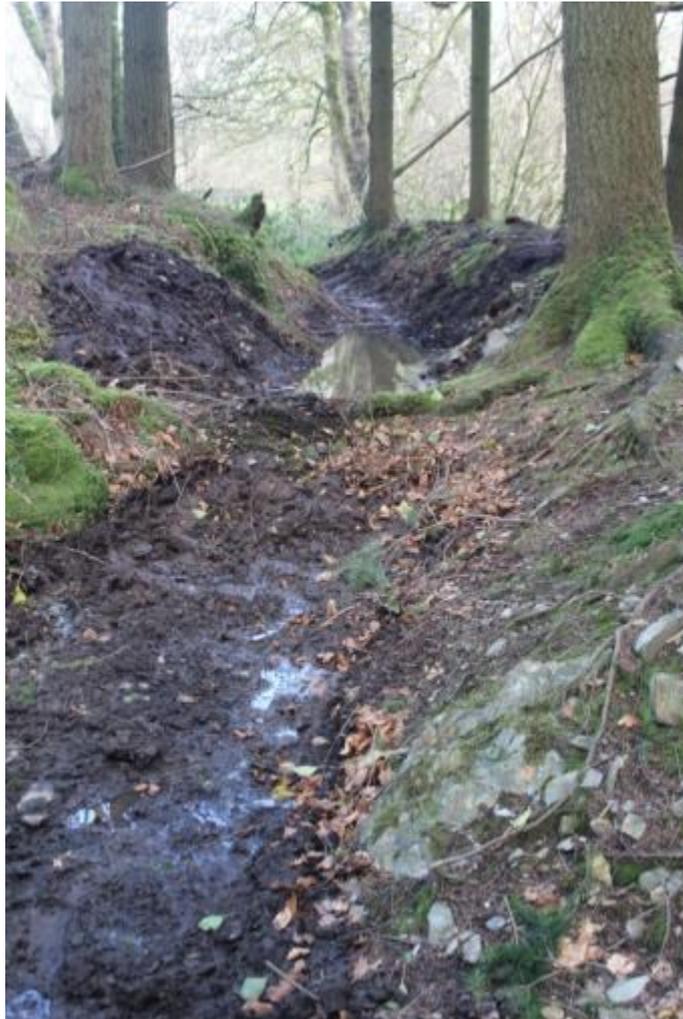
Photo 18: Looking northeast along the northern part of the leat after excavation

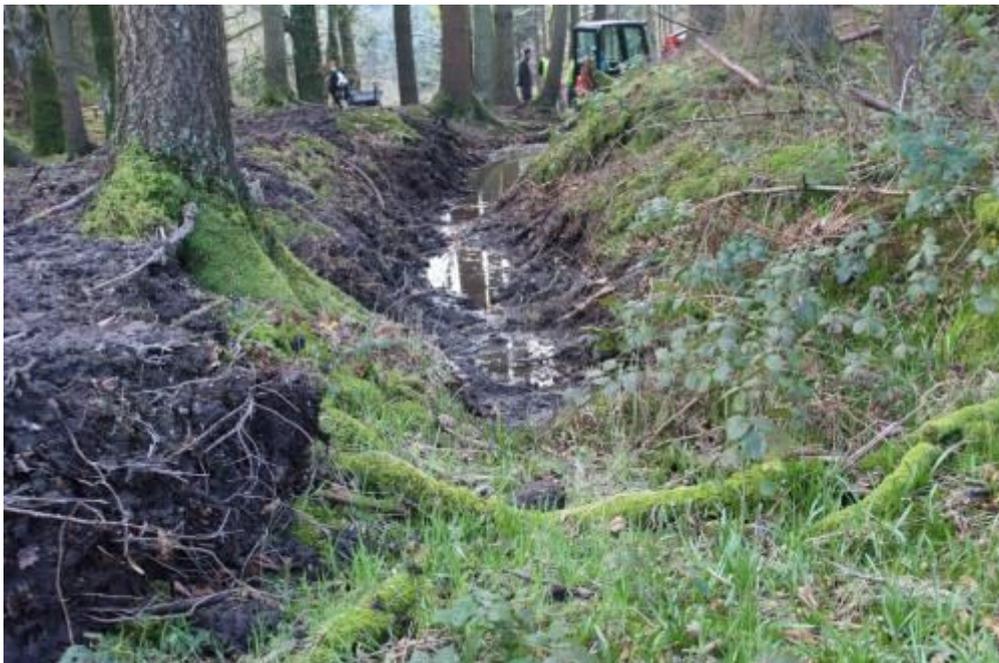
Photo 19: Looking southwest along the northern part of the leat after excavation

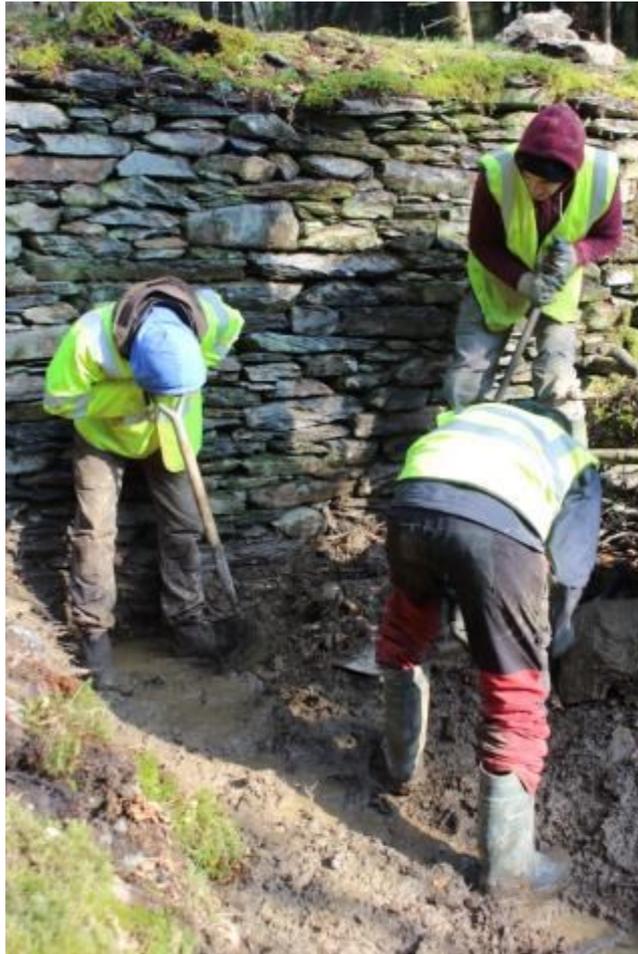
Photo 20: Excavating the leat southwest of the bridge abutment by hand

- 5.4 Southwest of the bridge abutment excavation was carried out by hand by the Hafod Trust volunteers under supervision (Photo 20), as the machine could not gain access there. After removal of many tree roots it was seen that what was previously thought to be the base of the leat was actually still very silty and loose as well as containing a lot of gravel, so this deposit was removed until bedrock was encountered. The west bank of the leat was also established, but the further tree roots prevented complete excavation of the east bank.

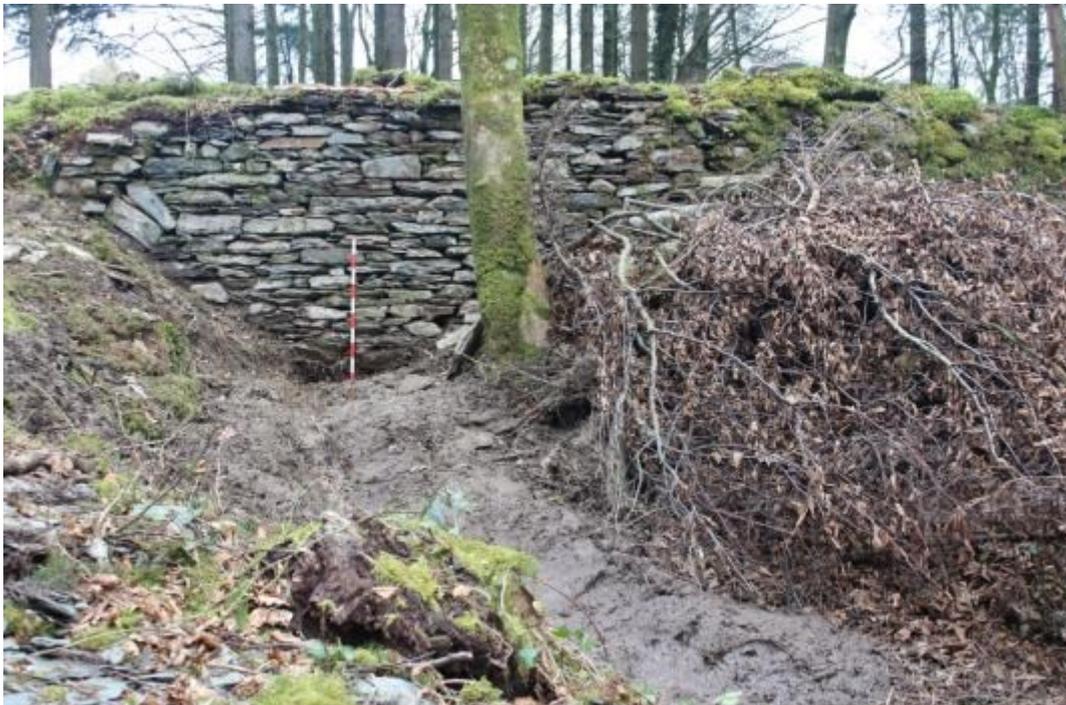
- 5.5 The rate of flow of water through the wall did not increase from a trickle during the excavation or a day after it. The base of the wall was observed to sit on the base of the leat and there was no sign of a culvert. The water coming through the wall was percolating through the gaps in the drystone wall of the bridge abutment. Photo 21 shows the area after excavation.

Photo 21: Southwest side of the bridge abutment and leat after excavation, with a 1m scale
