PONT NEWYDD, HAFOD, CEREDIGION: ARCHAEOLOGICAL EVALUATION AND WATCHING BRIEF 2017

Prepared by DAT Archaeological Services
For: Natural Resources Wales

RHIF YR ADRODDIAD / REPORT NO. 2017/21
RHIF Y PROSIECT / PROJECT RECORD NO. 110436

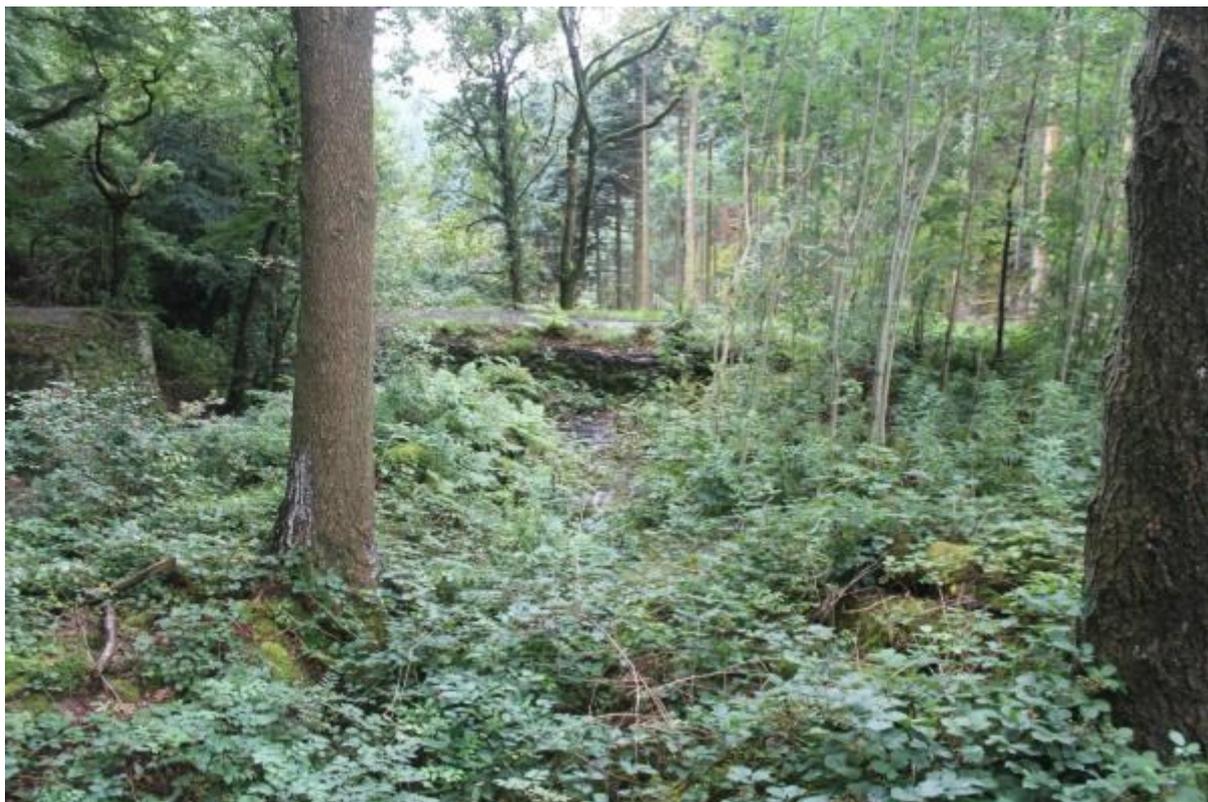
Photo 1: View east along former leat running to the Nant Peiran Cascade, with the bridge abutment visible at the far end
