# **SCHEDULING ENHANCEMENT PROJECT 2009: MEDIIEVAL MINOR DEFENDED SITES**

RHIF YR ADRODDIAD / REPORT NO.2009/37  
RHIF Y PROSIECT / PROJECT RECORD NO.94895

# SCHEDULING ENHANCEMENT PROJECT 2009: MIEVIAL MINOR DEFENDED SITES

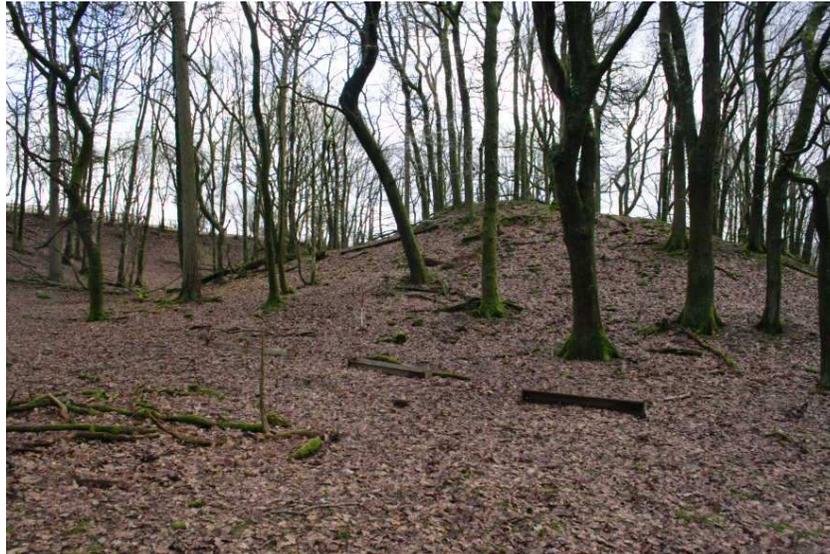
Baily Bedw is a large rounded mound c. 42m diameter and c. 8m in height; it lies on a broad, flat, natural terrace on a steep west-facing slope within deciduous woodland. The mound is tree covered, several of which have fallen and exposed what appears to be natural bedrock. Although the mound is 'motte'-like in appearance it seems more likely to be a natural topographic feature, given the presence of the *in situ* bedrock.

View of Baily Bedw mound, looking south-southeast.

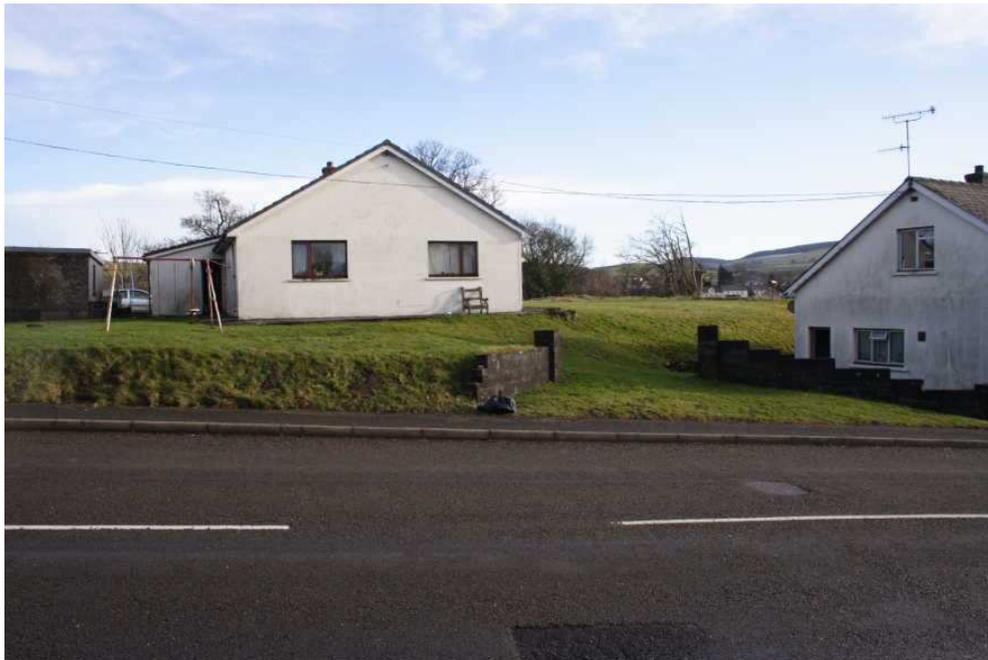
Castell Dolwlff is situated on a scarp edged promontory overlooking the Afon Teifi at 99m above sea level. The steep fall of c. 9m down to the river on its eastern side afforded good natural defence to this former 24m diameter ringwork; the remaining defences comprised a strong bank and 6m wide ditch on the north and west sides. The site was formerly scheduled (SAM no. Cd 75) but became so mutilated by building development and landscaping that it was descheduled in 1990. Very little, if any, of the original defences are now evident save for the scarp to the east and south overlooking the river.

View of Castell Dolwlff, looking east. The building on the right has been dug into the exterior of the bank, the building on the left was erected in 1984.

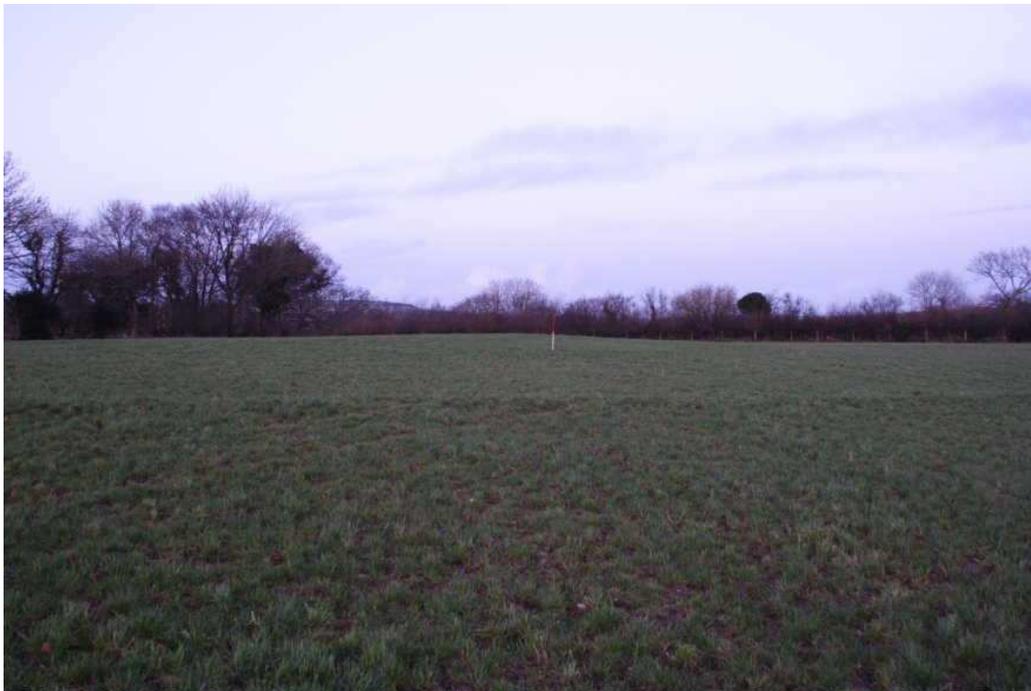
Castell is a ploughed down circular earthwork mound c. 38m diameter and c. 0.4m in height with a centrally located smaller circular mound to a further height of c. 0.4m. There is a hint of a ditch just discernible on its eastern and south-eastern sides. The farmer ploughs the field every three years and says that the ground around and on the earthwork is very stony compared with the rest of the pasture field. The site lies in a field named Parc Castell, on a local highpoint at 115m above sea level.

View of Castell, looking north-northwest. The linear feature in the foreground represents a former field boundary

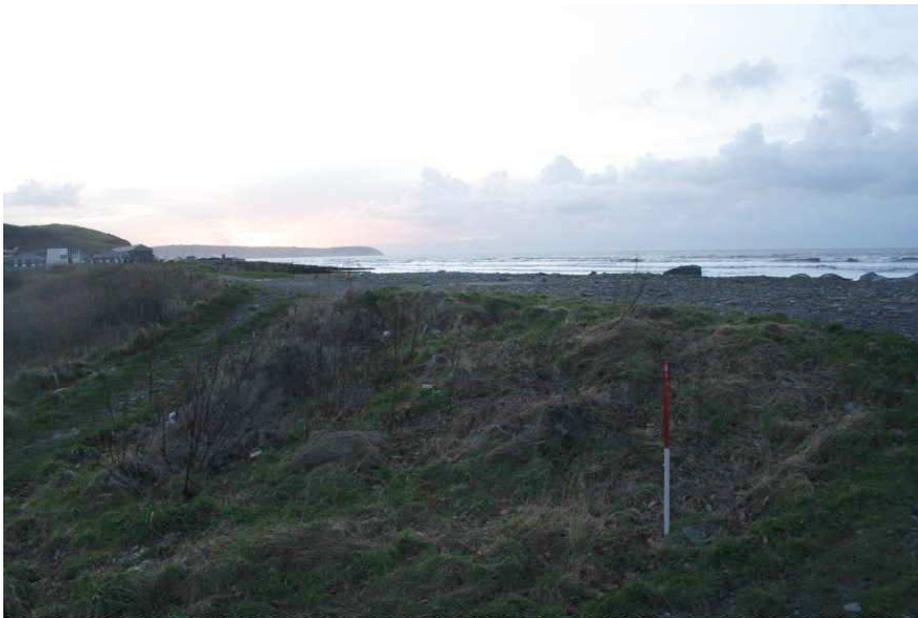
Castell Cadwgan is shown on the first edition 25" Ordnance Survey map where it appears that much of its seaward fabric had suffered extensive erosion, leaving only the landward half of the monument as an approximately 60m long curving bank on the shoreline. By the time of the publication of the second edition Ordnance Survey map the earthwork is shown to have been further compromised by the construction of a breakwater. Nothing of the Castell bank can be seen at the site now; it has either been totally destroyed or has been incorporated into the high pebble bank sea defence that currently occupies the space.

View looking west across storm defence in former location of Castell Cadwgan bank.

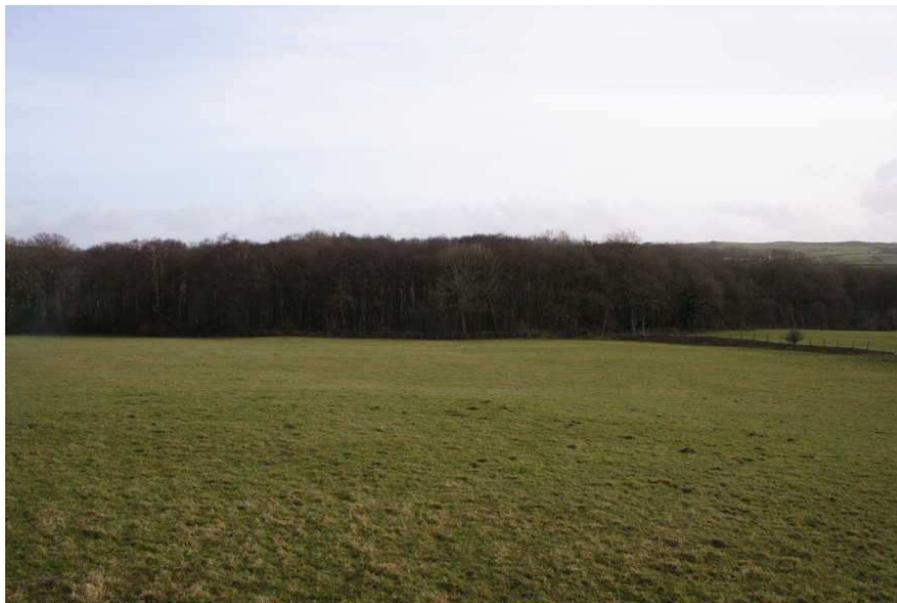
A rectangular moat, Coed Llys, was noted at this location by the RCAHM in 1970, and visited by the Ordnance Survey in 1974. At that time it was noted that the long axis of the moat measured 50m long, internally, and was aligned northeast to southwest with the shorter side being 30m long. The eastern side consisted of two fragmentary banks with a maximum height of 0.9m, which were in Coed Llys woods, the outer bank continued around the southern side where it was preserved under rough pasture. The northern and western extent of the moat ditch were observed to be "extremely spread", with a break of level ground in the southwest corner. At the time of the recent site visit Coed Llys woods were too overgrown with vegetation to enable an assessment of the current state of preservation of the two fragmentary banks. There is only a slight indication on the ground of the bank continuing around to the southern side. Elsewhere the monument is only barely discernible as nebulous linear hollows on very gently sloping, southwest facing, improved pasture at 122m above sea level.

View of Coed Llys, looking south.

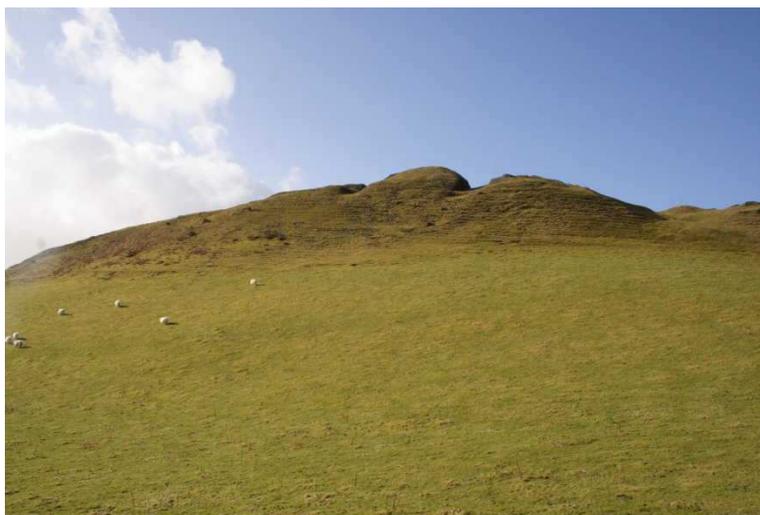
Castell is a prominent, small (some 320m long) rocky ridge rising to about 305m above sea level; it rises commandingly above the surrounding land. The long axis of the ridge is aligned north to south with its slopes falling away steeply to the north, south and west. The eastern side falls away steeply at first but then slopes more gently for 60m or so, forming a natural moderately sloping terrace, before falling away steeply again. The summit of the ridge appears to have been artificially sculpted into a mound and well-defined rock-cut ditches have been excavated across the ridge to both the north and south of the mound. The ditches effectively give the mound summit a definite circular, motte-like appearance measuring approximately 15m across. The mound is solid bedrock and not constructed from the excavated ditches' spoil. Beyond the more northerly rock-cut ditch, some 25m or so away, there is a further linear hollow running across the ridge which has a definite artificial earthen bank enclosing about two thirds of its eastern end. To the south of the summit there is a small natural shelf which may represent a small ward or bailey, and towards the northern end of the ridge there are larger areas defined by natural rock outcrops which may equally define areas of occupation. The moderately sloping terrace and improved pasture to the east of the ridge may have served as an outer bailey with enclosing banks long eroded away or obscured by modern field boundaries. The ridge commands strategic views along the meandering Rheidol valley to the northwest, north and east and communication routes to the south along Nant y Fawnog. There appears, however, to be no documentary evidence to support the hypothesis that the site is that of a medieval motte and bailey castle. A sketch from c.1800 shows the artificially fashioned profile of the mound on the ridge summit.

View of Castell summit, looking west-southwest

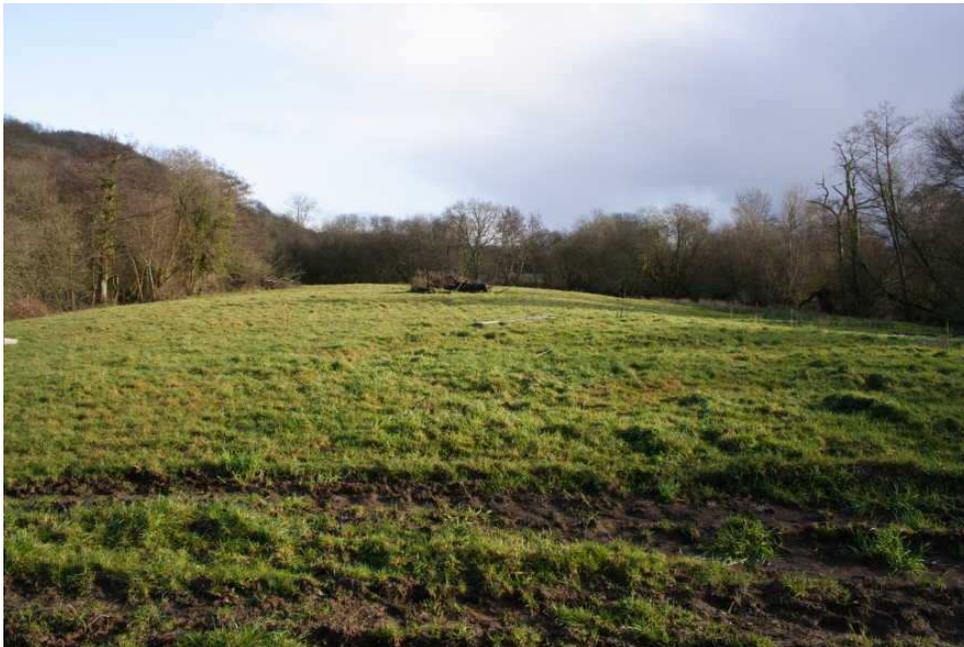
Castell Henllys comprises a water filled ditch or moat, averaging 30m in width, which encloses a sub-rectangular area of slightly raised ground measuring c. 175m east to west by c. 90m north to south. The moat is weak at the western end where the outer bank is untraceable. The enclosed interior is on average some 1.2m higher than the surrounding Afon Teifi floodplain and is currently under pasture. A near rectangular hollow, measuring c. 30m east to west by c. 13m north to south, situated centrally along the southern edge of the interior may represent a building platform. Elsewhere the interior is generally featureless with a few undulations. The flooded moat contains a fairly dense growth of deciduous trees and shrubs throughout its length. As indicated by the Ordnance Survey, in 1971, it is possible that the site may have originally been an ox-bow lake that has been artificially modified to form an animal enclosure or, indeed, adapted as a defended moated site. The site lies on the north bank of the Afon Teifi at just under 30m above sea level.

View of the interior of Castell Henllys, looking east.

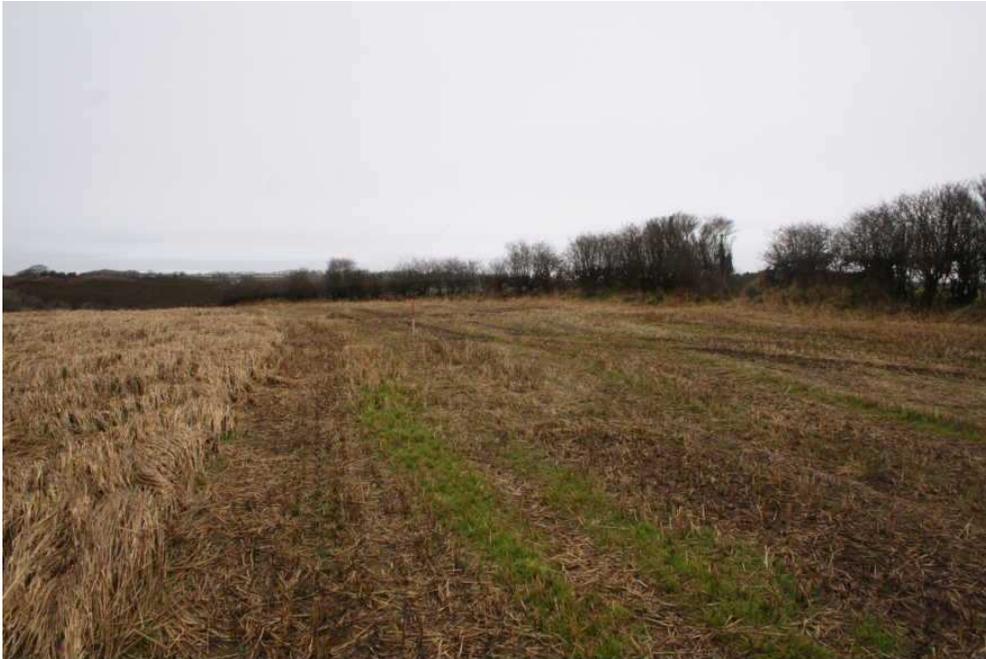
This site comprises a much ploughed down sub-rectangular earthwork, measuring c. 30m east to west by c. 25m north to south, just discernible as a low bank lying on a west facing gentle hillslope at 82m above sea level. The bank is best preserved on the north side, average height c. 0.3m, with an outer ditch clearly visible. There are indications of the presence of an outer bank on the southern side of the enclosure. The enclosed ground is crossed from north to south by a hedgebank field boundary, which places the eastern quarter of the earthwork in a field under pasture with the remaining three quarters lying in an arable field. It is possible that the field boundary overlies the eastern bank, possibly preserving it. At the time of the site visit the westerly field had recently been machine harvested, leaving deep wheel ruts that had severely damaged the earthwork banks and causing waterlogging of the enclosed interior. Small and medium size stones had been exposed and eroded out of the banks.

View of earthworks situated in the western field, looking north.

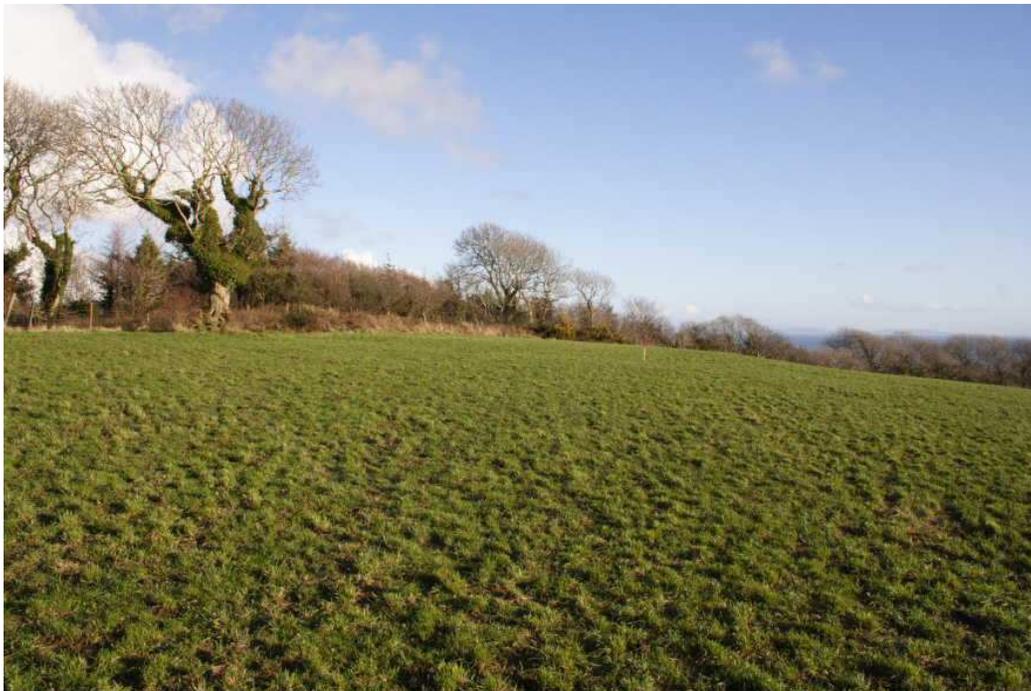
Little Castle Park is a low circular earthwork c. 30m diameter by c. 1m high with a discernible outer ditch best preserved on the west side. A trackway has been cut through the eastern edge of this monument at the top edge of a steep natural, wooded, slope which acts as a natural defence on that side. Elsewhere the topography is a south facing gentle slope in an improved pasture field at 80m above sea level. The field name for the site is 'Little Castle Park'. The Royal Commission on the Ancient and Historic Monuments in 1925 noted that an earth mound in the vicinity is traditionally believed to be the site of Earwere Castle (later known as Amroth Castle), which was later replaced by a stone castle some 0.46km to the southeast. The land is currently owned by the National Trust.

View of Little Castle Park earthwork, looking east.

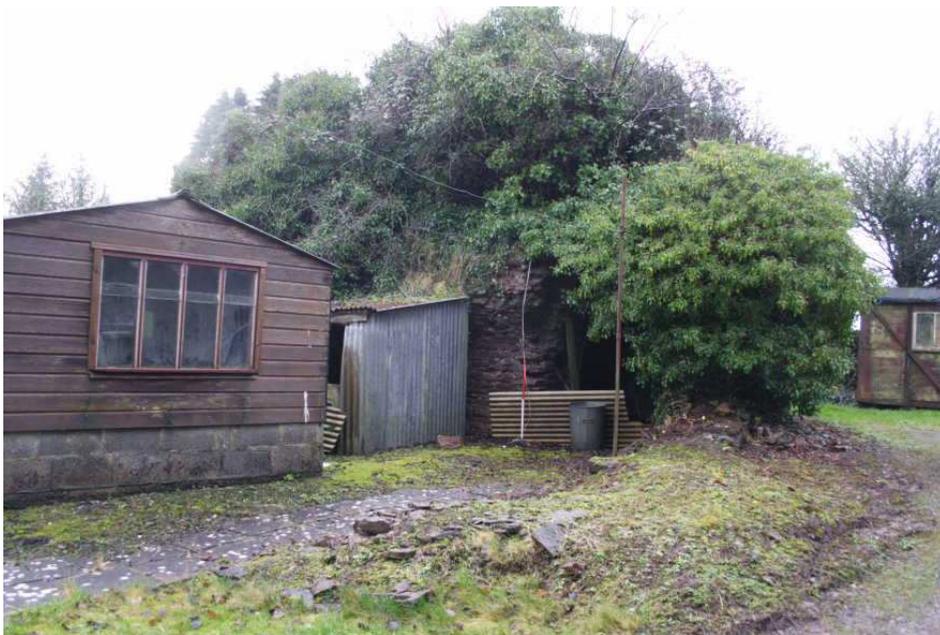
All that remains of Roche Castle today is a single stone tower with small stretches of abutting walls projecting from it to the northeast and southeast. The tower and walls were heavily covered with ivy at the time of the site visit but some architectural details were observable such as a fragment of arched vaulting and the chamber within the circular tower. The castle was in a ruinous state by the early 17<sup>th</sup> century when it is recorded as being robbed of stone for the construction of the nearby mansion at Broadway. The Ordnance Survey map of 1831 shows a wall linking two towers on the south-western side of a flat platform area. Subsequent building development on the site, especially during the 1960s, has presumably destroyed much of the fabric of the original castle and its foundations. The castle lies on a platform that is terraced into a gentle southeast facing slope, the platform is still recognisable despite the presence of modern buildings and the effects of later landscaping. The site lies on the 40m contour.

View of the ivy-clad tower of Roche Castle, looking south-southwest.

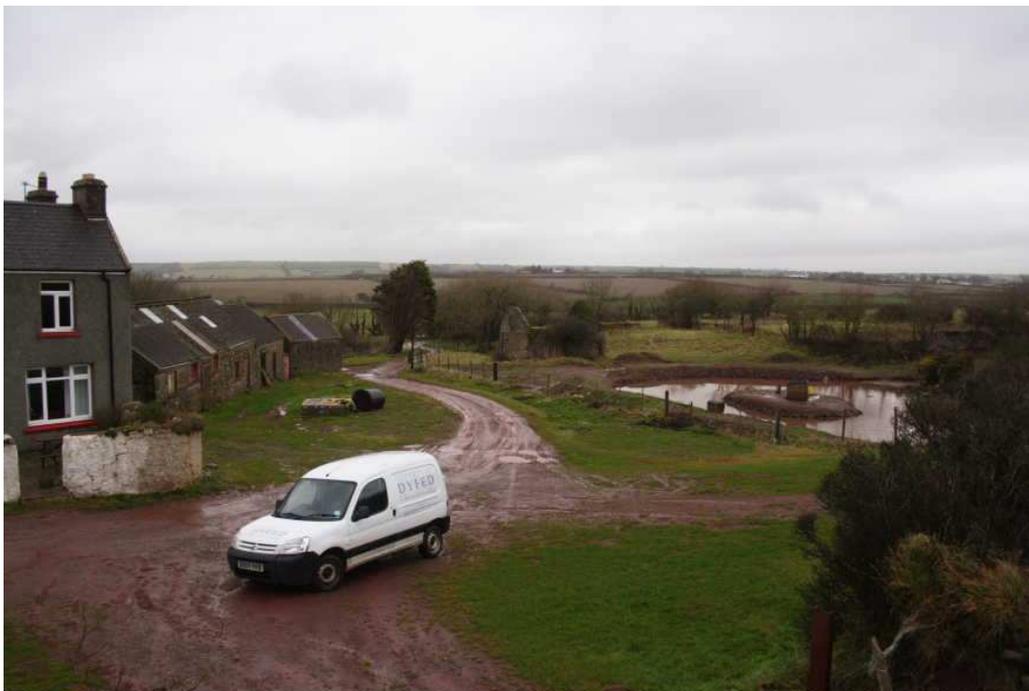
Early map evidence and photographs show a range of buildings in what is now a pond area and farmyard to the east of the present day farm buildings. Richard Fenton mentions East Moor in his Tour of Pembrokeshire (1811) describing it as having been "one of the chief mansions in the district" some 200 years earlier. The site is known to have been the home of Sampson Lort, who was the second son of Henry Lort of Stackpole Court, in the 17<sup>th</sup> century. Of the buildings shown on the early maps only one small ruin, the most northeasterly of the group, now remains. Photographs of the demolished buildings, the last one was demolished in 2004, suggest that they were architecturally in keeping with the style of known medieval buildings still extant in the locality. Recent development of a pond area may have destroyed important archaeological evidence for the southern extent of the medieval farmstead. A rectangular walled garden, on higher ground to the east of the former building complex, and a circular parcel of land adjacent to its north side may represent an even earlier phase of occupation. There is no evidence for a moat. The farm lies on the 80m contour 250m northeast of the coast; the Pembrokeshire Coast National Park coast path skirts the farm's southern boundary.

View looking north-northeast across East Moor farmyard.

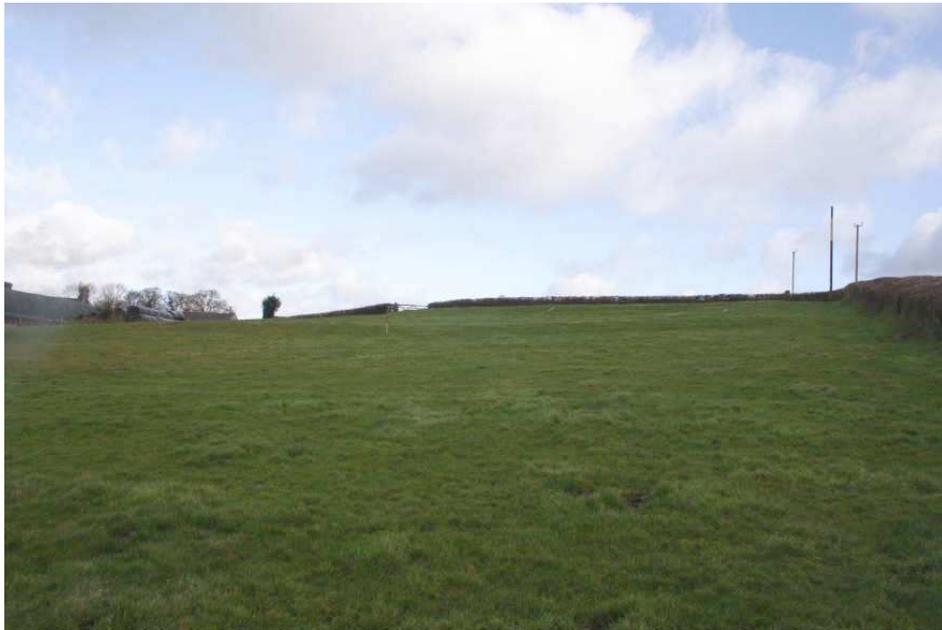
This site was first detected as a rectangular cropmark during aerial reconnaissance in 1979 and its presence is confirmed on Meridian Airmaps from 1955. On the ground the enclosure survives as a low rectangular bank terraced into a west facing moderate hillslope at 50m above sea level. The long axis of the enclosure, at c. 40m long, is aligned approximately north to south, with the lesser sides measuring c.30m. The bank on the west side averages 0.4m high whilst the upslope eastern bank is lower and more spread. The southern bank may have been incorporated into the field boundary bank. There is no trace of a bank on the northern side where it may have been destroyed by a trackway. No ditch or moat is discernible. The site looks more like a typical Iron Age rectangular enclosure rather than a moated medieval site.

View of Cwm Agol enclosure looking northeast

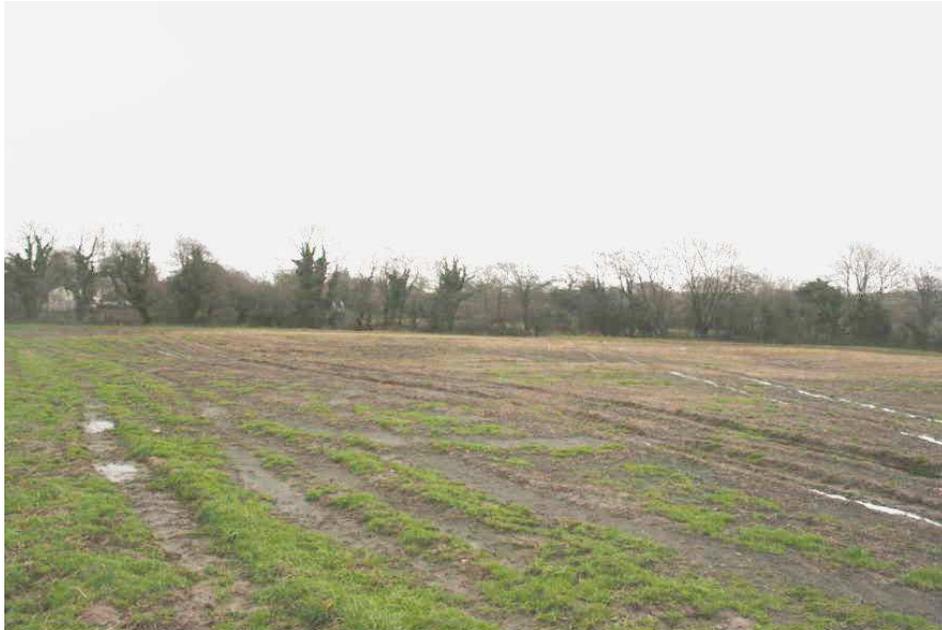
This site was discovered by aerial reconnaissance undertaken during the drought of 1984. Oblique aerial photographs taken at that time, and two years later, clearly show a square ditched enclosure situated in the field some 160m northeast of Cwrt Malle farm. Historical documents appear to confirm that the site is medieval, probably being the home of Robert de Malley in the early 12<sup>th</sup> century. On the ground the site is defined by a very low earthwork bank c. 60m by 60m with a discernible internal ditch surrounding an approximately square raised platform. The aerial photographs also appear to indicate a linear crop mark to the north of the site that may represent a leat that fed the moat, but nothing of this evident on the ground. The field is ploughed every two years and planted for silage. During the site visit the badly drained enclosure was seen to have suffered extensive damage from farm vehicles. The site lies on a very gentle south facing hillslope at 55m above sea level.

View across the site of Cwrt Malle enclosure, looking east. Note vehicular damage.

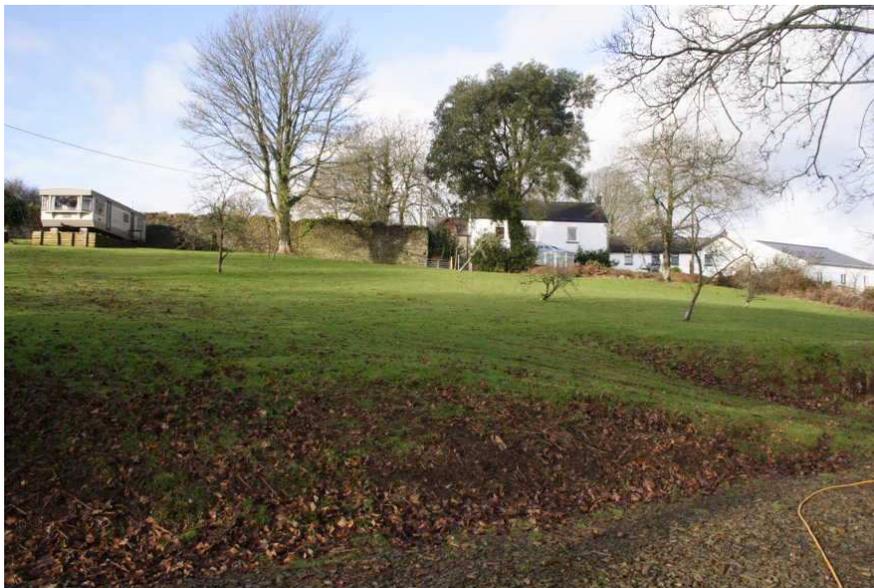
This site was first recognised as being a potential medieval moated site during a topographic and historical survey of Narberth undertaken by Heather James in 1992 in which there is an unsourced reference to the 'Medieval manor of Whitley'. Early edition Ordnance Survey maps show the presence of a rectangular earthwork platform in front of (southeast side) the house, modern edition maps omit this detail. The main farmhouse and outbuildings of Whitley Farm have undergone much recent modernisation. A large walled garden survives to the southwest of the house, a drystone 'Ha-Ha' lies to the southeast, in front of the house and is obscured by vegetation. There is now no indication on the ground of the raised rectangular platform marked on the early Ordnance Survey maps, and there are no earthworks resembling a ditch or moat in the vicinity. The basement in the main farmhouse has architectural details that appear to be of some antiquity; the walls are of substantial stone masonry, the floor is of cut stone slabs, there are pointed arch stonework niches in at least one of the walls, and the ceiling is barrel vaulted. These features suggest medieval origins.

A view of Whitley Farm, looking northwest. Note walled garden to the left of the farmhouse.
