# PREHISTORIC DEFENDED ENCLOSURES 2009 – ADDITIONAL SITES

RHIF YR ADRODDIAD / REPORT NO.2009/15  
RHIF Y PROSIECT / PROJECT RECORD NO.63968

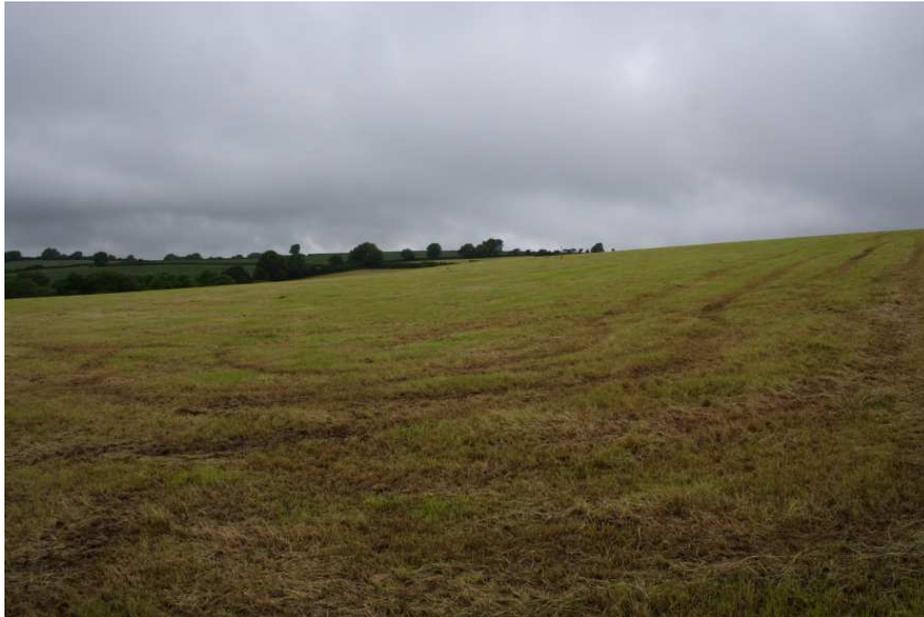
Aerial photographs of the 1980s appear to show a circular univallate defended enclosure with a concentric annexe. Situated on a moderate west facing hillslope at 150m above sea level, this site is overlooked by ground to the east. The inner circular enclosure measures approximately 40m in diameter and the concentric annexe has an approximate diameter of 100m. On the southwest an approaching ditched/banked trackway runs between the two concentric ditches of the inner enclosure and the outer annexe. Darker splotches within the annexe area visible on the aerial photograph may indicate the presence of hut circles. A linear feature/ditch runs from the outer edge of the concentric annexe on the southeast to the centre of the enclosure. In 2008 no earthwork could be identified on the ground. The site lies within a field under arable and is regularly ploughed.

Looking N across area of cropmark enclosure site

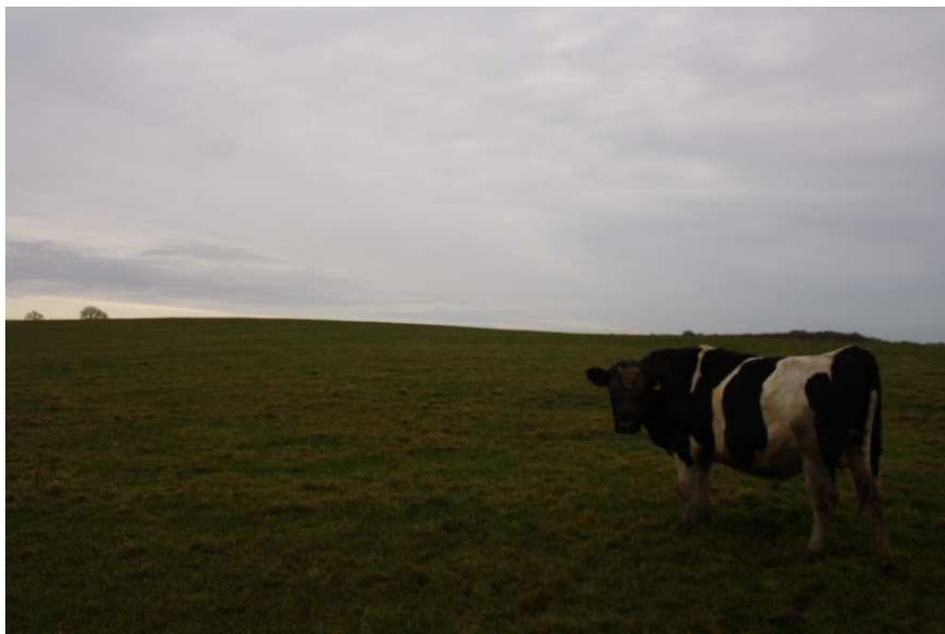
No evidence for any earthwork was noted during the 2008 visit, although some rather belligerent bullocks hampered the survey and the surface of the field, currently under pasture, was pitted and muddy from their hoof-prints. The site is regularly ploughed.

Looking SE - across area of putative cropmark enclosure site - nothing visible on ground

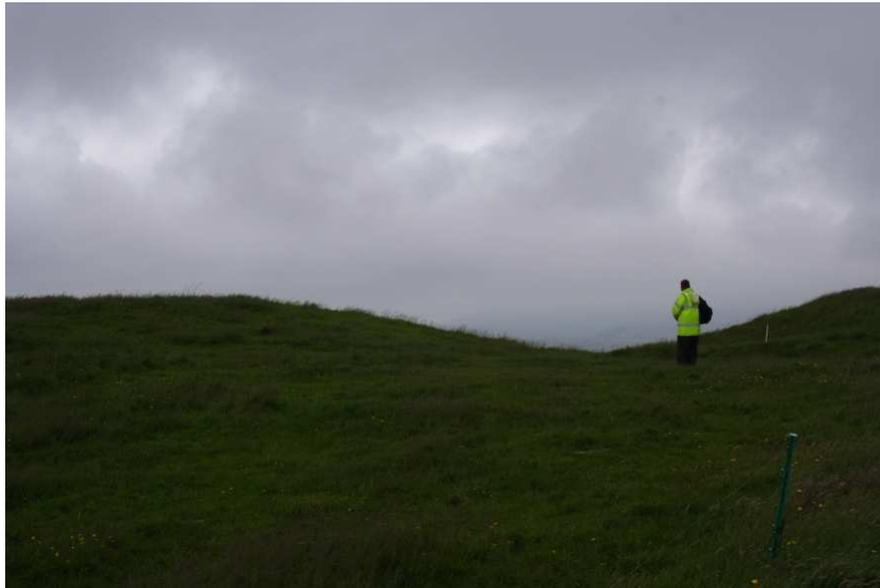
This south facing coastal promontory at 100m above sea level overlooks the estuaries of the rivers Towy, Taf and Gwendraeth. Situated on this promontory is a much denude promontory fort. The earthworks have been severely damaged by later quarrying. Remnants of concrete structures lie towards the southern tip of the promontory, and may be a result of quarrying, or perhaps WWII defences. A number of natural features also confuse the characterisation of the fort's earthworks. However, it is possible to identify a curving defensive bank running from east to west to the north of the promontory. It fades away at its east and west ends, which may be an indication of the former positions of entrances, but it is not clear. Externally the bank measures c.1.5m high but internally there is no break of slope. An outer ditch to the bank is just visible and is approximately 3-4m wide but it is very difficult to decide where its outer edge is. According to a site visit in 1989 by Terry James of Dyfed Archaeological Trust a ditch could be clearly seen protecting the landward side, when viewed from sea level.

Facing W - possible outer bank and ditch of promontory fort at Wharley Point

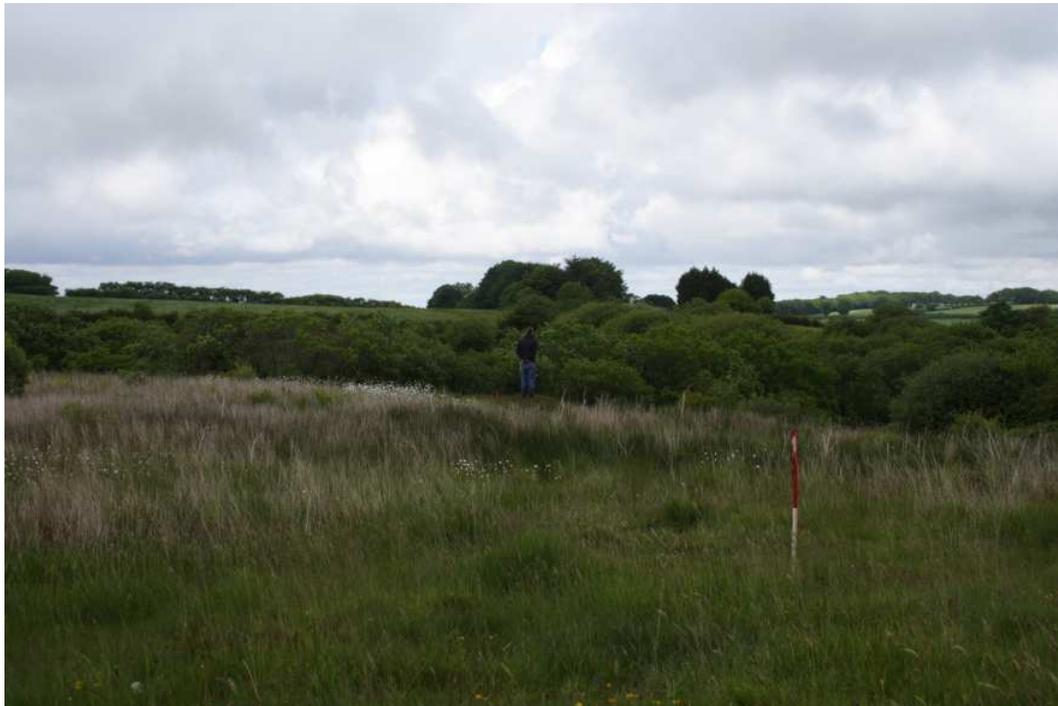
The site lies within an area of rough, wet ground covered in scrub, reeds, some grass, and small trees. It is used for the grazing of horses.

Facing E - showing curving bank of oval enclosure and simple entrance (marked by ranging rods)

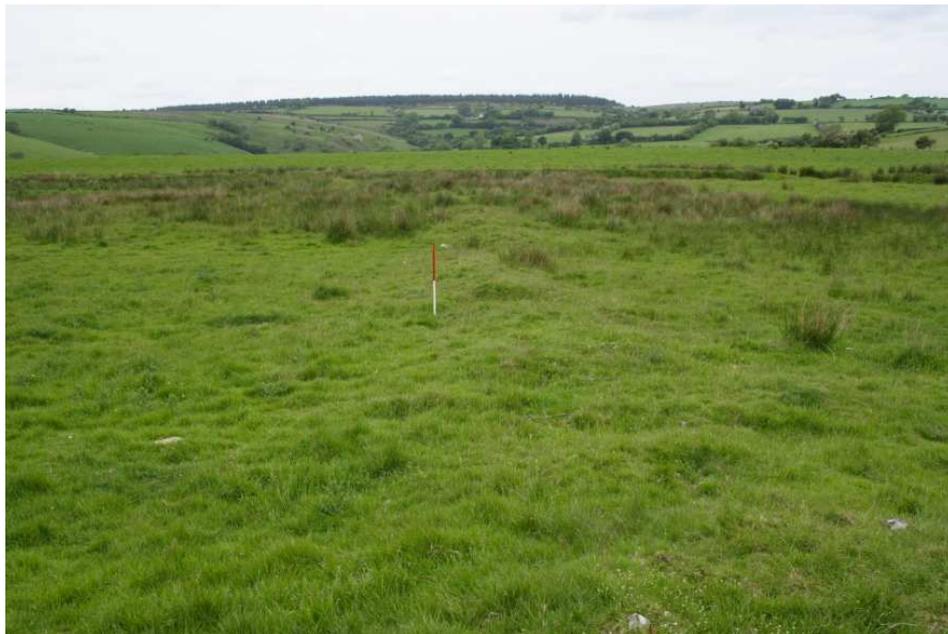
Maes Ifan is a large, elongated, D-shaped, univallate defended enclosure located on level ground at 270m above sea level. A single bank forms the three rounded sides of the 'D-shape' but the straight side of the 'D' runs along the edge of a northeast-southwest scarp slope that drops steeply to the southeast valley below, and here no bank exists. In 1968 the Ordnance Survey describe the enclosure as having axes of 180m by 100m, and as comprising a turf covered stone bank, 0.5m high, except in the northwest where it is overlaid by modern walling, and on the southeast where the bank is superseded by the steep natural slope. They identified a possible entrance on the west where there was some inturning. In 2008 the site is much as described by the Ordnance Survey, although the banks appear more denuded at c.0.3-0.5m high, and in places are harder to trace. The site lies within a field of improved pasture.

Looking NW at low linear bank of earthwork enclosure  
- bank runs NW to SE

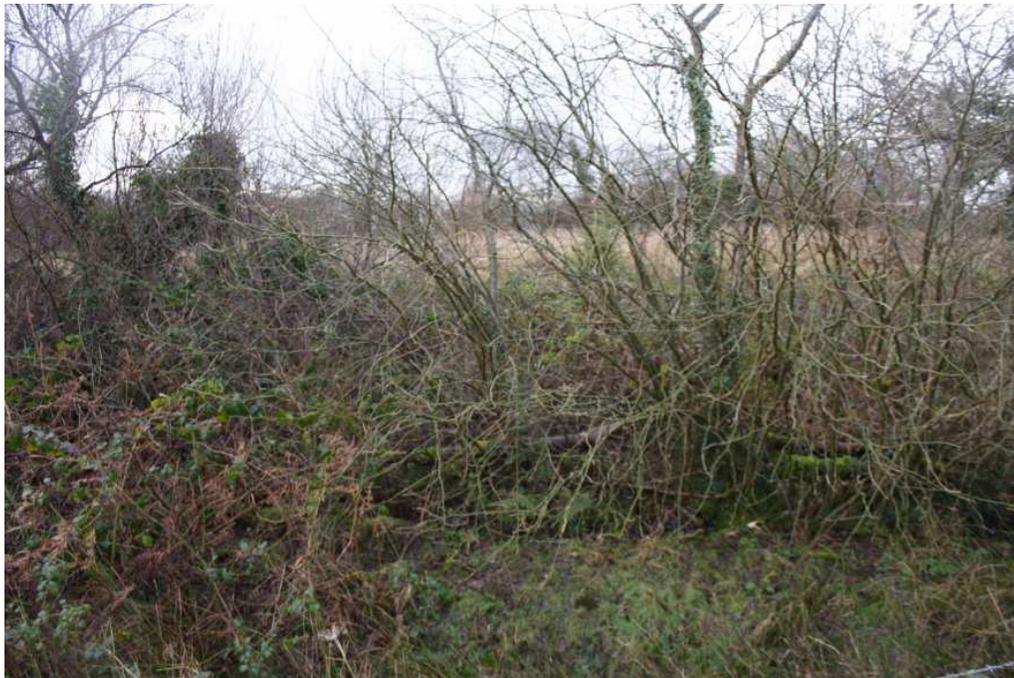
Access to the site was restricted in 2008 and it could only be viewed from a neighbouring field to the north. The area of the site is securely fenced off and heavily overgrown, with mature trees planted along the boundaries and a thick cover of brambles. Even so, the ditch and bank along the northern boundary were still visible and the interior appeared to be relatively level, although under tall grass. The site does not appear particularly defensible, lying lower than land to the north and west.

Looking W - bank and ditch in foreground, yellow grasses beyond covering the enclosure interior

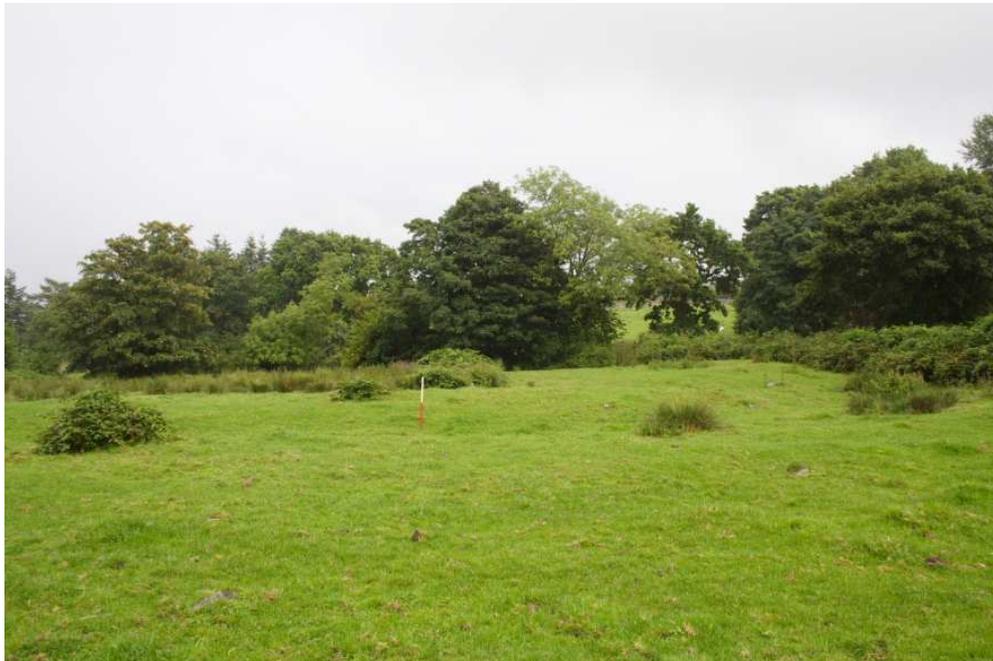
Facing NNE towards circular earthwork - possible defended enclosure

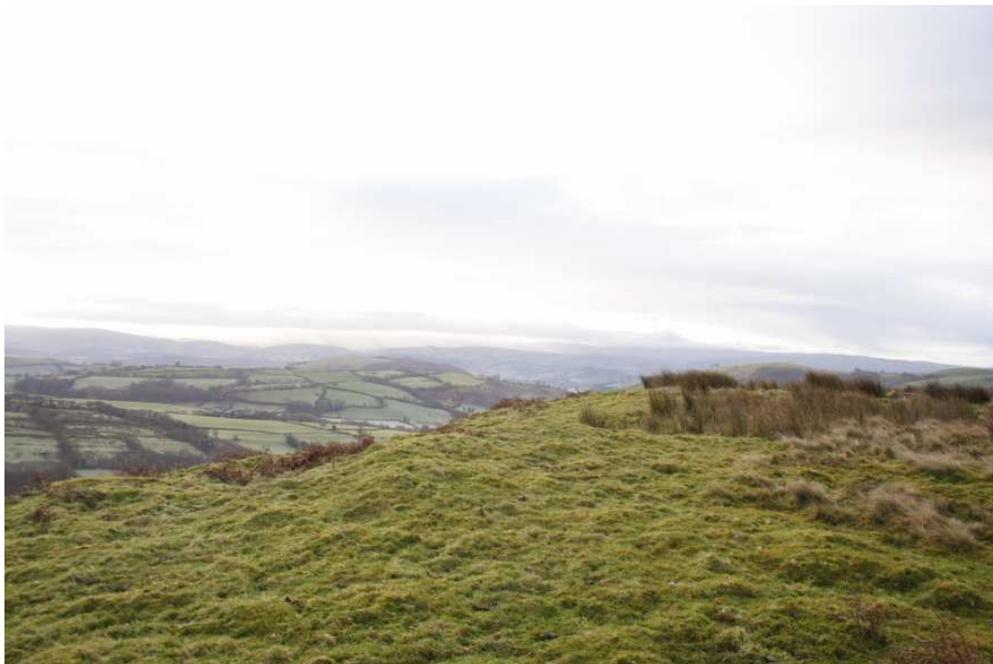
The site is located on the edge of a southwest facing scarp slope towards the summit of a hill at 285m above sea level. It is clearly visible on modern aerial photographs as a possible sub-circular earthwork on a scarp edge. However, the site visit in 2008 found that the topography, vegetation cover and lack of distinction in the earthwork remnant make it less clear on the ground. The area is exposed scrub grass and marsh and the topography on the hilltop is very pitted and uneven, with drainage channels cut into the hillslope. There appear to be possible curving earthwork remains to the southeast and north, comprising earthen banks that stand to a maximum 0.40m high. However the earthworks are broken and incomplete, with nothing appearing to survive to the south and east. No ditch was noted. On ground evidence alone it would be difficult to determine the nature of the site, but the aerial photographic evidence and its superb defensive location would strongly suggest that this is an Iron Age defended enclosure.

Looking SE – showing remains of enclosure bank

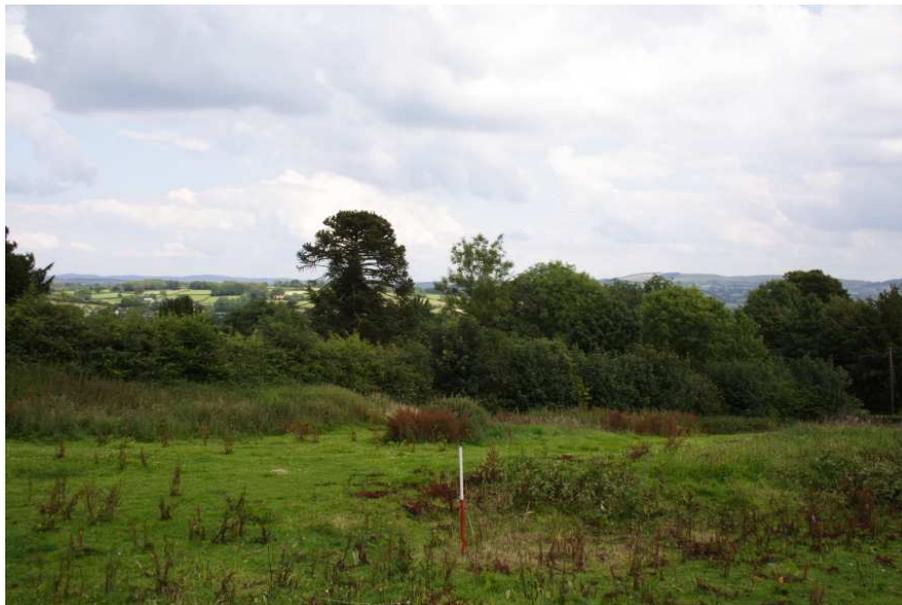
Looking E - across area of circular defended enclosure visible as a slight earthwork

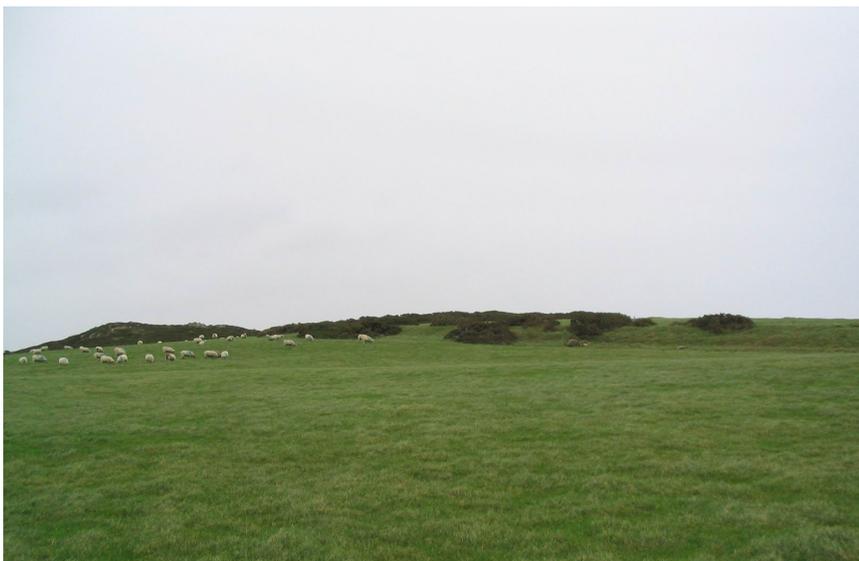
A further enclosure, perhaps forming a northern annexe to the main enclosure, was suggested by evidence viewed during the site visit, and this seems to be substantiated by aerial photographic evidence. Aerial photographs of this part of the promontory show faint lines of possible banks/ ditches extending north from the main enclosure, heading towards a third rocky outcrop. On the ground, a very substantial bank consisting of heaped loose stone with a flattened top has been identified. The bank lies on steeply sloping ground, on the southeastern side of this northern rocky outcrop, and runs almost parallel to a surviving field boundary. The land upslope of this bank is not suitable for ploughing, making it unlikely to be a lynchet. The size and location of the bank strongly suggest a defensive function. The general area is heavily overgrown with gorse at present.

Looking E - towards the northern end of the main enclosure

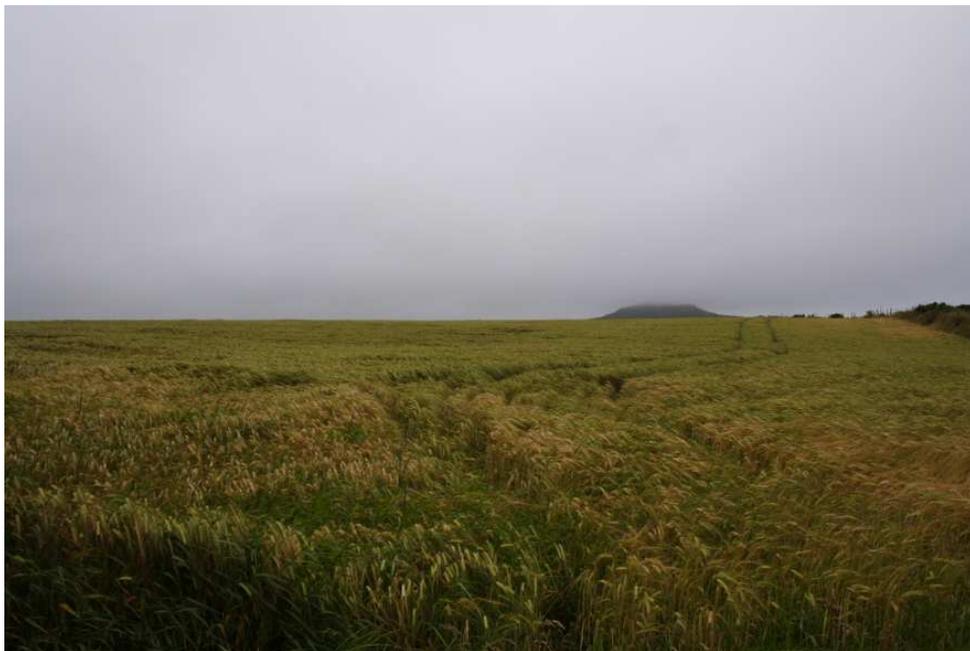
A large circular parchmark is visible on aerial photographs of the 1950s within a level field situated at 85m above sea level, 260m southwest of Tremynydd Farmhouse and cist findspot (PRN 2965). The field is named 'Parc Caer Ain' on the St Davids tithe schedule of 1838. The circular cropmark has a diameter c.120m and appears to incorporate a wide bank. At the time of the site visit in 2008 the field was under a mature wheat crop and no earthworks were visible on the ground. The nature of the site is uncertain, but the field name would suggest that it is an Iron Age defended enclosure.

Looking WSW - across area of possible defended enclosure cropmark -  
under field of wheat.

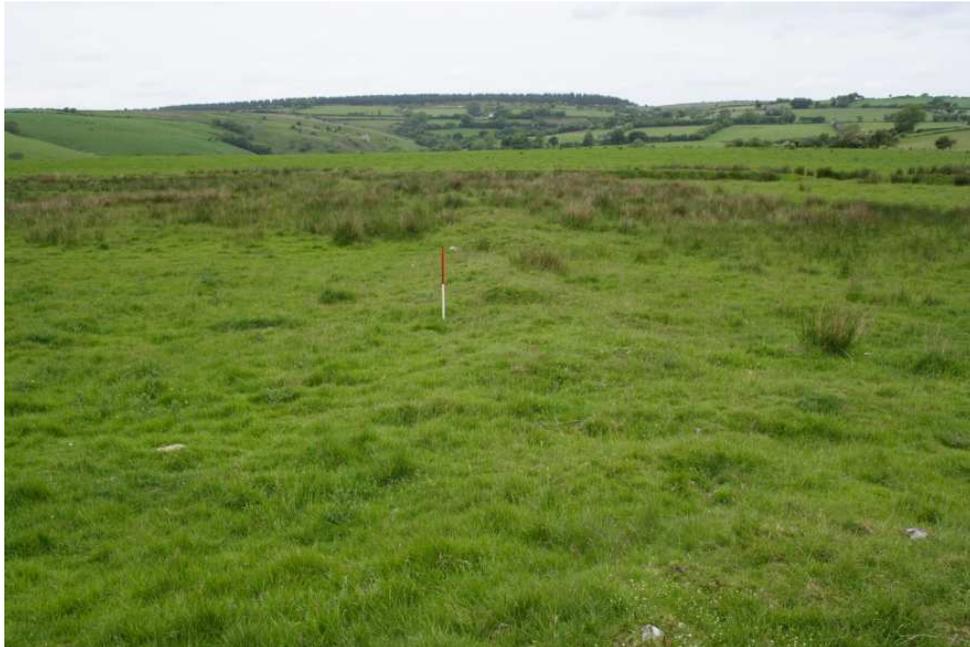
The site is located in a pasture field, at 60m above sea level, on a wide natural shelf approximately two thirds of the way up the southeast facing valley side of the Western Cleddau. In 2009 it was noticeable that the site of the cropmark is more level than the surrounding land although no clear earthwork traces of the defences or other associated features could be discerned.

Looking NE - across site of possible cropmark defended enclosure

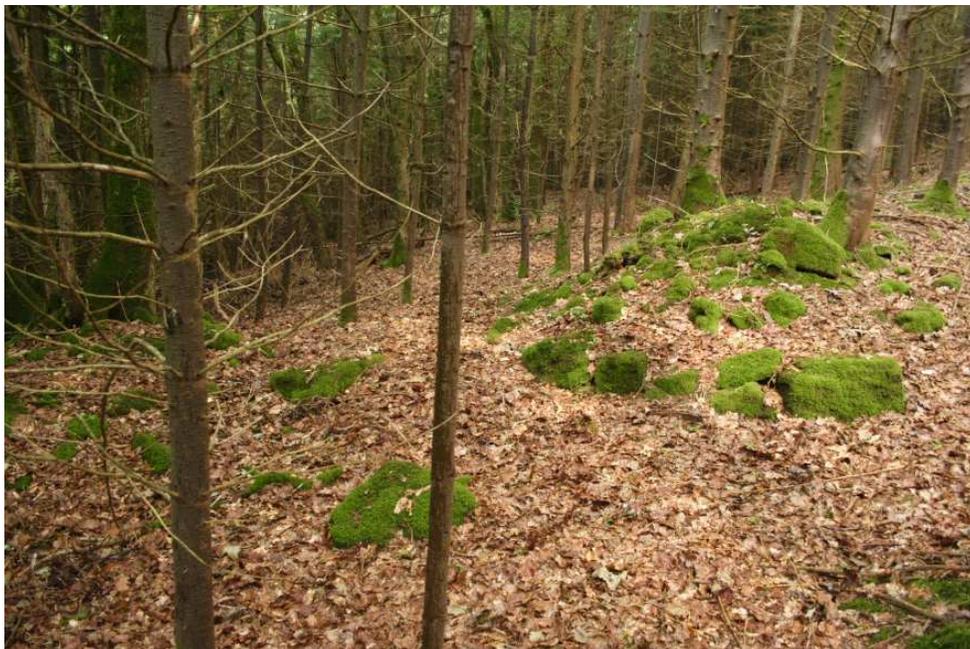
The site is under coniferous forestry. There are two old badger setts on the western side of the interior, and many other setts in the surrounding woodland, some of which are active. A mountain bike course runs around the site, mostly along the base of the ditch, but on the east side it runs up along the front edge of the bank creating a c.0.5m deep scar in the bank.

South facing entrance of well preserved, circular, earthwork enclosure in Treffgarne Gorge

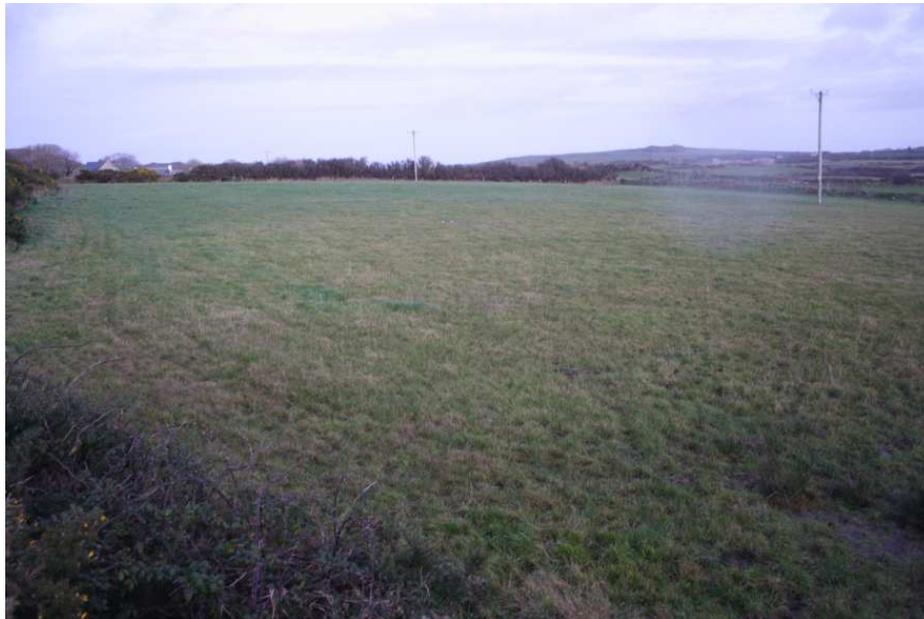
The RCAHMW (1925) describe this site as possibly an old Welsh tribal homestead, with enclosures still traceable at the time of writing. They list a description by an Edward Llhuyd (c. 1700):: "... 1 round and 5 square intrenchments, each joining to one another, called by the neighbouring inhabitants Tre Gyllwch, in the par of Llanunda. The circular intrenchment is about 30 paces in circumference. The square ones are of equal magnitude; each being about 12 yards and 6 yards broad." In 2009 the given grid reference for this site is situated in a field under pasture and no surface traces of any earthworks are visible. The site is on fairly level ground at approximately 100m above sea level on a slight southeast-facing hillslope. There is some uncertainty as to whether this is the location of the site mentioned by Llhuyd and an alternative location at SM90333854 (PRN 2484) is suggested. Certainly the coordinates given in the RCAHMW inventory (1925) do not match this location.

Facing NE - across area of putative cropmark defended enclosure

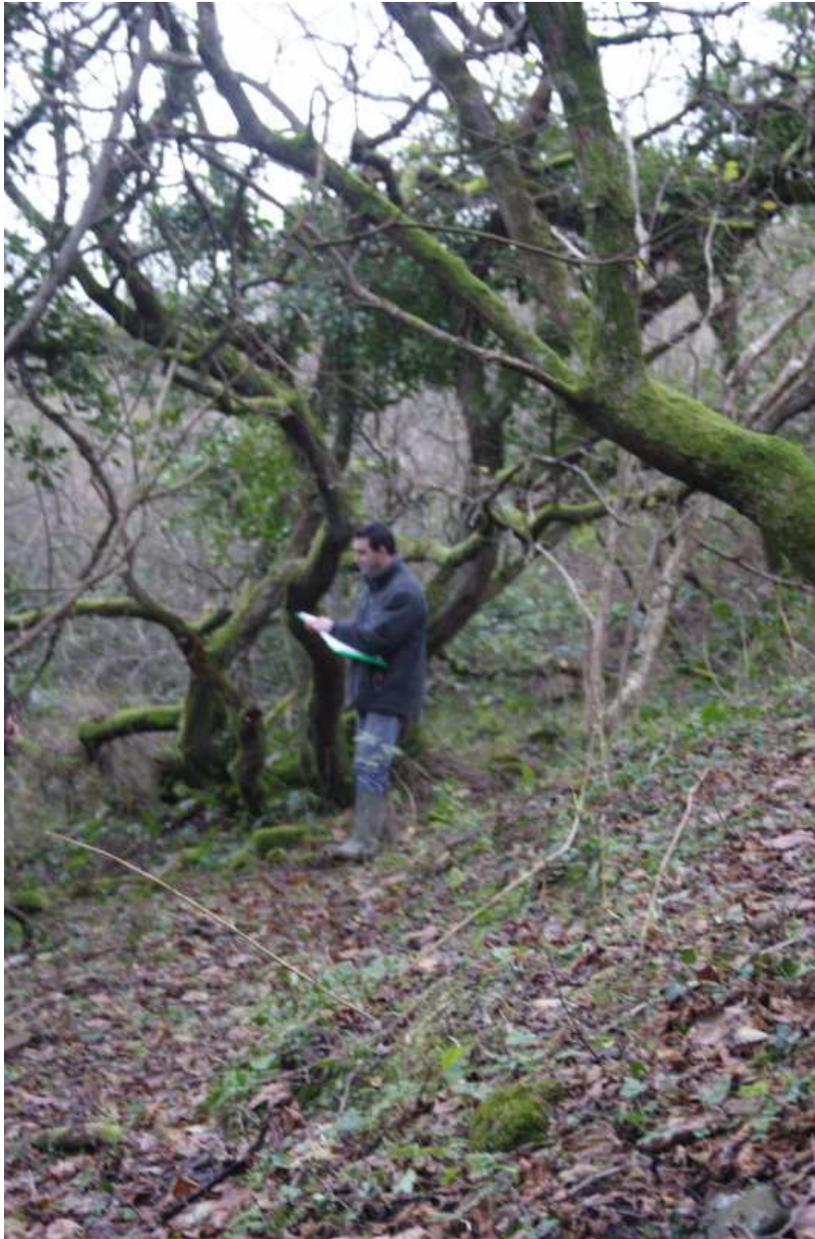
There are no traces of habitation within the interior although according to the owner a stone circle, approximately 6m in diameter, defined by a low stone bank was once visible within the interior. The location of this feature was pointed out but it could not be located with confidence beneath the undergrowth.

Facing E - along the defensive scarp on the N side of the possible defended enclosure (PRN 2537)

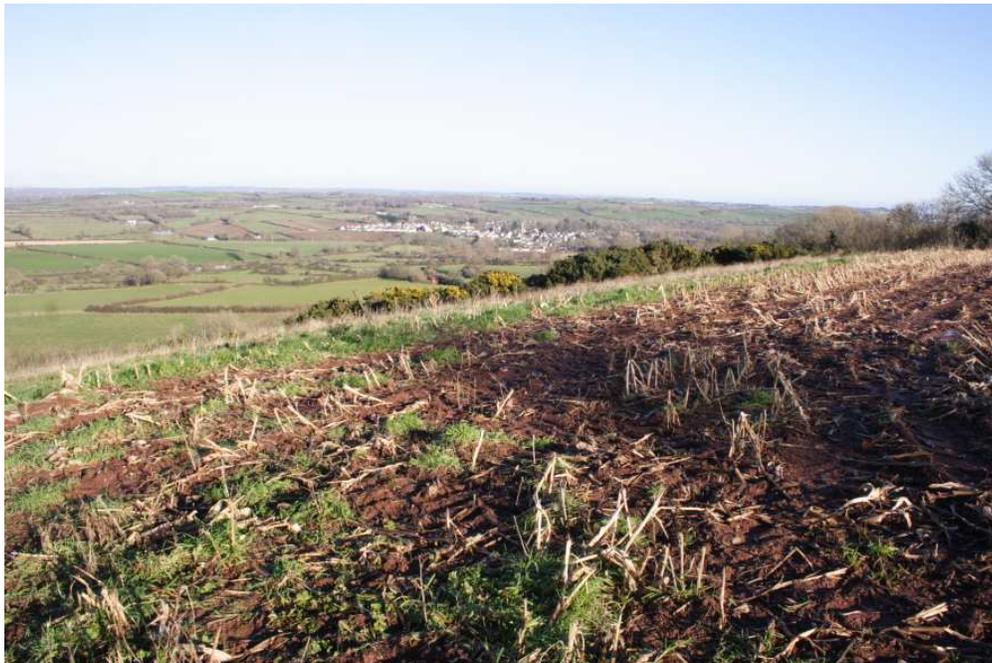
A rectangular earthwork situated on a natural shelf on a steep north-facing hillslope at 70m above sea level. Dearden first describes it in 1851 as a rectangular, ploughed out earthwork. The Ordnance Survey visited the site in 1965 and reported that the sub-rectangular earthwork was still visible on the ground, with mainly the east side, of length 40m, surviving, although sections of the adjacent sides were still in evidence. The bank measured up to 1m high and the sloping interior was uneven and covered by rough grass. It is suggested that the site is unlikely to be prehistoric. However, by 1975 the Ordnance Survey lists the site as an Iron Age homestead. In 2009 the site was totally obscured by dense bramble and gorse growth, and it was not possible to determine whether the earthwork survives.

Facing E - towards heavily overgrown possible defended enclosure (PRN 3536)

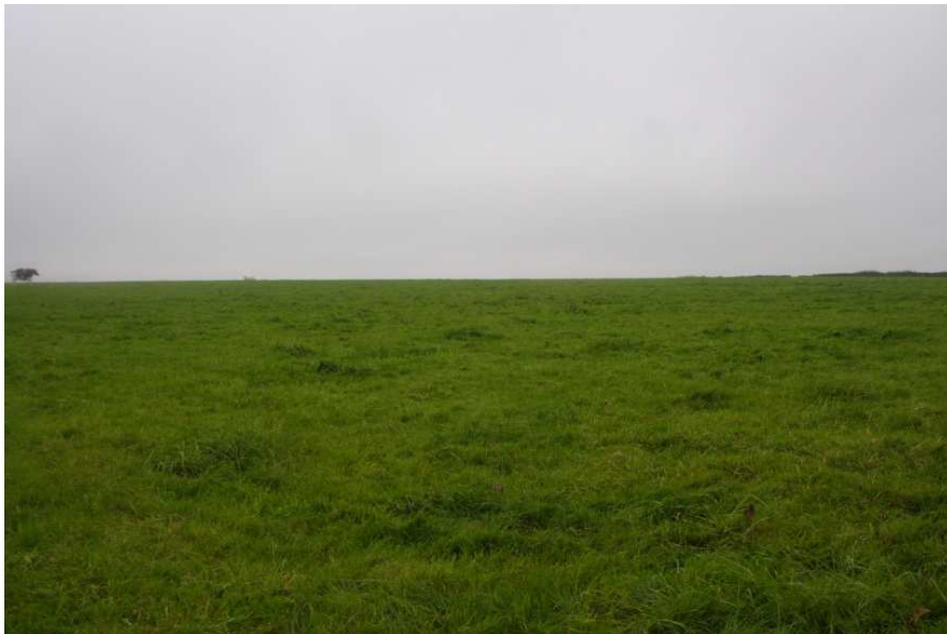
Woodstock I is a small bivallate sub-circular enclosure with widely spaced ramparts surrounded by a large concentric annexe. It is situated on a gentle southeast-facing hillside at 175m above sea level. This site was identified from aerial photographs of the 1950s. The site visit in 2008 found no evidence for any earthwork on the ground, therefore the site description is gained from the aerial photograph. The central enclosure would appear to be approximately 60m north-south and 40m east-west. It has two visible widely spaced ramparts, but no obvious entrance. The central enclosure is surrounded by a large concentric annexe c.140m in diameter with a ditched/tracked entranceway on the south.

Looking WSW - across area of defended enclosure cropmark - nothing visible on ground

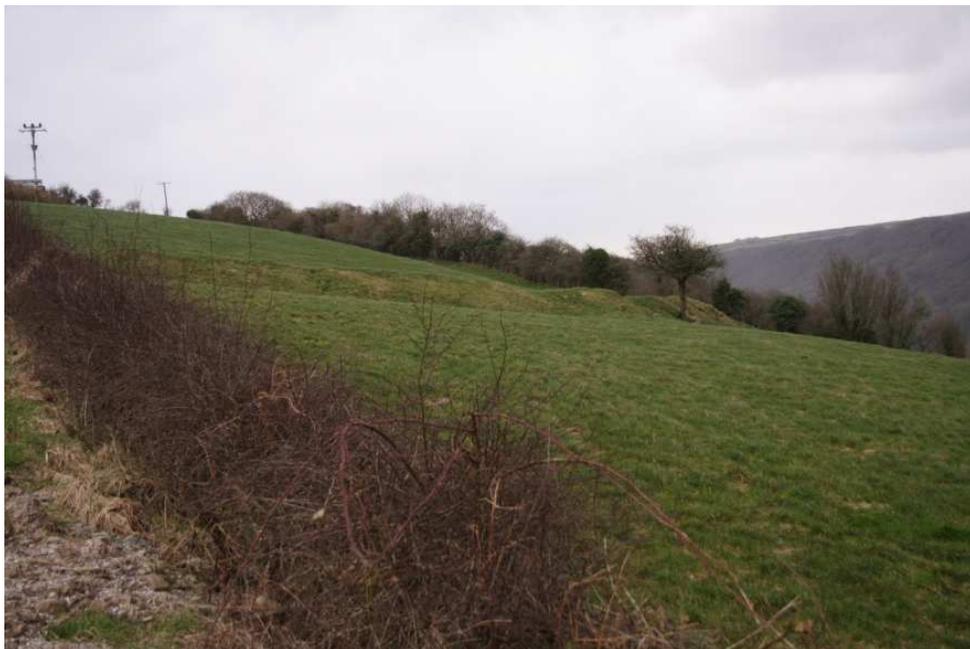
The eastern portion of the bank has been utilised as a field boundary in the past, and was once planted with a hedge. There are signs of possible modern repair in at least two places on the east. There are also signs that livestock are causing the bank to erode in places.

If the bank once formed a complete circle there is no evidence of any earthwork to the southeast of the minor road that cuts across the site, but it is possible that this area has suffered from more intensive ploughing and the construction of modern farm buildings.

Looking W - from road - at curving defensive bank of enclosure PRN 63970

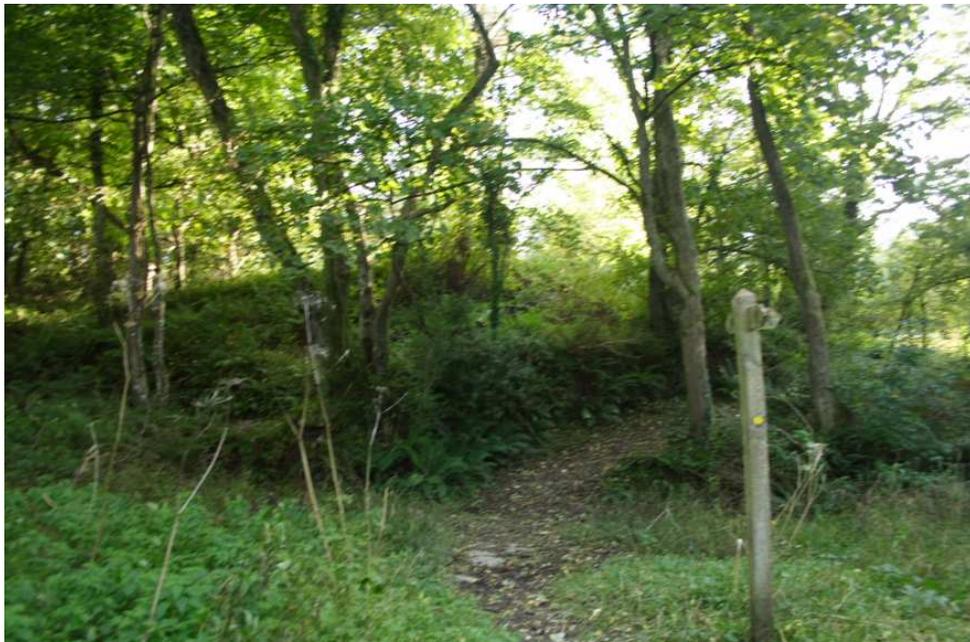
The steep slopes of Cwm Dyffryn to the north and west naturally defend the enclosure whilst the land rises gently away to the east and south. Internally the enclosed area measures 45m E-W by 70m N-S, defined by a curving ditch and bank on the steeply sloping north side, and a ditch on the east. Beyond this a deep stream gully (tributary of Cwm Dyffryn) could have provided a further line of defence. The defences on the southern side (the neck) no longer survive; the landowner remembers low ramparts here although these have since been spread by ploughing. Jones describes "*hummocks or banks*" and although not currently visible these could lie beneath the scrub. Traces of scarping can be discerned in the undergrowth on the steeper west side.

A number of hedge banks cross the area that may be related to the later farmstead of Dyffryn-isaf - this and other landscaping may confuse the original appearance of the monument. The tithe apportionment (1843?) gives the field name as "*waste and old road*" and it is possible that an old trackway may have skirted the eastern part of the site whilst a gap has been driven through the rampart on the northwest side. The interior of the enclosure lies under improved pasture that is kept mown by the owner; the defences and slopes are under scrub and woodland. A history of tree cover makes interpretation from the air difficult. W Steele 2008

Facing N - towards defensive bank of inland promontory fort PRN 94219

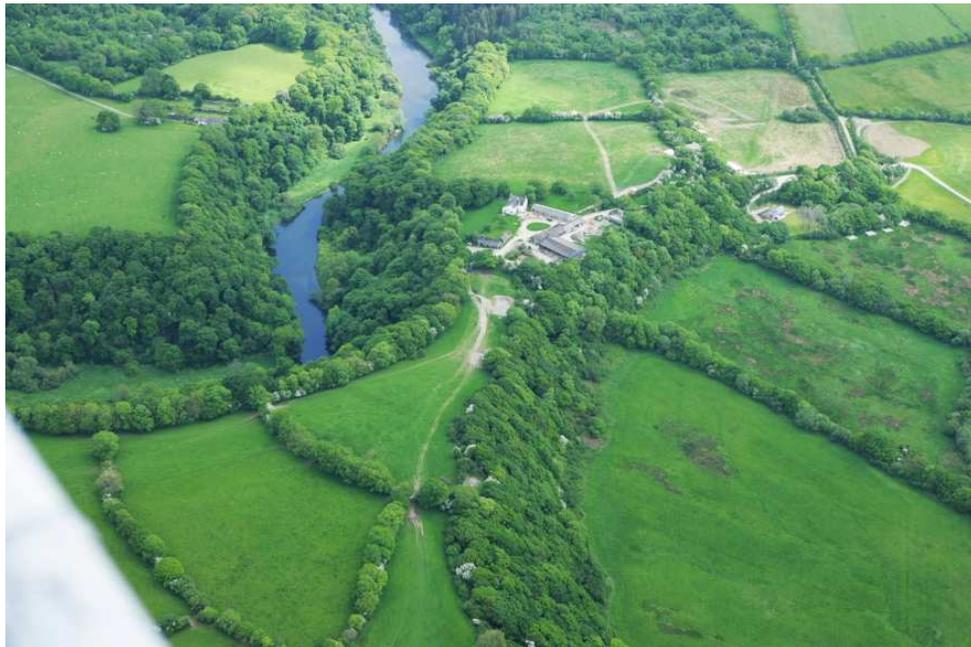
Discovered during RCAHMW aerial reconnaissance on 20<sup>th</sup> May 2008, this would appear to be an inland promontory fort, though not a typical one. It occupies a raised isthmus of land at 60m above sea level between two larger areas, formed by the steep slopes of the Teifi to the east and a steep escarpment to the west. The promontory fort itself occupies part of the northern portion of the isthmus, enclosing an area of approximately three acres, defended to the north by a curving rampart (bank then ditch), approximately 45m long, 0.8m high and 6.0m wide. Concentric field boundaries to the north of the rampart, copying its curving shape and extending out onto the wider plateau to the north, suggest that these may indicate the former positions of the outer defences of the promontory fort, although on closer inspection they appear to be later in origin, perhaps relating to the reorganisation and enclosure of the landscape in the post medieval period. The fort interior slopes gradually to the south towards Forest farm. The interior is under improved pasture, as are the banks. The steep slopes are under woodland. Some small scale quarrying has been carried out recently in the enclosure interior and may pose a threat to the archaeology.

Aerial photograph of Forest promontory fort. RCAHMW Crown Copyright © reference DI2008\_0746
