**DYFED ARCHAEOLOGICAL TRUST**

REPORT NO. 2019-16  
EVENT RECORD NO. 112156

**HISTORIC FARMSTEAD RECORDING;  
(Carmarthenshire)**

ERN 112156 Recording Historic Farmsteads (Carmarthenshire)  
**HISTORIC BUILDING RECORDING;**

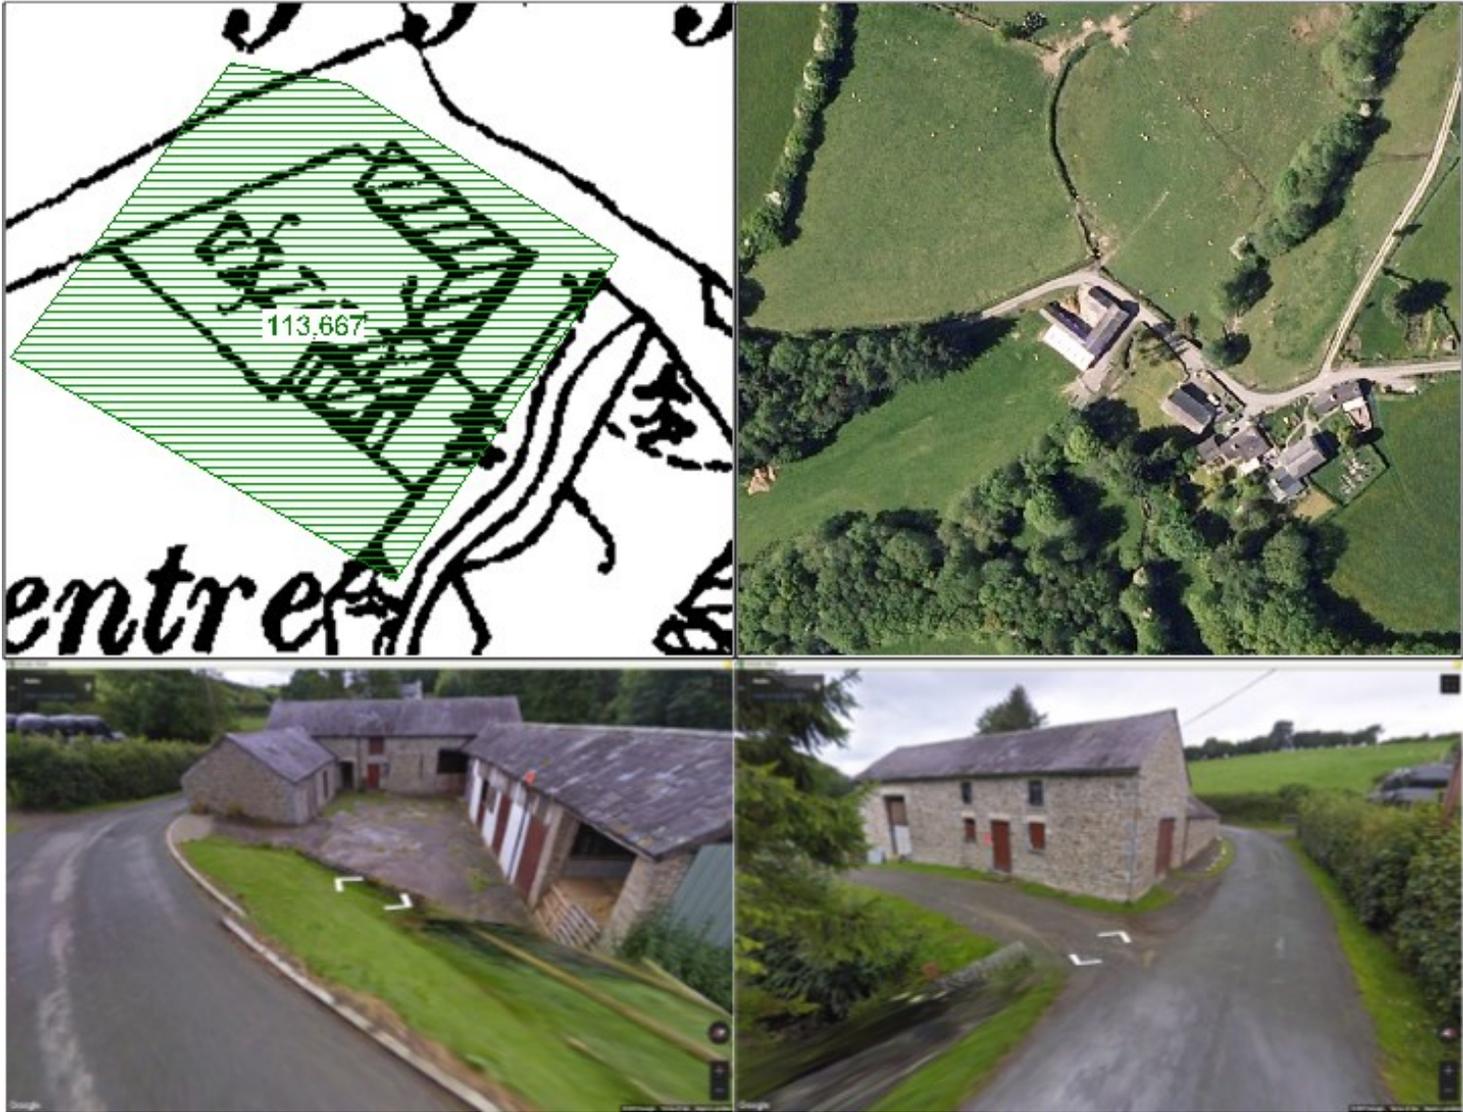
Figure 2

DAT PRN 113667 Farmstead of Pentre. Historic OS 2<sup>nd</sup> Ed map showing a U-shaped regular courtyard farmstead with detached farmhouse. The modern vertical aerial and land-based photography indicating complete survival of plan-form in very good condition.

**(2)** The historic mapping was used to define the plan-type of each farmstead, see Appedix 1 for plan-form types as defined by Historic England. The historic mapping was then viewed against the current mapping and aerial photography to assess how much of the historic farmstead survives. Google Streetview™ was used where possible to rate the condition of surviving farmstead elements, see Figure 2.

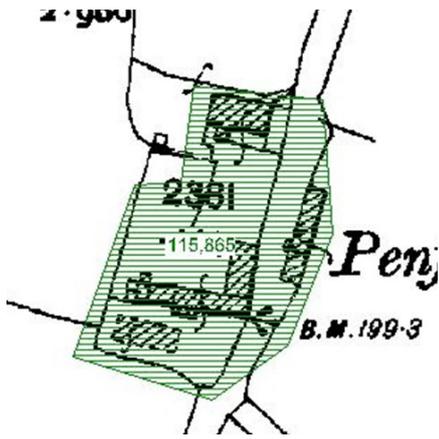
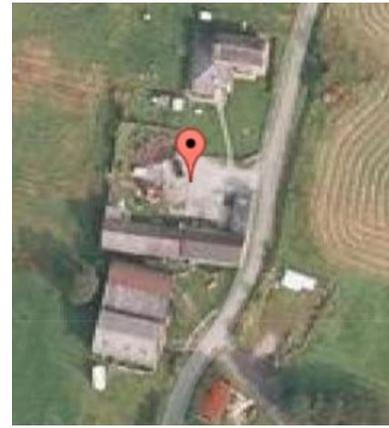
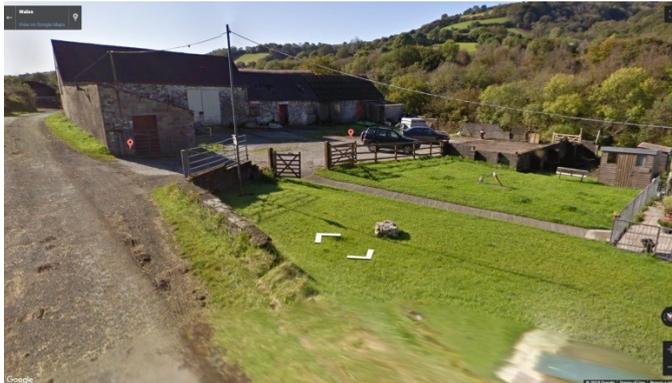
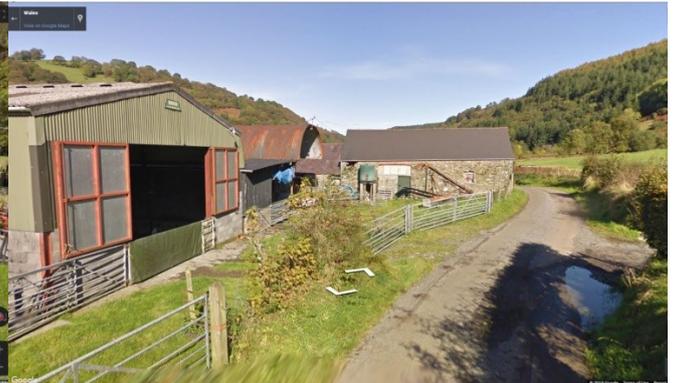
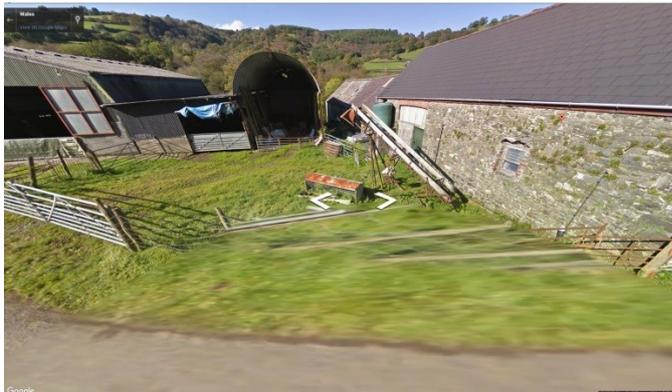
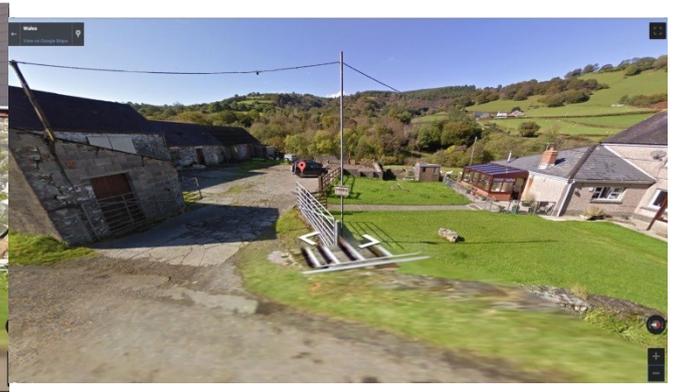
Figure 3

DAT PRN 115865, showing a regular L-plan farmstead with detached elements. It's condition is described as damaged because the additional detached elements are either missing or subsumed within newer structures. However, the L-Plan range of buildings retain original features and as surviving elements warrant "Good" rating.

Using a combination of Condition and Rating it is possible to create more sophisticated description of survival. Thus enabling a farmstead to have a "Damaged" plan in relation to % of buildings surviving but "Good" survival in those elements that remain, see Figure 3.

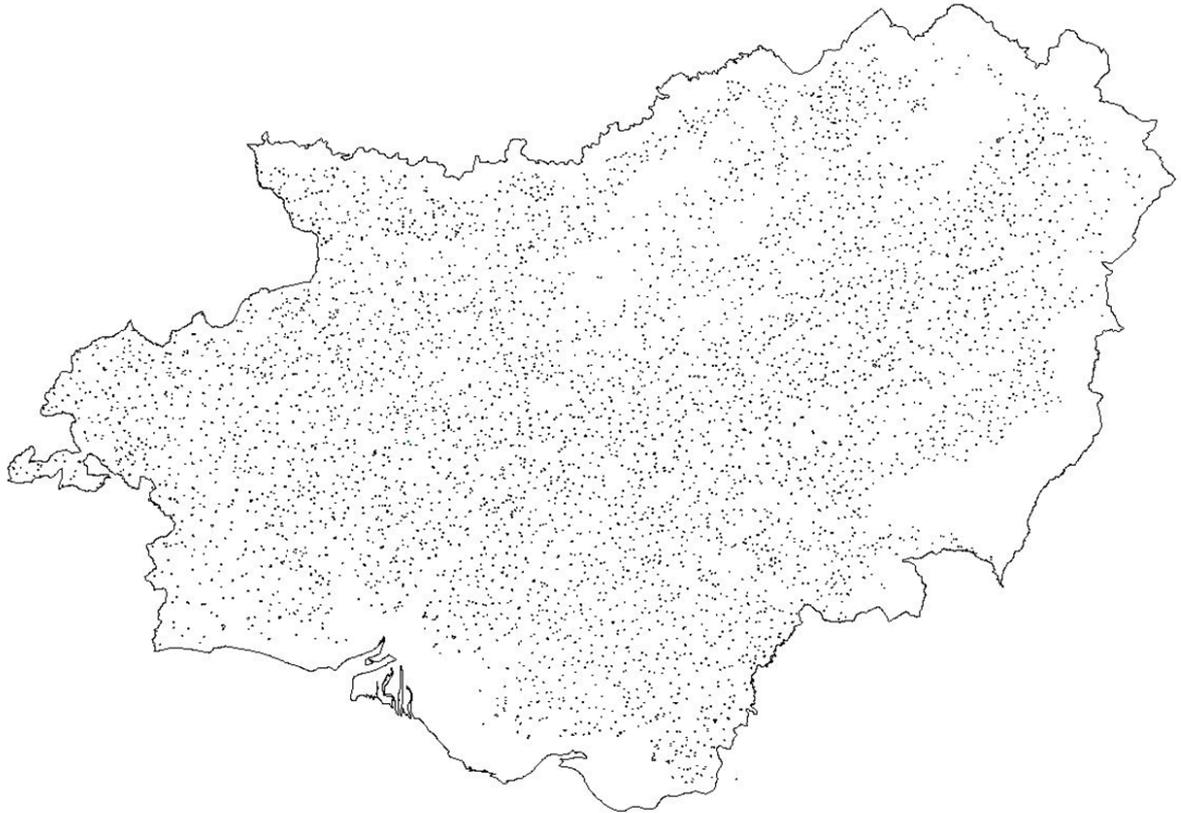
Figure 4  
Distribution of sites in Carmarthenshire (recording during pilot and full project phase 2017-2019)

A total of c.5300 (pilot and full project) farmstead polygons were created. It was not within the scope of this project to analyse the results of the project but Figure 4 and Tables 2-3 Give an indication of the spread of plan types, assessment of condition and the overall distribution of sites.

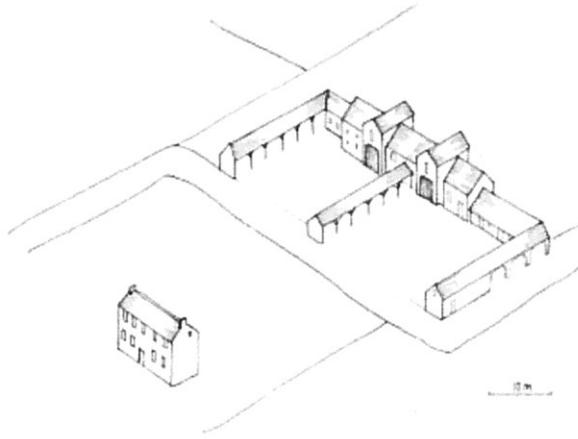
Regular E plan

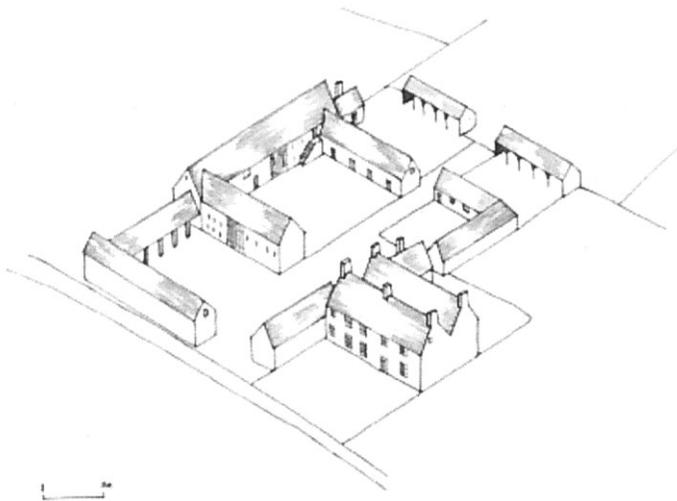
Regular Multi-yard

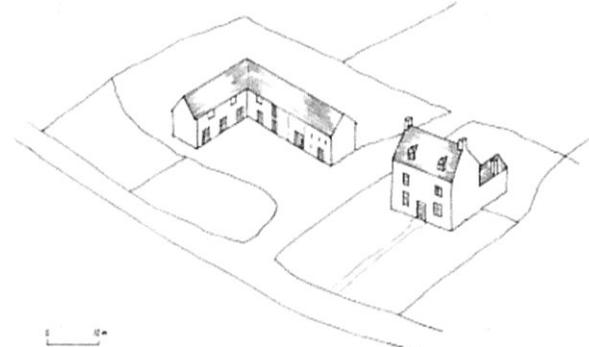
RCL

Regular courtyard - L plan

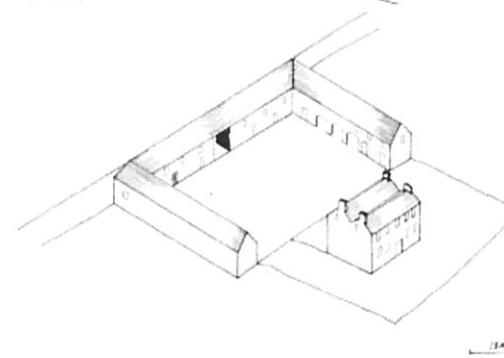
Regular courtyard - U plan

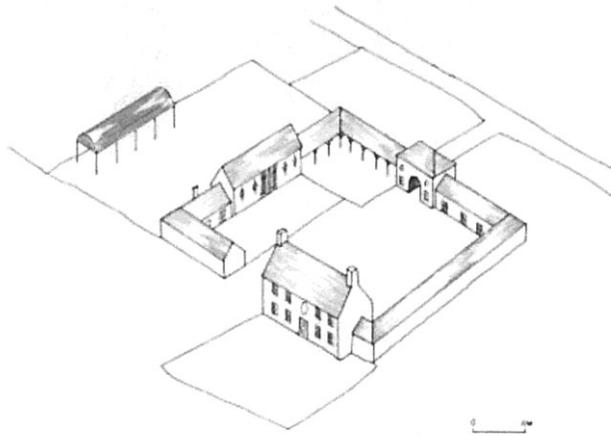
Full Regular Courtyard
