HISTORIC FARMSTEAD RECORDING: PEMBROKESHIRE

*PRN DAT119688 Farmstead at Walwyn's Castle,
Pembrokeshire*

Prepared by
Dyfed Archaeological Trust
For: Cadw

REPORT NO. 2020/21
EVENT RECORD NO. 121276

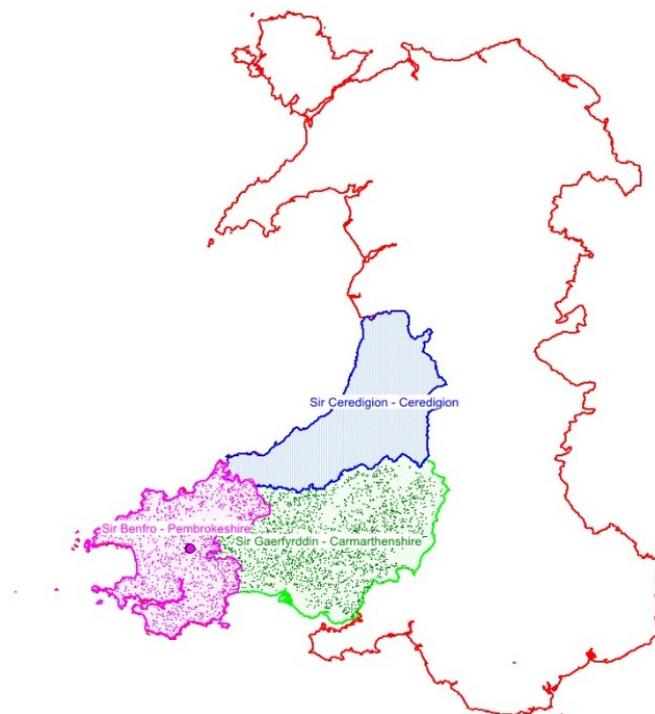
Figure 1: Distribution of farms characterized in Pembrokeshire (pink), including farms in Carmarthenshire (green), shown in relation to Dyfed and Wales.

The area examined in 2019-20 was Pembrokeshire (Figure 1), By March 2021 all sites across the Dyfed region will have been characterised which will also include sites in Carmarthenshire and Pembrokeshire that have not been examined for any other reason, such as lack of digitized 1:2500 2nd OS coverage.

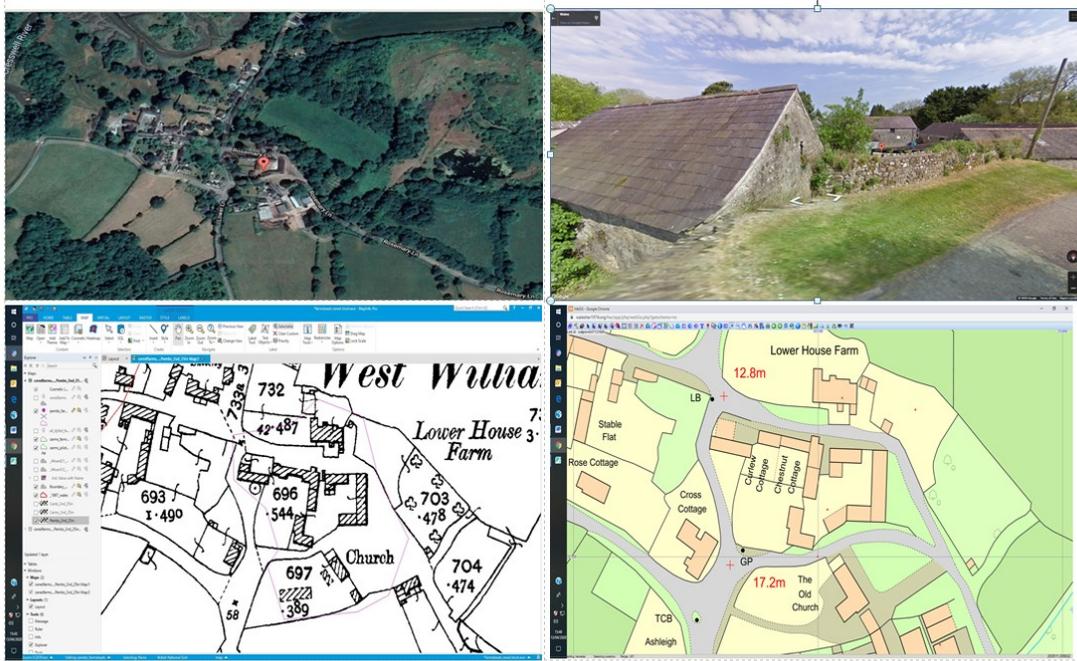
Figure 2

DAT PRN 1121500 Farmstead of Lower House Farm, West Willamson. Historic OS 2nd Ed map showing a regular multi-yard arrangement with a detached house. Part of the complex has been converted to residential accommodation but the remaining yard shows good survival of original features

used where possible to rate the condition of surviving farmstead elements, see Figure 2.

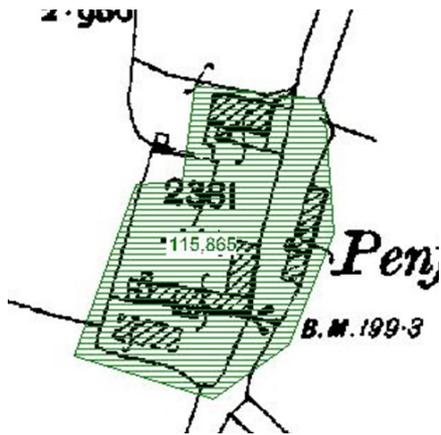
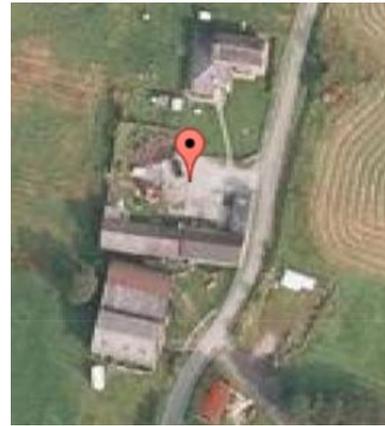
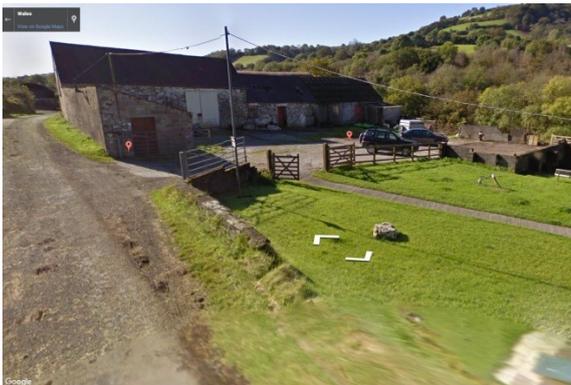
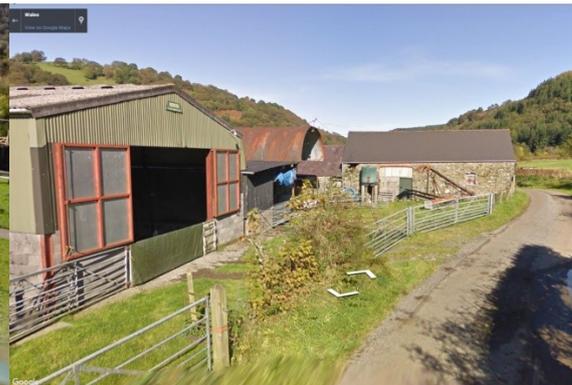
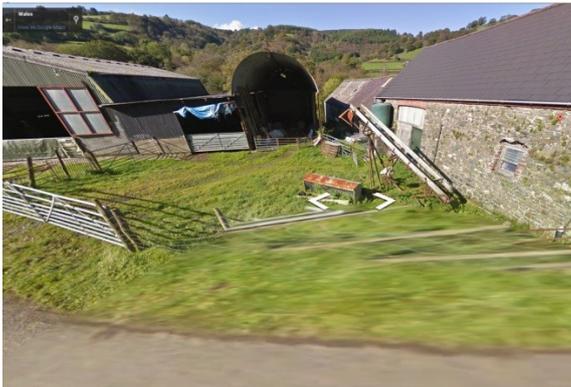
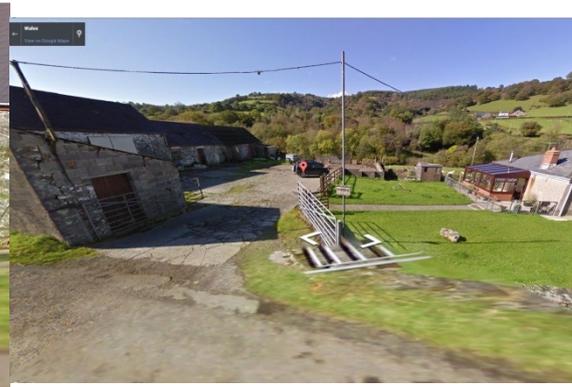
Figure 3:

DAT PRN 115865 (example from Carmarthenshire), showing a regular L-plan farmstead with detached elements. It's condition is described as damaged because the additional detached elements are either missing or subsumed within

newer structures. However, the L-Plan range of buildings retain original features and as surviving elements warrant "Good" rating.

Using a combination of Condition and Rating it is possible to create more sophisticated description of survival. Thus enabling a farmstead to have a "Damaged" plan in relation to % of buildings surviving but "Good" survival in those elements that remain, see Figure 3.

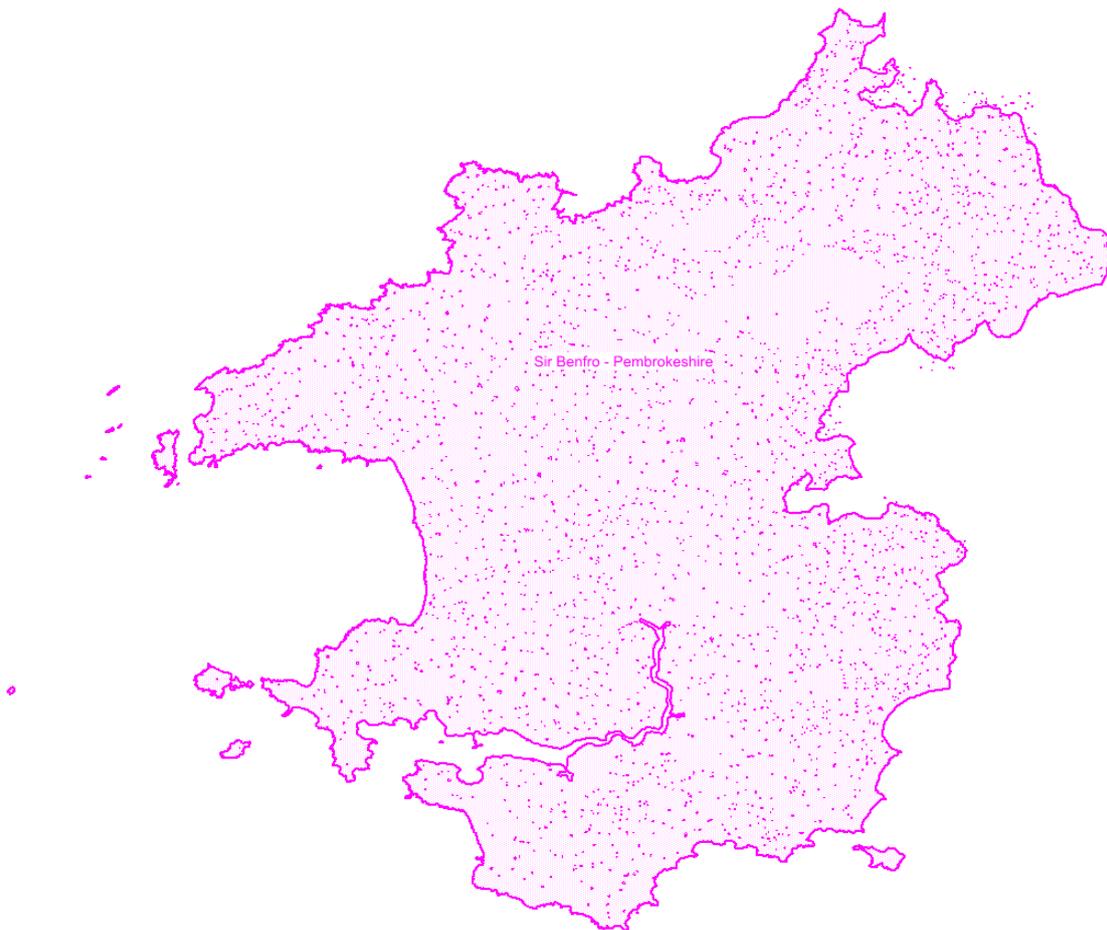
Figure 4: Distribution of sites in Pembrokeshire

A total of c.3500 farmstead polygons were created. It was not within the scope of this project to analyse the results of the project but Figure 4 and Tables 2-3 give an indication of the spread of plan types, assessment of condition and the overall distribution of sites. The density of sites is equal to 2.2 farmsteads per sq km, this is the same farmstead density as Carmarthenshire.

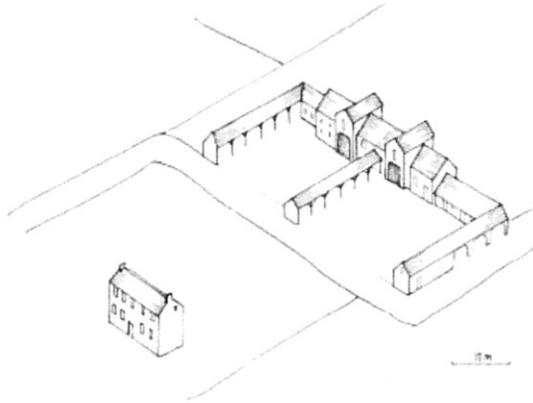
Regular E plan

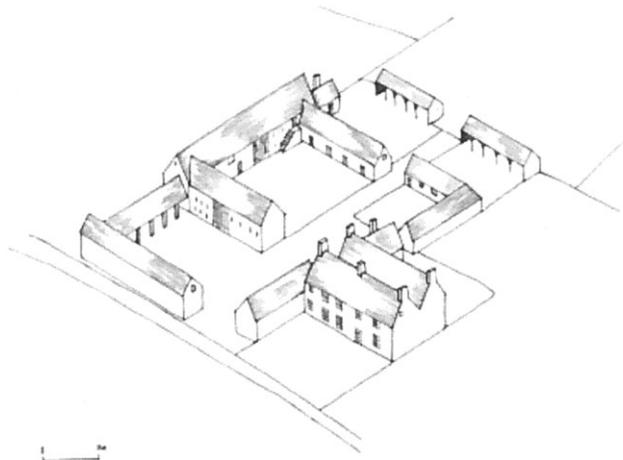
Regular Multi-yard

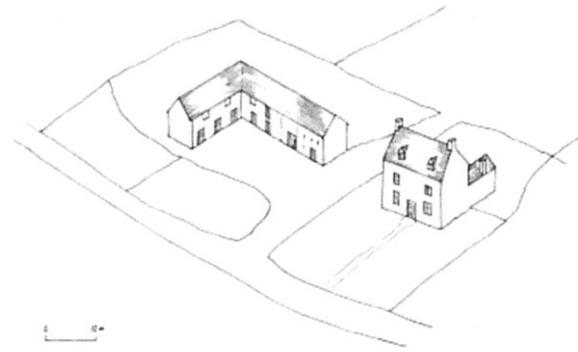
RCL

Regular courtyard - L plan

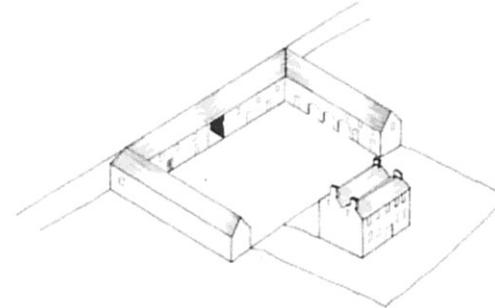
Regular courtyard - U plan

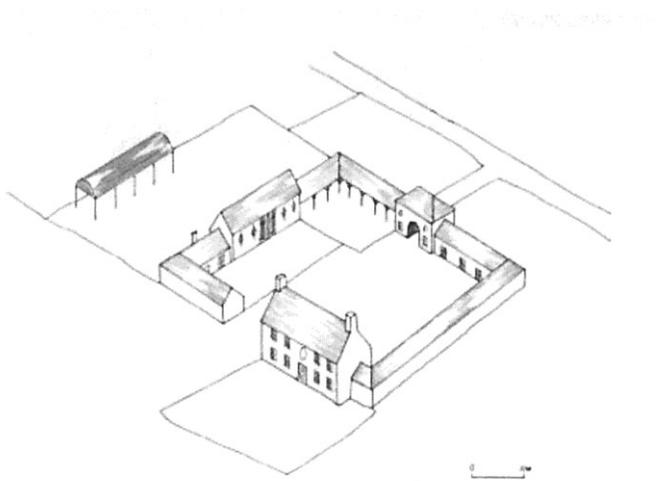
Full Regular Courtyard
