SURVEY AND EXCAVATION AT LLANLLYR MEDIEVAL NUNNERY AND POST-MEDIEVAL MANSION, CEREDIGION, 2014-2015

By Frances Murphy

SUMMARY

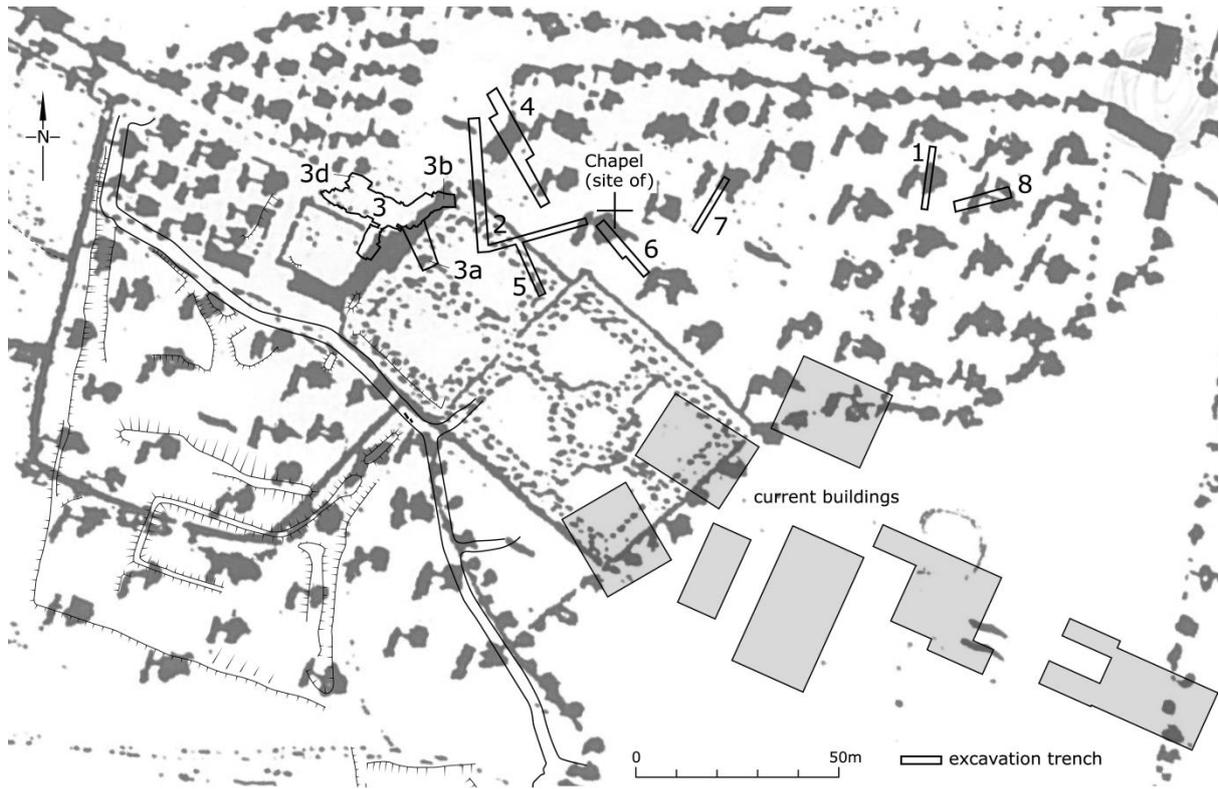
Figure_Llanllyr_3_The excavation trenches, topographic survey, current buildings and site of chapel superimposed over part of the 1768 estate map.

A 1768 estate map of 'Llanllear Denesne' (in the ownership of the Lewes family) shows the old house with formal gardens to the south-east (Fig. 3). Reconciling Dineley's drawing and the 1768 estate map is not possible, as undoubtedly changes were made to the buildings and surroundings in the 84 years between the two depictions. On the

estate map, the site of the new 1830s house is shown as a field (no. 11) and is named on the accompanying schedule as 'Cae'r Odyn' (kiln field). It is interesting to note that the c.1843 Llanfihangel Ystrad Tithe Map depicts the old house and garden exactly as on the estate map, but surprisingly the 1830s house is not shown. It may be that the Llanllyr part of the tithe map was copied from the estate map. There are sufficient similarities between the landscape depicted on the estate map/tithe map and that shown on recent maps to locate with a high degree of confidence the old house and garden in the modern landscape, as is shown on Figure 3.

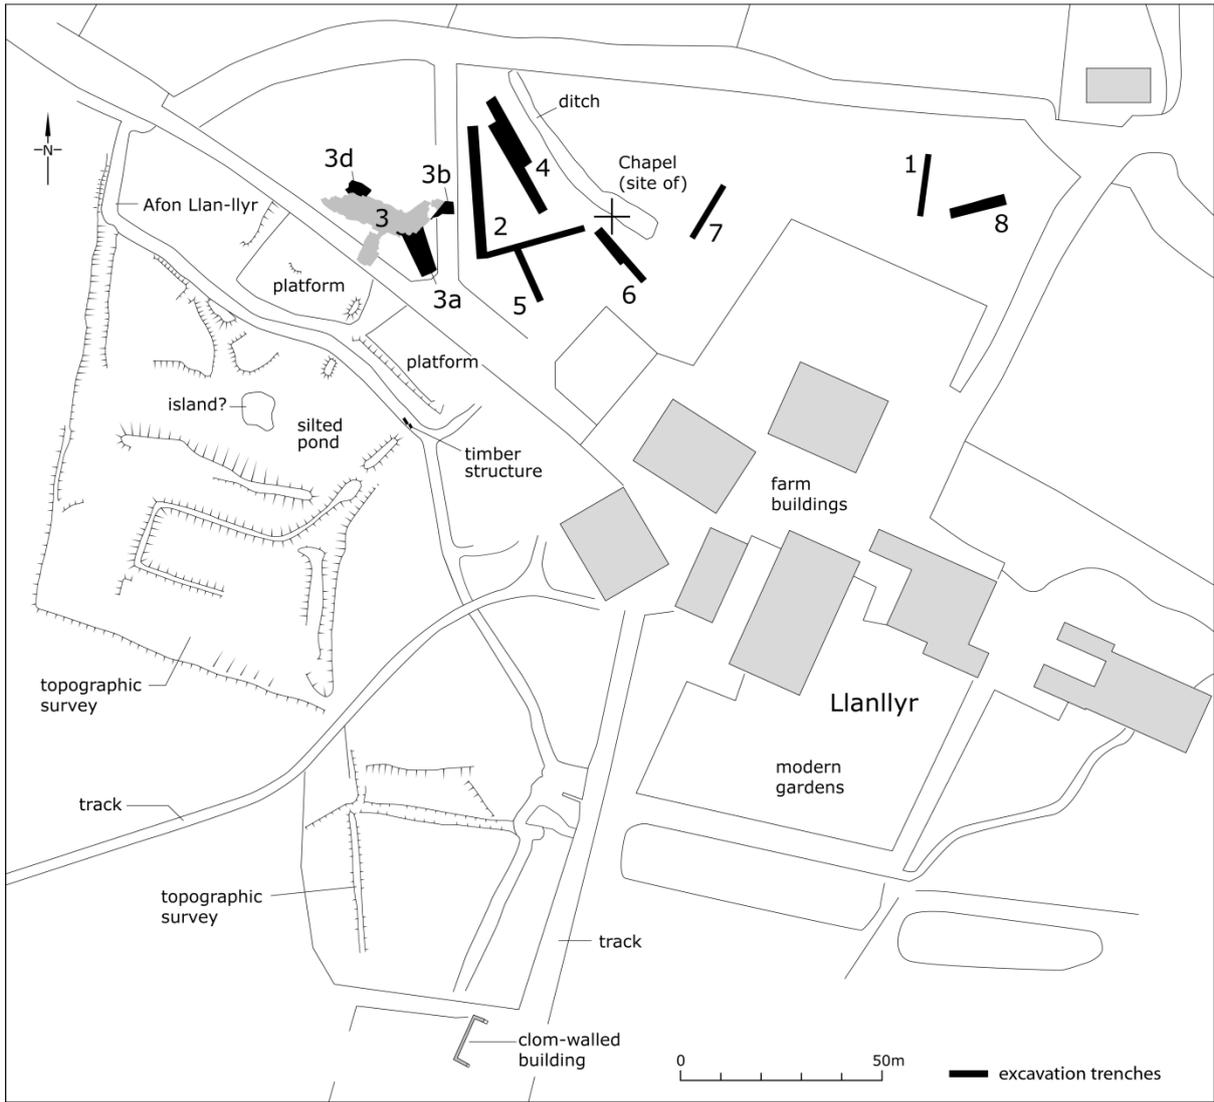
Figure 4.

Figure_Llanllyr_4_Plan of the excavation trenches, the topographic survey and the modern landscape.

Over three weeks in May-June 2014 Trenches 1-7 were machine-excavated, followed by hand-excavation. During the two-week excavation in July 2015 Trench 3 was extended and Trench 8 was machine-excavated (Fig. 4).

The main area of survey lay immediately to the south of the excavation trenches, with a smaller detached area a little further south (Figs 3 and 4). It is clear from the survey that the course of the stream (Afon Llan-Ilyr) that runs through this area has undergone considerable modification. Its present course can be explained by reference to the 1768 estate map and the results of the excavation, as it is quite clear its course respects the southern side and part of the eastern side of the old house and its formal gardens; the two platforms recorded on the survey being the site of buildings and part of the gardens. To the south and east of the stream are channels leading in and out of what is probably a silted-up pond. A curving bank corresponds to a boundary shown on the estate map and more recent maps. Timbers located where the projected line of the bank crosses the stream probably formed a drain or some other element of a water management system. Roderick Bale of UWSTSD has investigated disarticulated timbers from this structure and obtained three terminus *post quem* tree-ring dates of AD1262, AD1269 and AD1270. None of the samples contained sapwood, and so the dates only provide a date after which the parent trees were felled (Bale n.d.). Partial excavation in 2016 revealed a timber structure that may be a drain (Fig. 10). Elements of this have been recovered and are currently undergoing a program of recording and tree-ring dating which should refine the date of the structure.

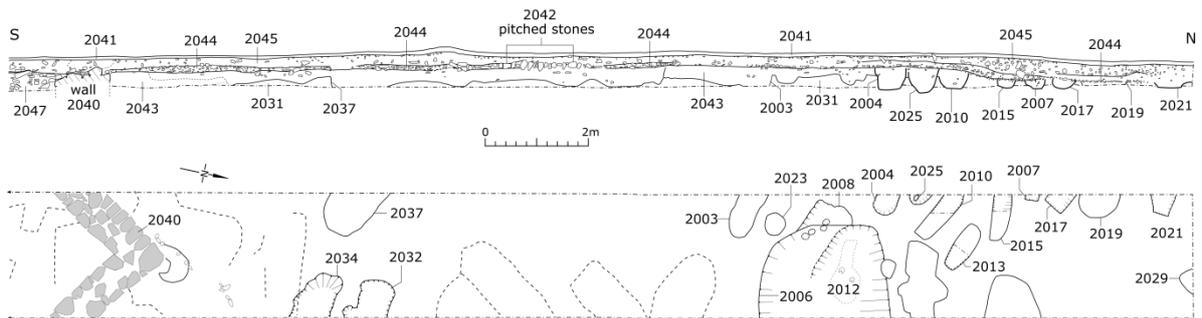
Figure 5.

Figure_Llanllyr_5_Plan and east-facing section of Trench 2.

Trench 2 was excavated by machine to a depth of approximately 0.60m down to the top of geological deposits either side of a clear raised deposit of stone rubble that was later found to cover a wall (2040). No further work was undertaken south of the wall, as this area never recovered from prolonged episodes of rain at the start of the excavation and acted as a sump for the rest of the trench. The following sequence of deposits and features were identified to the north of the wall (Fig. 5):

Below topsoil (2041) was a layer of silty clay (2045), beneath which lay a stony layer (2044) which butted up against wall 2040 and overlapped the edges of a pitched stone surface (2042), probably a track-way; the same track-way as recorded in Trench 4 (4004).

A loamy soil (2043) lay beneath the pitched stone surface (2042) and the stony layer (2044). Wall 2040 sat within layer 2043. The relationship between wall 2040 and layer 2043 was unclear; no foundation trench for the wall was apparent, but a pit had been dug on its south side (2047). Wall 2040 turned a right angle in the centre of the trench. There was no evidence of bonding material. A George II coin dated 1739 was found between stones of the wall.

A series of roughly E-W aligned linear features cut through layer 2043 from directly below stony layer 2044 (Fig. 5: 2003, 2004, 2007, 2008, 2010, 2013, 2015, 2017, 2019, 2021, 2025, 2029, 2032, 2034, 2037, plus un-numbered examples). The fills of these features were very similar to layer 2043, and so it was only where they just cut into the underlying geological deposits that they became obvious in plan. They averaged 0.4m wide and varied in depth from 0.15m to 0.45m (when seen in section). No artefacts were discovered in the fills, and there were no diagnostic features to help characterise them. When first seen it was considered possible that they were graves, but given the height from which they were cut, the similarity of their fills to loamy soil 2043, their shallow nature and their rather uneven sides and irregular bottoms this is unlikely and they are more probably the result of gardening activity.

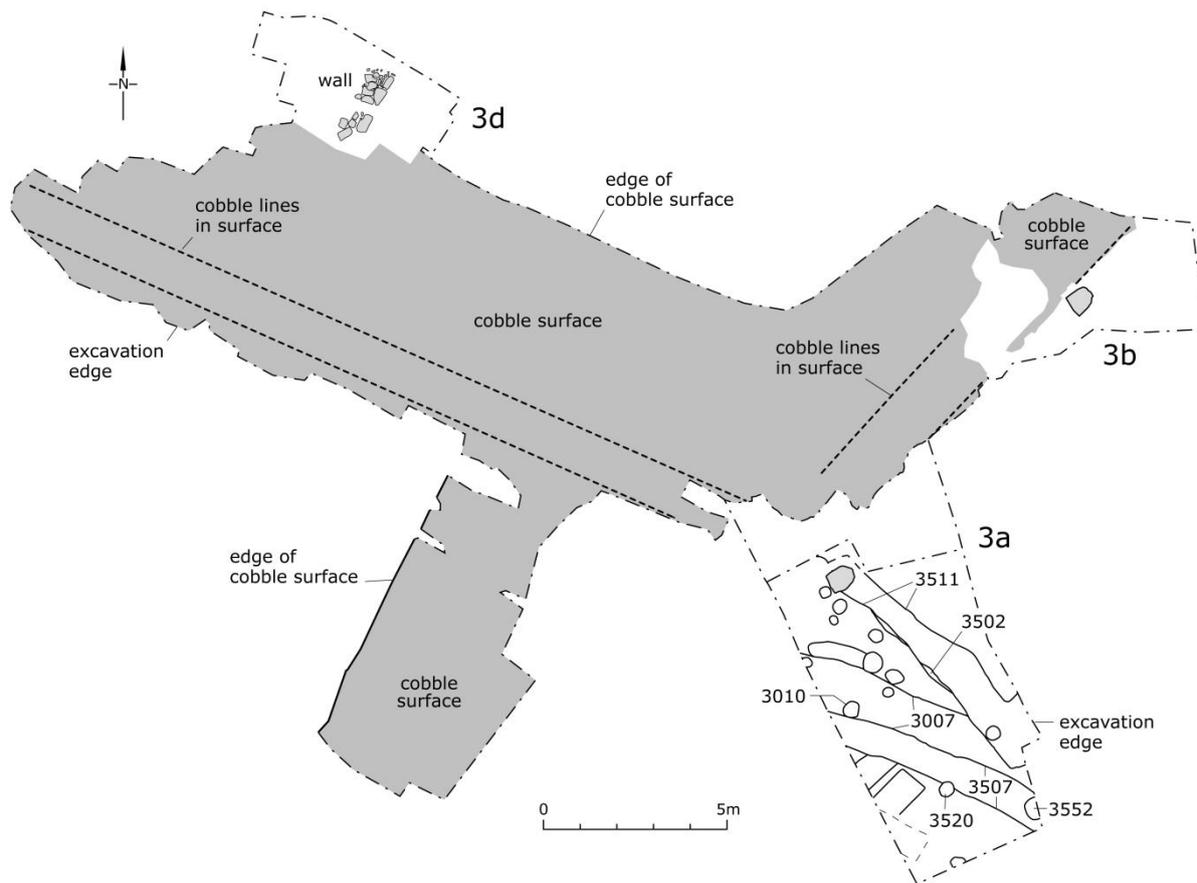
Figure 6.

Figure_Llanllyr_6_Plan of Trench 3.

planned and photographed. Artefacts from over the cobbles generally dated to the 19th and 20th centuries, but some 17th/18th century pottery sherds were present as well as a few sherds of Merida-type ware from the Iberian Peninsula dating to the 15th/16th centuries. As the surface was generally in good condition it was decided not to remove it, and thus the only excavation took place on the periphery of the surface in relatively small areas where the cobbles had been disturbed and where evidence may have survived for buildings shown on the 1768 estate map - Trenches 3a, b and d (Figs 6 and 7).

The cobbled surface. This surface survived in remarkable good condition considering it was covered by thin, loose material and trees had taken root in places. Minor irregularities in construction may have been the result of different workers laying the cobbles, or later repairs. The most noticeable features were two parallel lines of stones within the cobbles, one running approximately NW to SE, the other SW to NE, marking the lines of tracks/drives or paths, for decorative purposes, or both. The possible presence of robbed out buildings or walls are indicated by straight edges to the cobble surface.

Trench 3a. This trench was positioned to investigate a range of buildings shown on the 1768 estate map. Approximately 0.20m of loose soil and burnt material (3542 - from the recent burning of pallets) was removed down to a compacted silty clay deposit (3500) containing small and large stones, broken slate, mortar, window glass, roof tile and pottery, including some late 17th century/early 18th century wares, probably indicative of building demolition. This deposit butted up against the cobbled surface on its western side, and overlay a thin layer of mortar with charcoal specks (3541), below which were a series of features cut into geological sandy silts. Most of these features were difficult to characterise and contained no artefacts, they included shallow linear features (3007, 3507) and at least three postholes (3010, 3520, 3552). A more definite feature, a robbed-out wall (3511), containing a boulder at its northern end, ran NW to SE across the trench with a right angle turn to the N/E at its southern end. The robbed-out wall did not continue past the boulder, and there was no evidence for it having turned a right-angle to the north-east. There was evidence of what may have been the wall's foundation trench (3502) surviving in places; this contained a fragment of late medieval/early modern Normandy-type floor tile. A sherd of 17/18th century North Devon pottery was found in the fill (3005) of the robbed-out wall (3511).

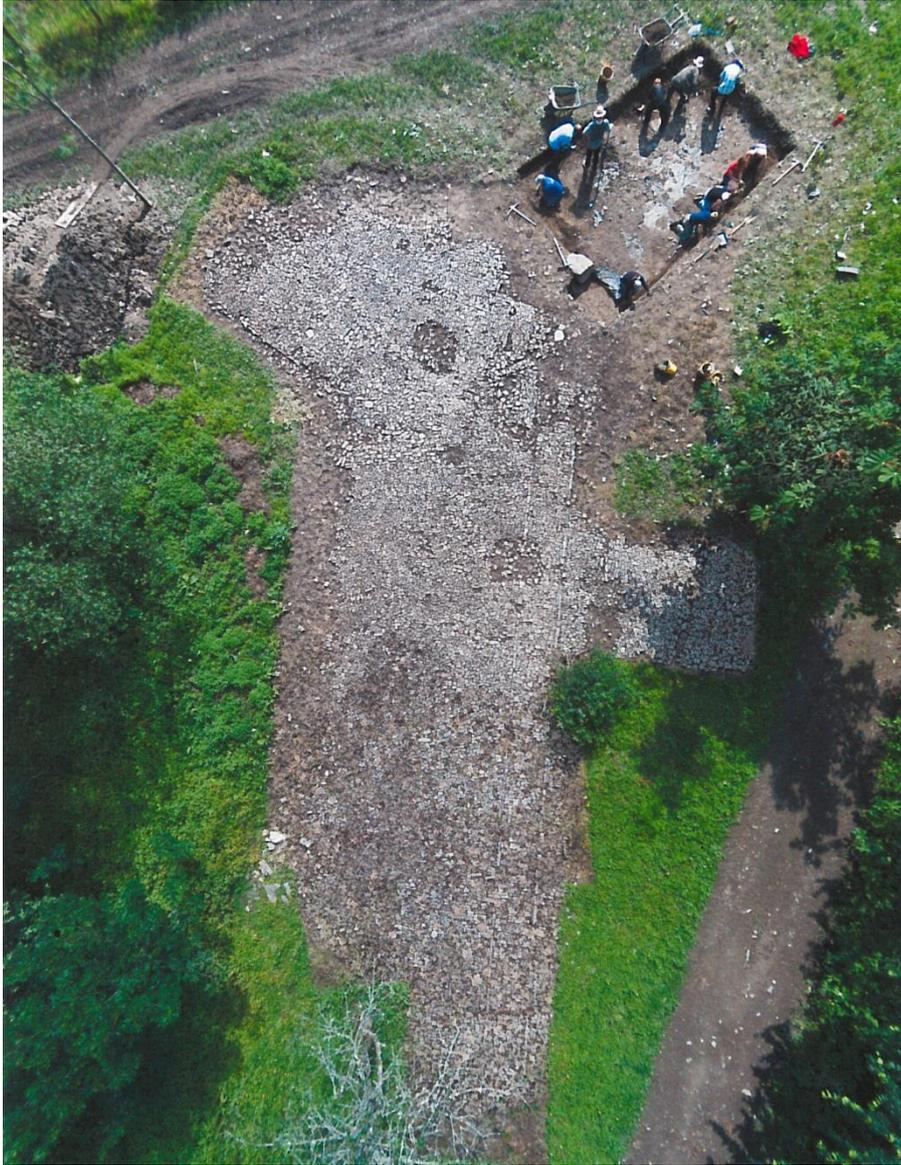
Figure 7.

Figure_Llanllyr_7_Drone photograph of Trench 3. Trench 3a is to the top (Photo: T Coombe).

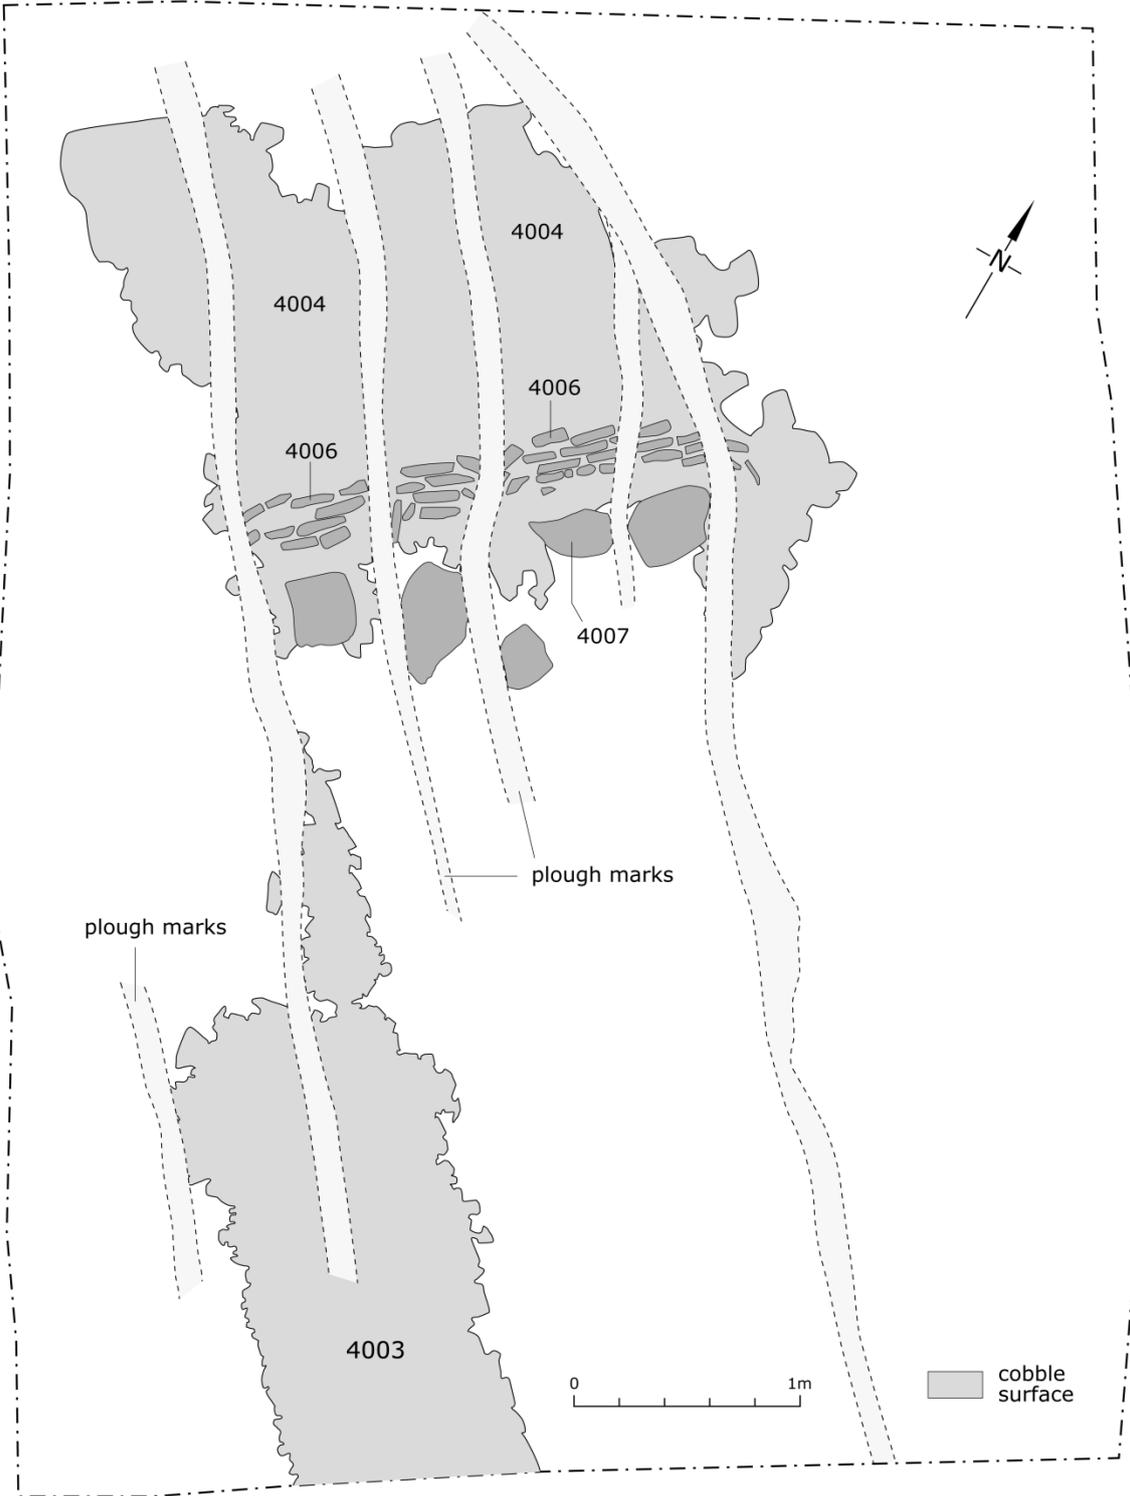
Figure 8

Figure_Llanllyr_8_Plan of Trench 4

The trench was positioned to locate a building shown on the 1768 estate map. Cobbled surfaces of a path (4003) and a track-way (4004) lay directly below a thin plough-soil (Figs 8 and 9). A stone-lined drain ran along the south side of the track-way (4006), to the south of which was a line of large stones. The line of large stones and the straight edge on the east side of the path seemed to indicate the location of a building - the

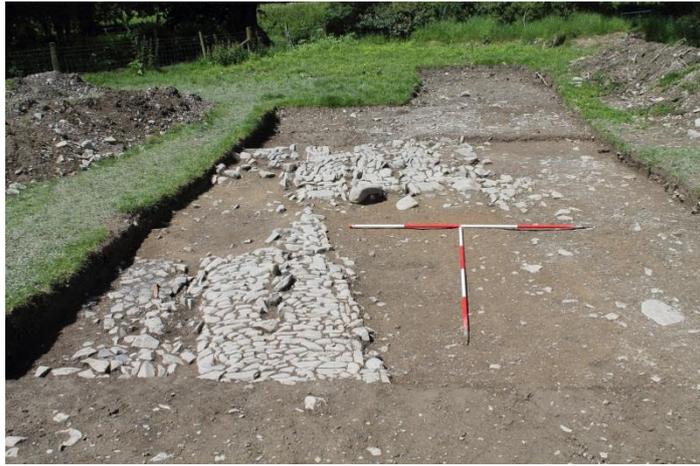
Figure 9

Figure_Llanllyr_9_Photo of Trench 4 looking north-west. Scales 2m.

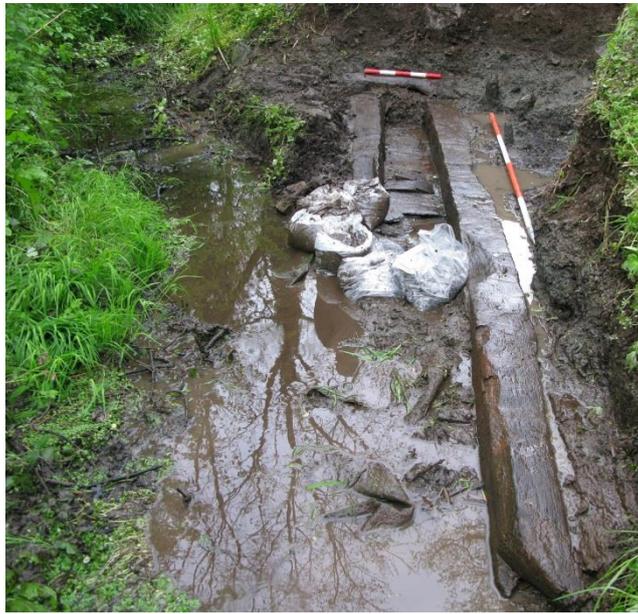
Figure 10.

Figure_Llanllyr_10_The timber drain in woodland after removal of the 'lid' timbers (Photo: R Bale).

During the winter of 2015-16 Trust staff carried out a topographic survey of earthworks in dense, wet woodland south of the excavation trenches. A wooden structure in and alongside the channel of the Afon Llan-llyr had been noted in this area. This structure, possibly a drain, has been investigated by Roderick Bale and Nigel Nayling of UWTSD, and tree-ring dates obtained.

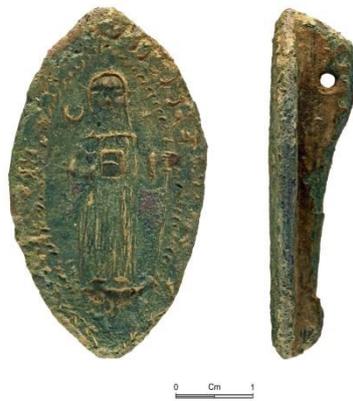
Figure 11.

Figure_Llanllyr_11_ Photograph of the medieval seal matrix (National Museum Wales).

A medieval copper alloy seal matrix of mid-14th to early 15th century date was found by a metal detectorist in a field to the east of the excavation (Figure 11).

The seal is pointed-oval and is complete although the die is eroded (length 46.8mm, width 25.6mm, weight of 18.2g). The rear of the die has a rounded, prominent and undulating midrib (height 11.83mm at the apex and 6.8mm at the base and with a width of 5.1mm). The rib has a circular perforation near the apex (of 2.4mm diameter).

The central device on the die has a standing figure with a crescent to the right of the head (from the viewer's perspective). The figure is clothed in a veil or hood and a monastic cowl. The figure's left hand is in front of his or her abdomen and is holding a book. The right hand is holding a pastoral staff, the crook of which interrupts the surrounding legend. The legend is in open black-letter script but little is now discernible; the only surviving letters are at the end of the legend and may read:

It is a monastic seal, depicting a religious superior holding the rule book of Saint Benedict and a pastoral staff. Few abbots' seals are known to depict a hooded abbot, and despite the absence of a wimple, the seal is more likely to be of an abbess. The end of the legend, if correct may refer to Llanllyr, indicating the seal to have possibly belonged to an abbess of the nunnery at Llanllyr.
