EXCAVATION AT ST PATRICK'S CHAPEL 2014 INTERIM REPORT

Report No. 2014/26

June 2014

EXCAVATION AT ST PATRICK'S CHAPEL 2014: INTERIM REPORT

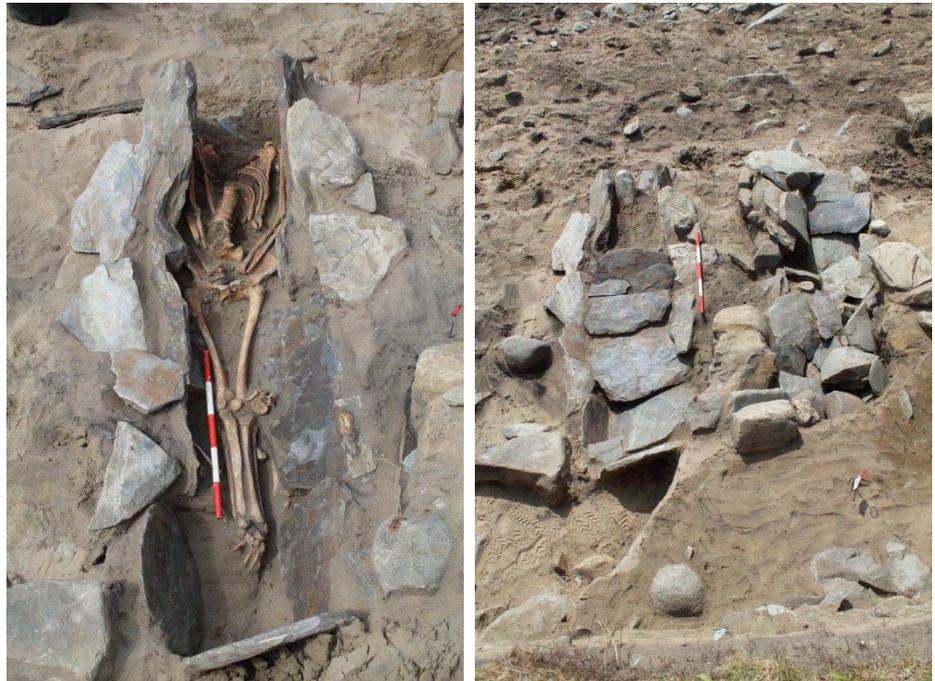
Skeleton 206/Cist grave 21. Cist grave with lintel and side slabs, no base slabs. The east end cut into the top of the wall 42, and some of the cist slabs were probably reused wall material. Directly overlay skeleton 210. Head to west. Supine with hands crossed over pelvis. Good preservation. Adult. A sherd of medieval pottery was found in the fill of this grave, possibly fallen in from overlying deposits.

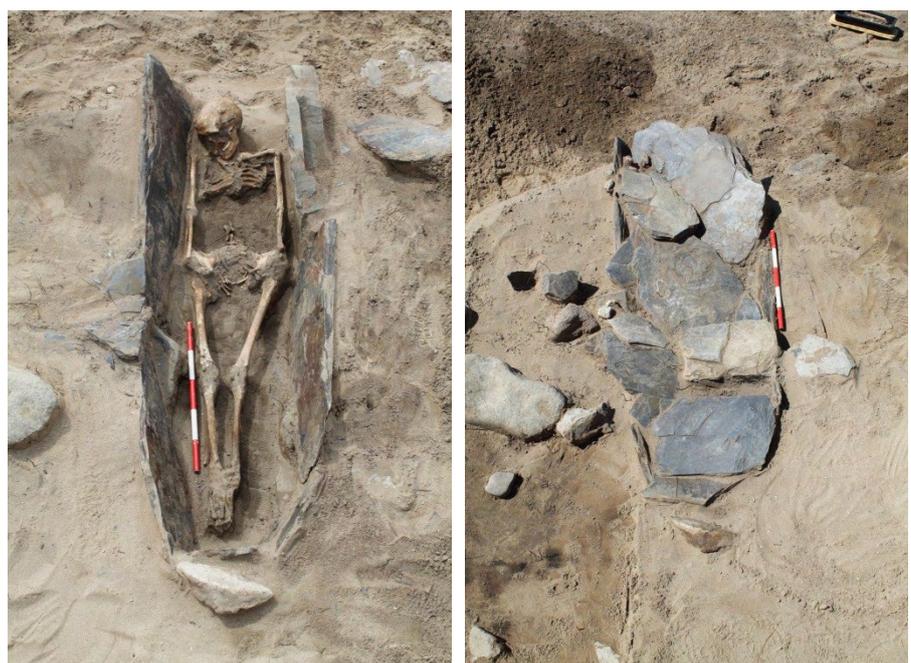
Skeleton 207/Cist grave 23. Cist grave with lintel and side slabs, no base slabs. West end of cist missing due to coastal erosion. Head to west. Supine with hands crossed over pelvis. Fair preservation. Adult.

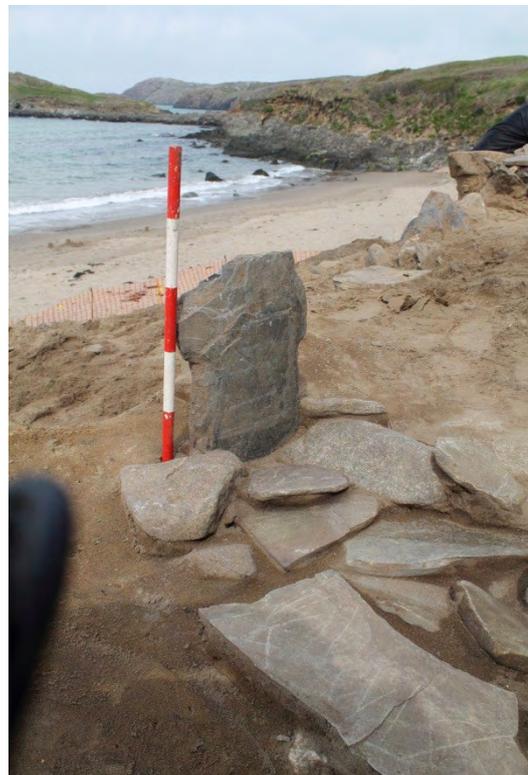
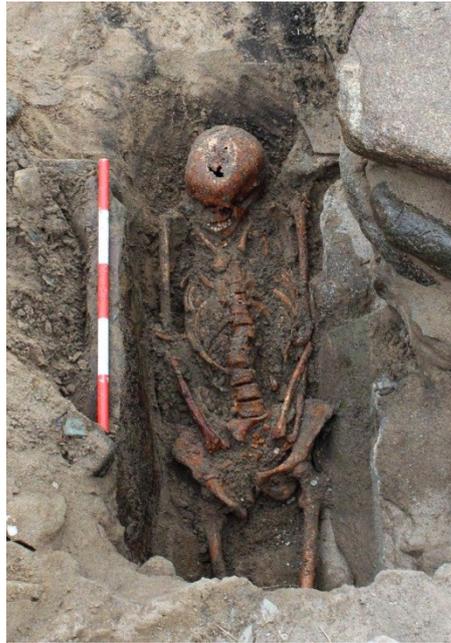
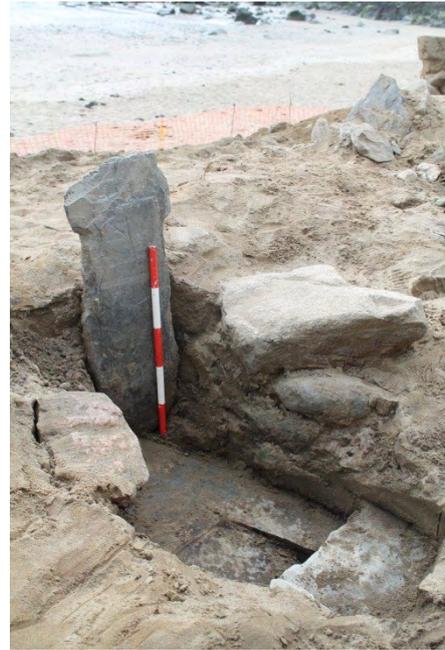
Skeleton 218/Cist grave 26 with grave marker 27 (Find no. 403). Cut through wall 42, and using some of the wall stones as part of the cist. The grave was 0.7m deep, with the cist's lintel slabs 0.3m below the top of the grave cut. No base slabs. E-W aligned with head to the west. Supine with hands crossed over the pelvis. Bone in good condition, but lower legs decayed. Skull slightly damaged and distorted due to pressure from lintel slabs. Adult (late 20s?), female. The east end of the grave lay beneath the edge of the site, **but all the bone was recovered.** The cist's side slabs were left *in situ* at the end of the excavation. A possible copper alloy shroud pin (411) was found amongst the hand bones.

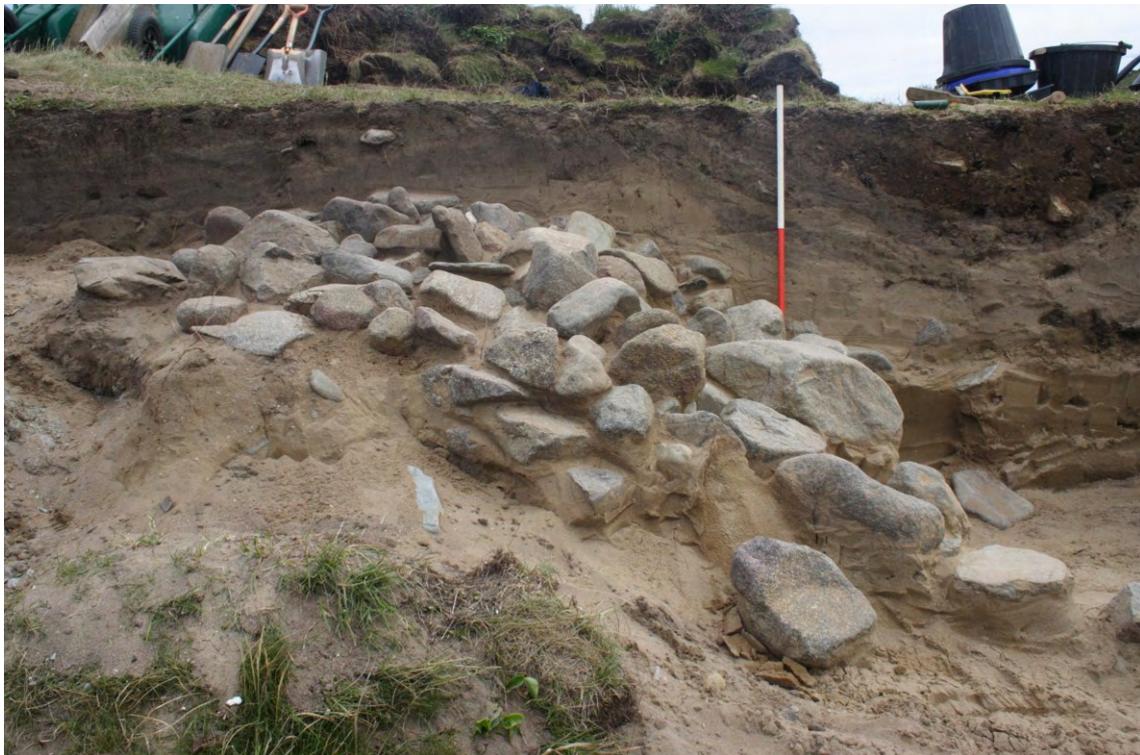
Photograph 6. Stone layer 10 in Trench 1.

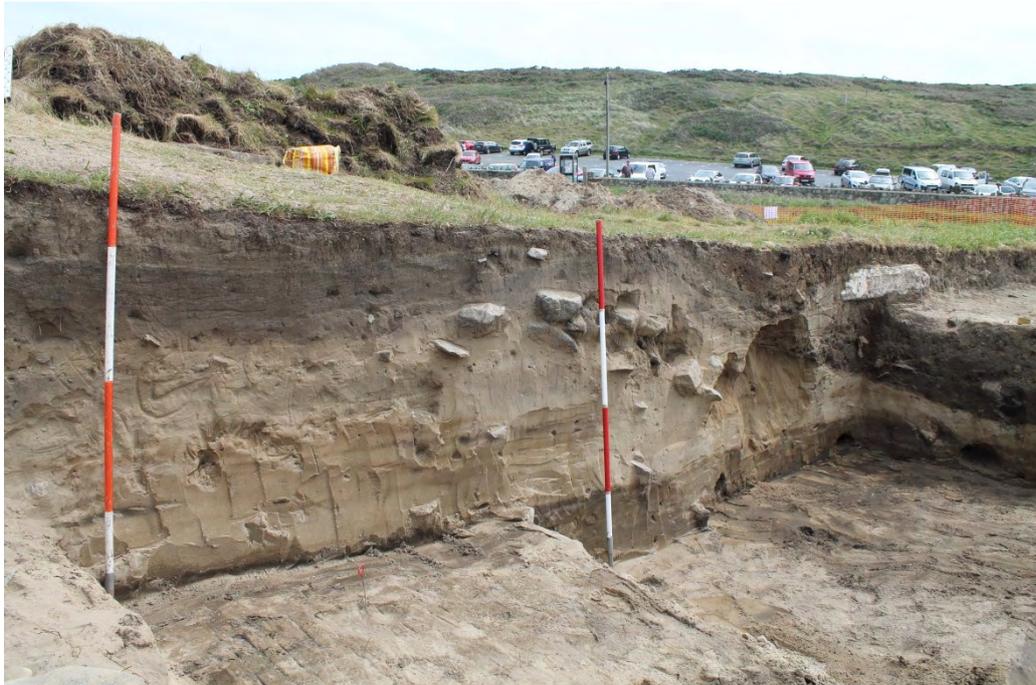
Photograph 9. Photograph of Trench 1 showing the dark soil layer (45) below wind-blown sand.

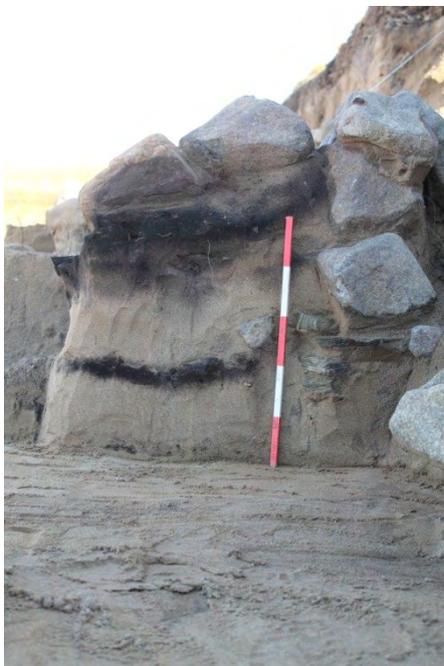
Photograph 11. The face of wall 42 is to the right with wind-blown sand accumulated against it and a dark soil layer 44 at the top of the scale, over which there is tumble from the wall.

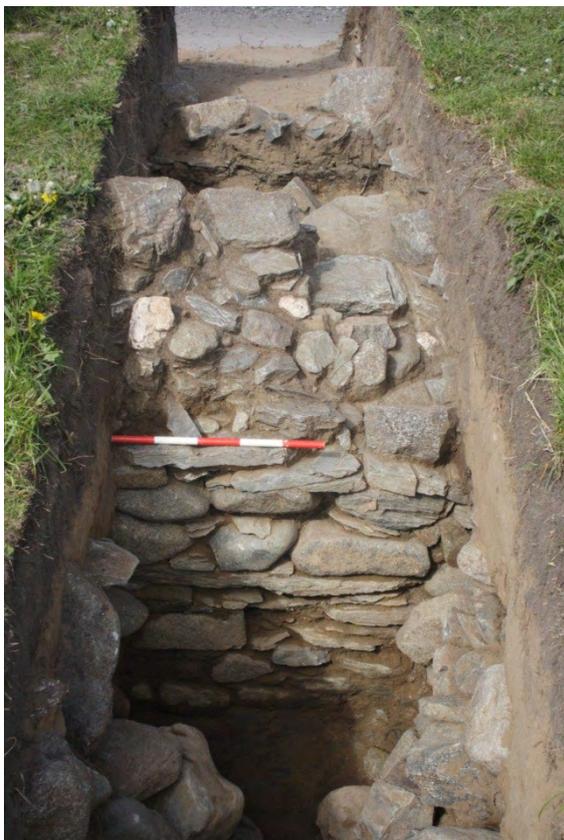
Photograph 15. Wall 9 in Trench 2.

The west wall (9) of the Chapel was 0.74m wide and stood to 1.28m high (Photo. 15). It was constructed from beach boulders and large slabs of quarried slate/shale, with no obvious bonding material. Coursing was random, although some of the slabs formed rough bands. Backfill from the 1924 excavation lay to the east of the wall. To the west lay banded wind-blown sand (13), with at the bottom of the trench at the west end the compacted stony silty-sand layer (19) encountered in Trench 1. Five sherds of medieval/post medieval pottery were found in the banded sand (13), but a clay pigeon and other modern artefacts evidenced disturbance to it.

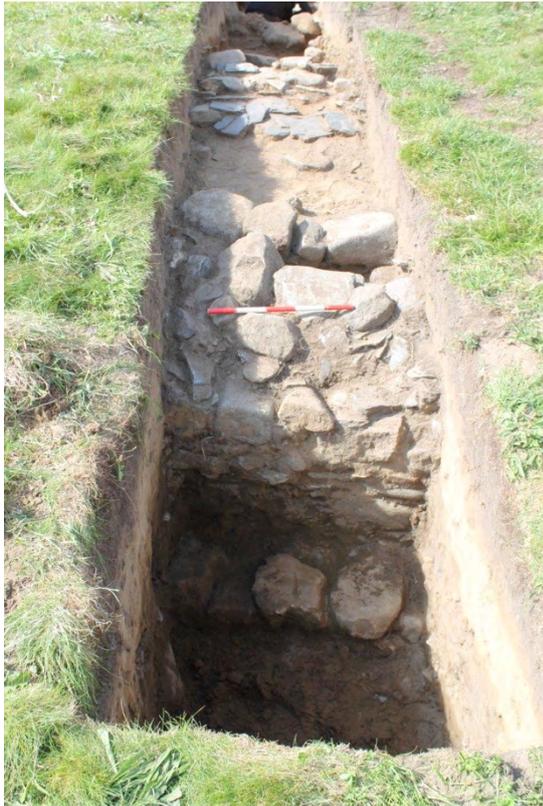
Photograph 16. Wall 17 in Trench 3.

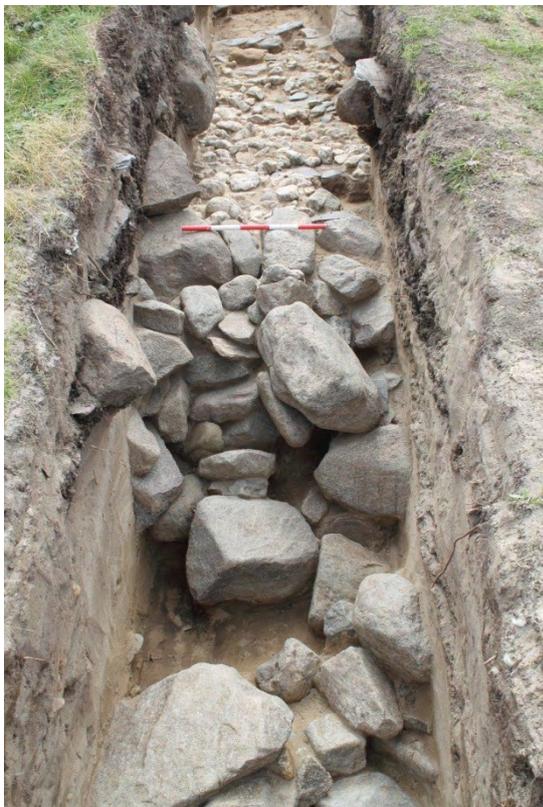
Photograph 17. The revetment wall 15 with the quartz/slate surface 14 beyond.

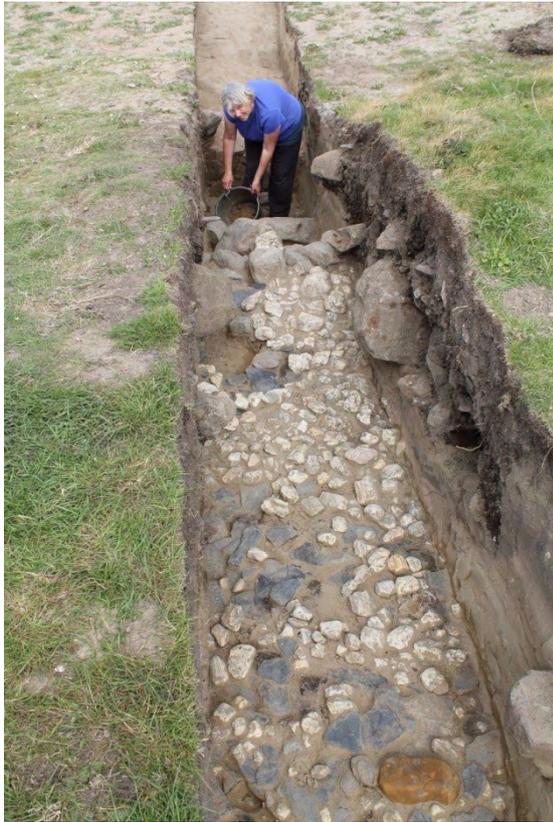
Photograph 18. The quartz/slate surface (14) in Trench 3.

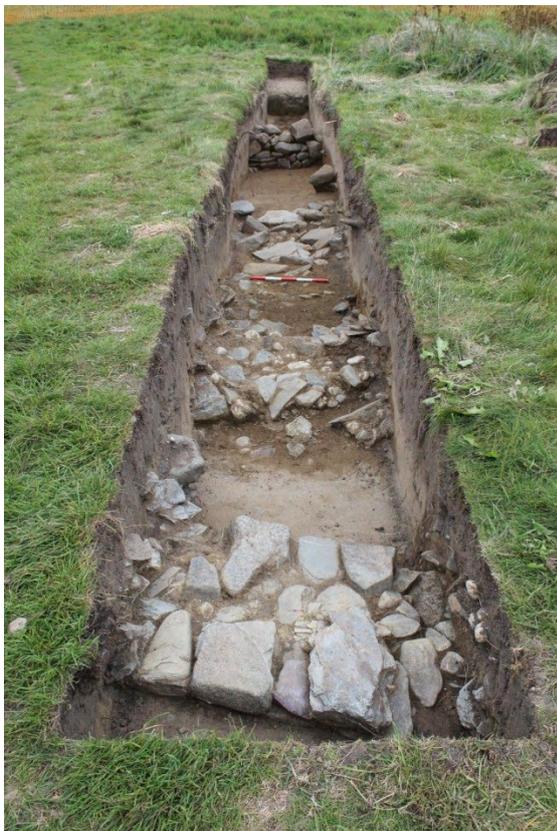
Photograph 19. Trench 4, with the south wall of the Chapel in the foreground, the quartz/stone layer beyond and the dry-stone wall (36) at the far end of the trench.

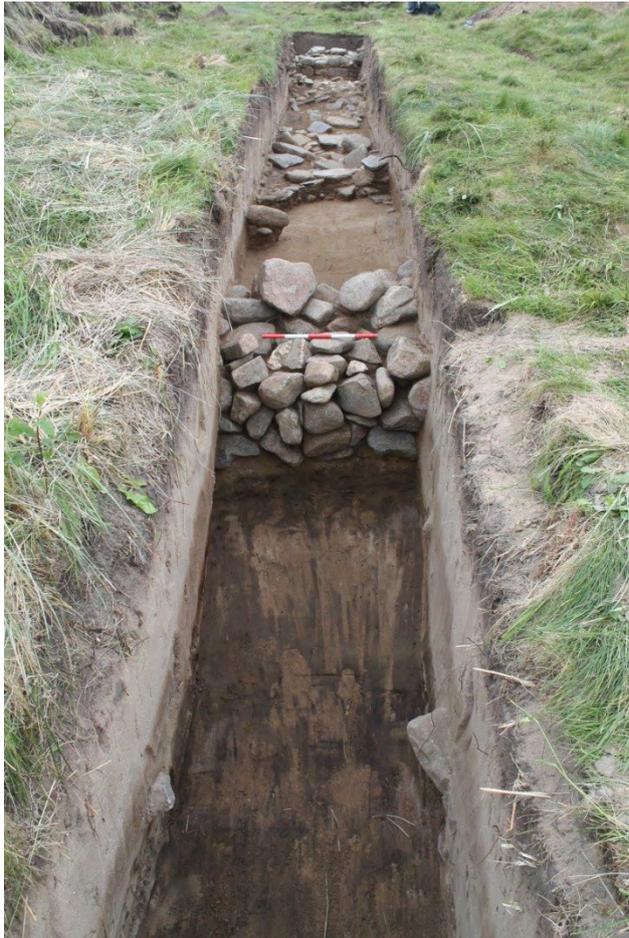
Photograph 20. Trench 4 with dry-stone wall 36 in the foreground.

A dry-stone wall (36 – Photo. 20) constructed from beach boulders lay c. 7.5m from the south wall of the Chapel resting on an old sandy soil (38). A rusty-brown coloured soil had developed against the south side of the wall.

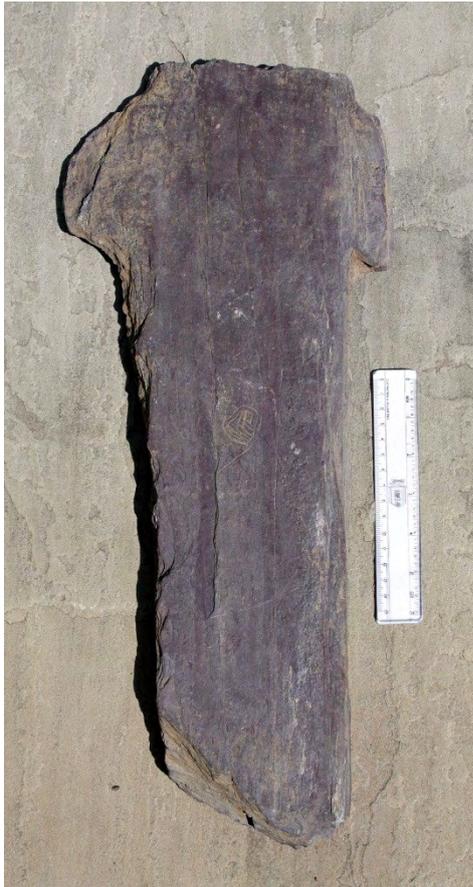
Photograph 23. Cross shaped stone (401) found on the beach below Trench 1.

402. Cross shaped stone, with a lightly incised cross on the face of the stone. A small panel of carved incisions below the cross could be an attempt at knot-work. Purplish coloured ?local slate/shale. 500mm x 210mm x 27mm. Found on the beach immediately below Trench 1 and also certainly eroded from one of the cist excavated cist graves during the winter storms of 2013-14. Photograph 23.

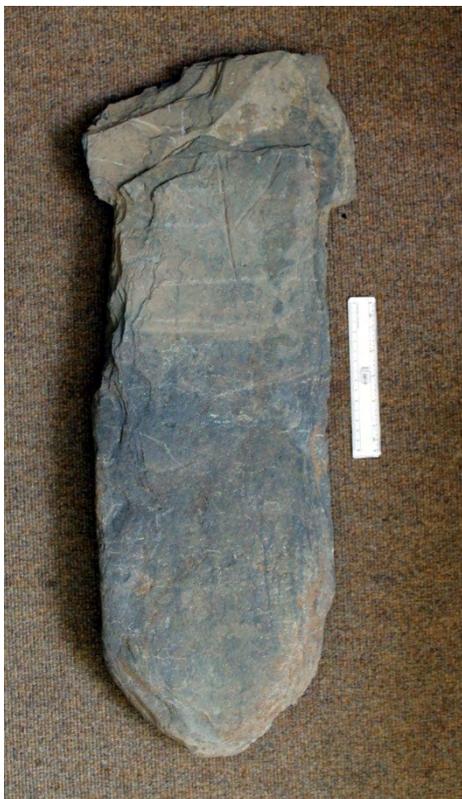
Photograph 24. Cross shaped stone (403) set upright at the west end of cist grave 26.

403. Grave marker. Cross shaped stone with the lower half of a coarse ring-cross incised on the face of the stone. The upper half of the cross is missing as the upper portion of the face of the stone has flaked off at the point where the cross arm was incised. 700mm x 270mm x 45mm. Bluish-grey local slate/shale. Set upright at the head end, west, of cist grave 26. Photograph 24.

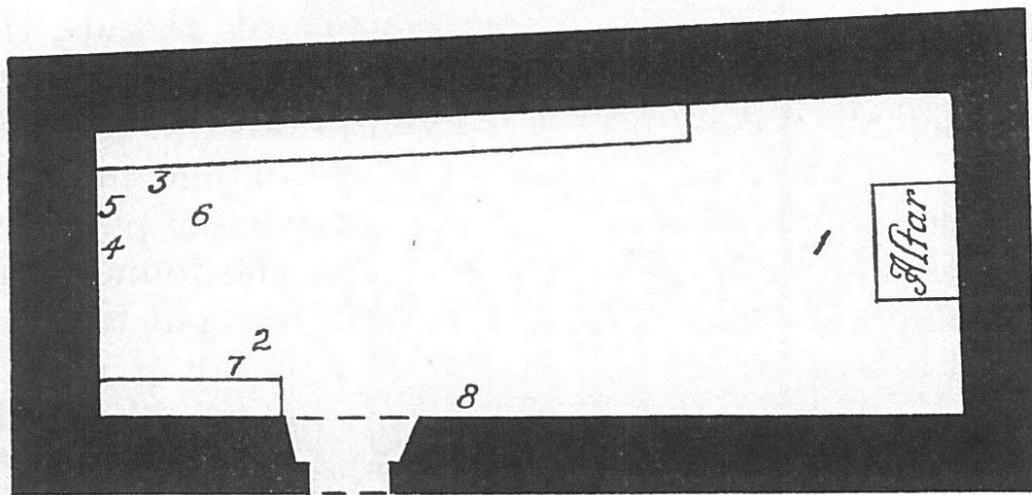
CHAPEL of ST PATRICK
Whitesands Bay, St Davids.

Photograph 25. Plan of the Chapel excavated in 1924. Reproduced from Badger and Green 1925.

Excavation in 1924 revealed the walls of a stone-built chapel, internally approximately 9m E-W and 3.3m N-S (Badger and Green 1925). Several well-preserved burials were found inside the chapel. No excavation took place outside the chapel walls. Although no dating evidence was recovered in 1924, the date of the stone-built chapel is probably later medieval. Photograph 25 is a reproduction of the plan of the Chapel from the 1925 publication.
