Hafod Flower Garden 'Mariamne's Garden', Hafod Estate Ceredigion Archaeological Evaluation

RHIF YR ADRODDIAD / REPORT NO. 2007/86
RHIF Y PROSIECT / PROJECT RECORD NO. 63302

Hydref 2007
October 2007

Hafod Flower Garden 'Mariamne's Garden', Hafod Estate Ceredigion
Archaeological Evaluation

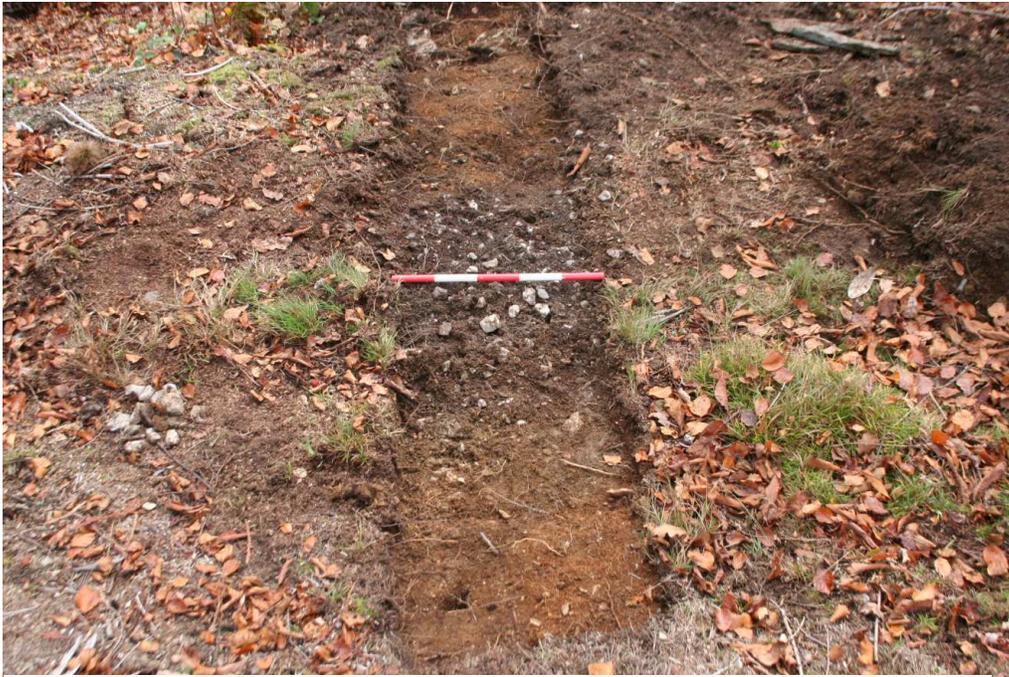
The path measured c.0.65-0.7m wide and was located to the northern end of the terrace running east-west. The path surface was made up of loosely laid angular quartz stones, with an average size of 50mm x 30mm x 30mm, simply laid on to the loose silty subsoil. The stones were not removed but the stone band appeared to be only one or two stones thick. The southern (downslope) edge of the terrace has clearly eroded and slipped downslope, and it is likely that the path was originally wider on this side.

Around 0.7m to the south and further downslope from the path and terrace several loosely laid flat stones were revealed. These stones measured on average 200mm x 100mm x 50mm, and appear to be the remains of a coarse revetment wall that has clearly slipped downslope over time. Remnants of this revetment wall are still visible further west along the lower edge of the terrace.

Plate 1: South-east facing shot of Trench 1. 1 x 0.5m scale

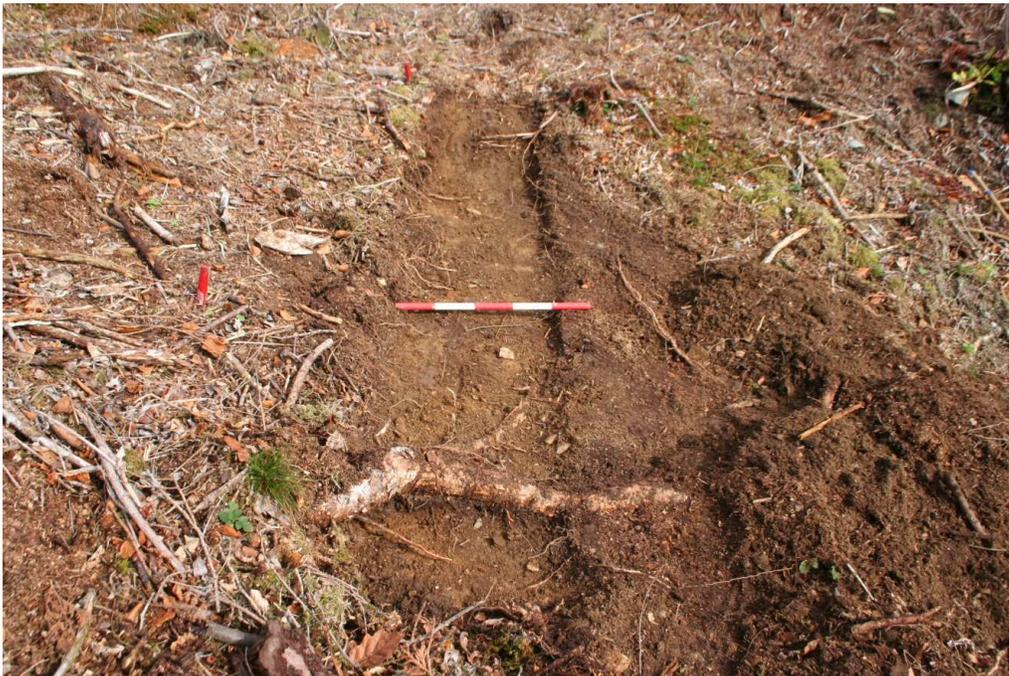
The trench measured 2.1m by 0.5m and was aligned north-south across the sloping ground. Between 0.05 and 0.1m of turf and leaf mould were removed overlying the subsoil, but no trace of a pathway was revealed. The lack of any quartz stones within the trench and the immediate area suggests that there may have been no formal surfacing to the path, or that it has completely eroded due to the nature of the sloping ground in this area.

Plate 2: North-east facing shot of Trench 2. 1 x 0.5m scale.

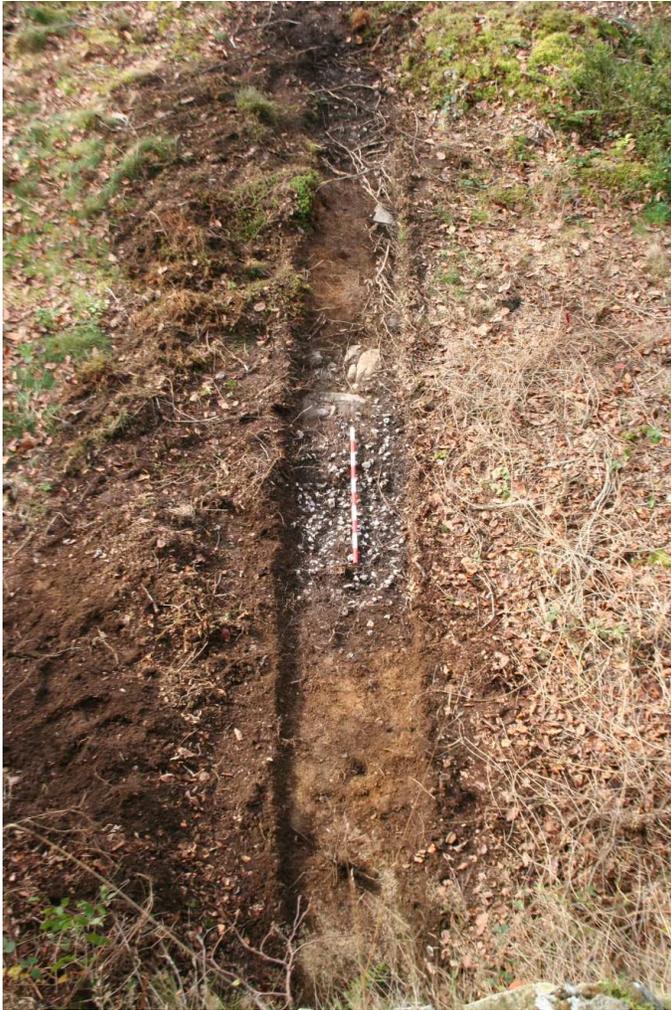
The central pathway measured at most 2.04m across and it was located approximately 2.38m to the southwest of the rock face to the northeast. The path surface was made up of loosely laid angular quartz stones, with an average size of 50mm x 30mm x 30mm, simply laid on to the loose silty subsoil, the same as the path revealed in Trench 1. The southwestern edge of the quartz-stone path was intermingled with an area of large flat loosely laid stones. These stones vary from 150mm x 80mm x 30mm up to 400mm x 200mm x 30mm, and appear to form part of a surface rather than a collapsed revetment wall. The edges of the path appear slightly splayed, being wider to the northwest than the southeast. The greater width of the pathway in this area may indicate this was indeed where pathways converged.

Approximately 1.4m further to the southwest the edge of a second path was revealed. This path was also made up of loosely laid angular quartz stones, with an average size of 50mm x 30mm x 30mm, simply laid on to the loose silty subsoil. The revealed edge of this path was disturbed by root action but it appeared to be curving, suggesting the path continued to run in a more southwesterly direction out onto a rocky outcrop where it meets with another path running towards some rock-cut steps taking the pathway down onto a lower terrace (a path marked on the 1:2500 Ordnance Survey map). The curve also suggested the path may have followed the contours to meet with the path visible within Trench 1.

Plate 3 (left): South-west facing shot of Trench 3. 1 x 1m scale.

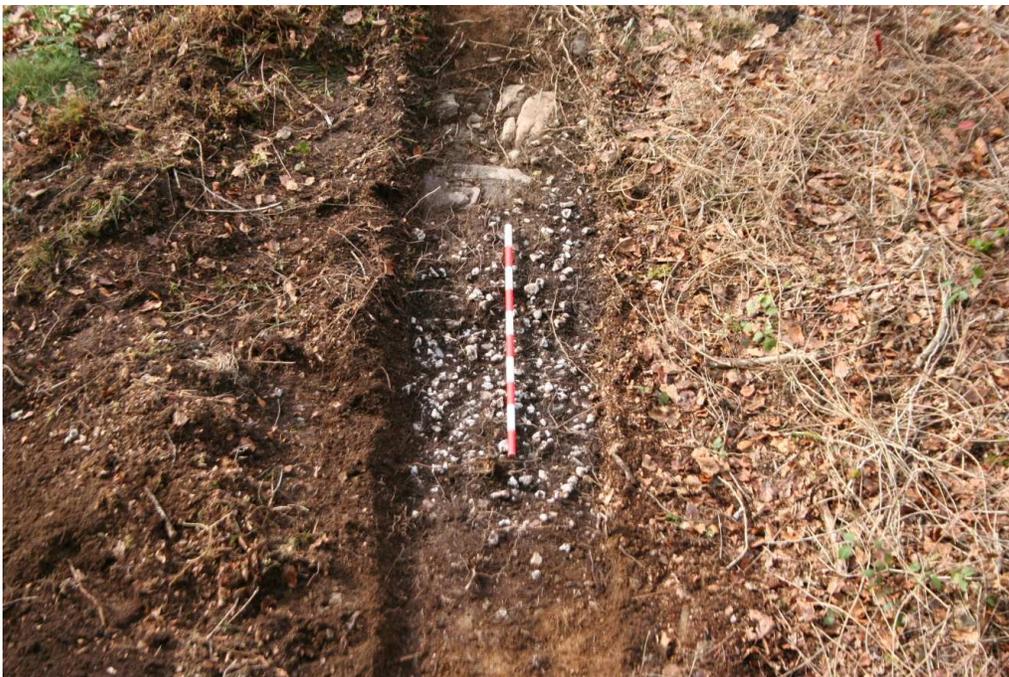
Plate 4 (below): Close-up of central pathway.

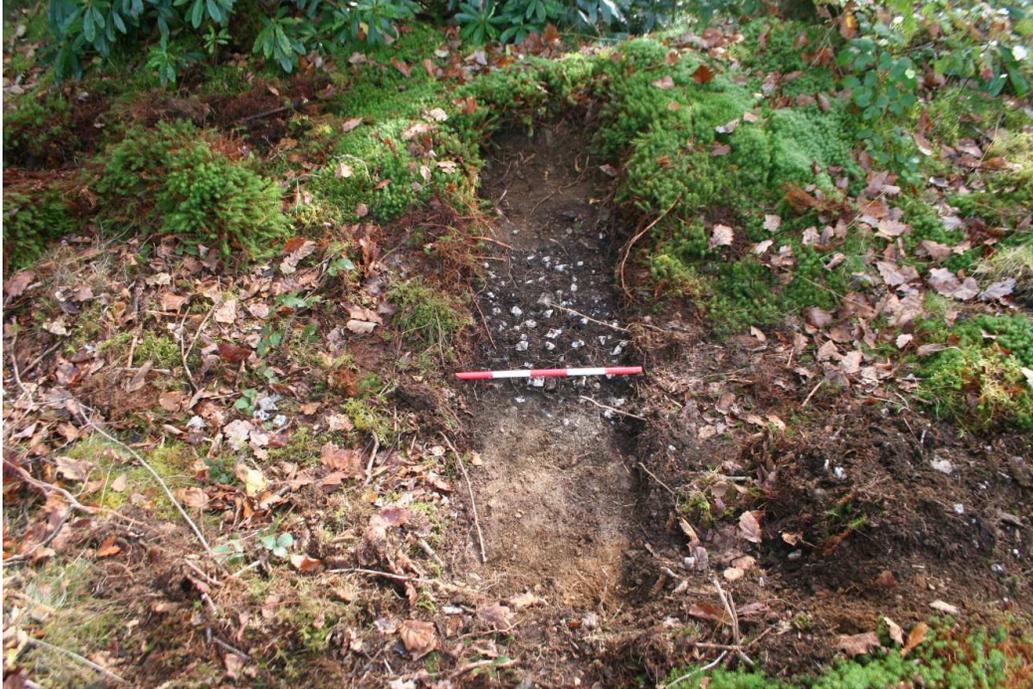
The path measured c.0.8m wide, running in a roughly northeast – southwest direction. As with all the other revealed paths this was also made up of loosely laid angular quartz stones, with an average size of 50mm x 30mm x 30mm, simply laid on to the loose silty subsoil.

Plate 5: South-east facing shot of Trench 4. 1 x 0.5m scale.

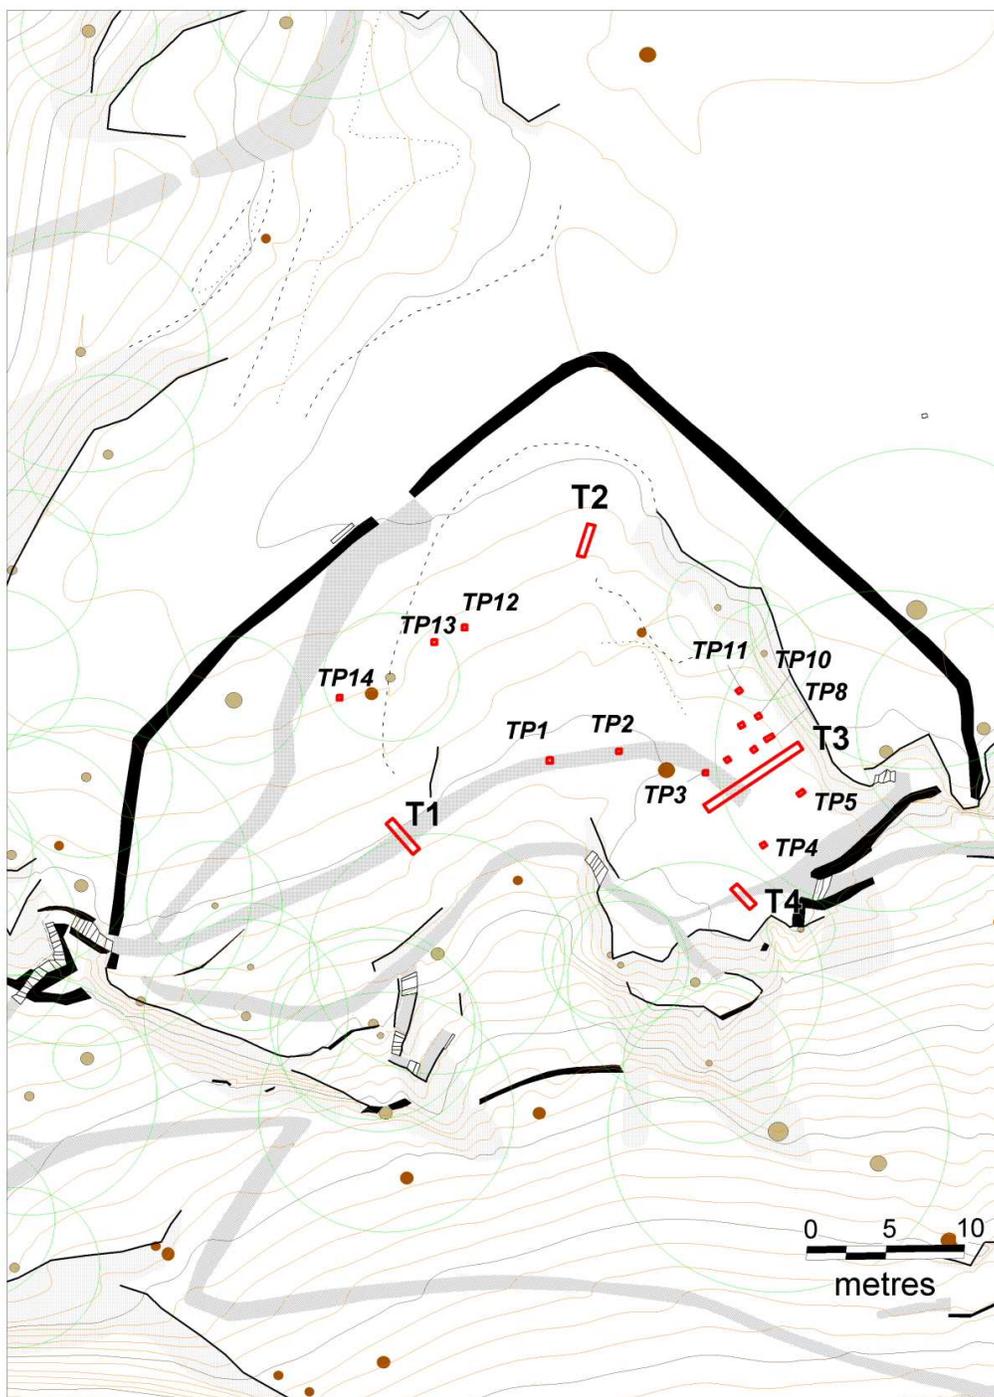
For the locations of the excavation trenches see Figure 2.

Figure 2: Location of Trenches and Test Pits (in red), overlaid on previous survey results.

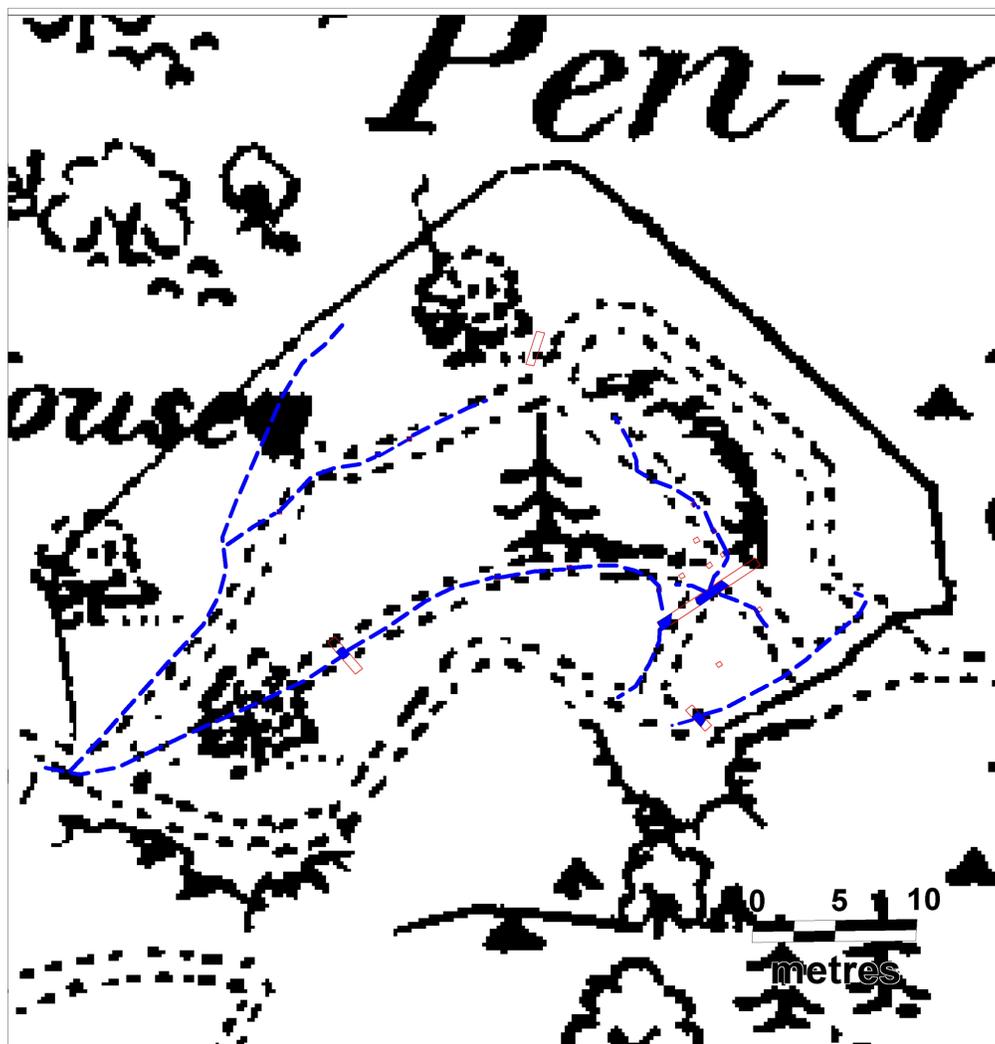
The trenches and test pits allowed the lines of many of the pathways to be established. Many of these paths correspond to the general routes shown on the 1:2500 1st edition Ordnance Survey map of 1888. However, excavation has revealed in greater detail the arrangement of the paths as they converge around the area of Trench 3, and excavations also show no evidence of a constructed pathway connecting the viewpoint/seat with the upper path as shown on the 1st edition Ordnance Survey map, although evidence of this may have been eroded away.

Figure 3: Copy of the OS 1:2500 1888, showing paths surveyed at that date. Overlaid on it are the position of trenches and pits, with blue dotted lines showing the path alignments confirmed by excavation.
