# AN APPLE STORE AT TYPICCA FARM, DRYSLWYN

## STANDING BUILDING SURVEY APRIL 2009

Report No. 2009/52

### AN APPLE STORE AT TY PICCA FARM, DRYSLWYN STANDING BUILDING SURVEY

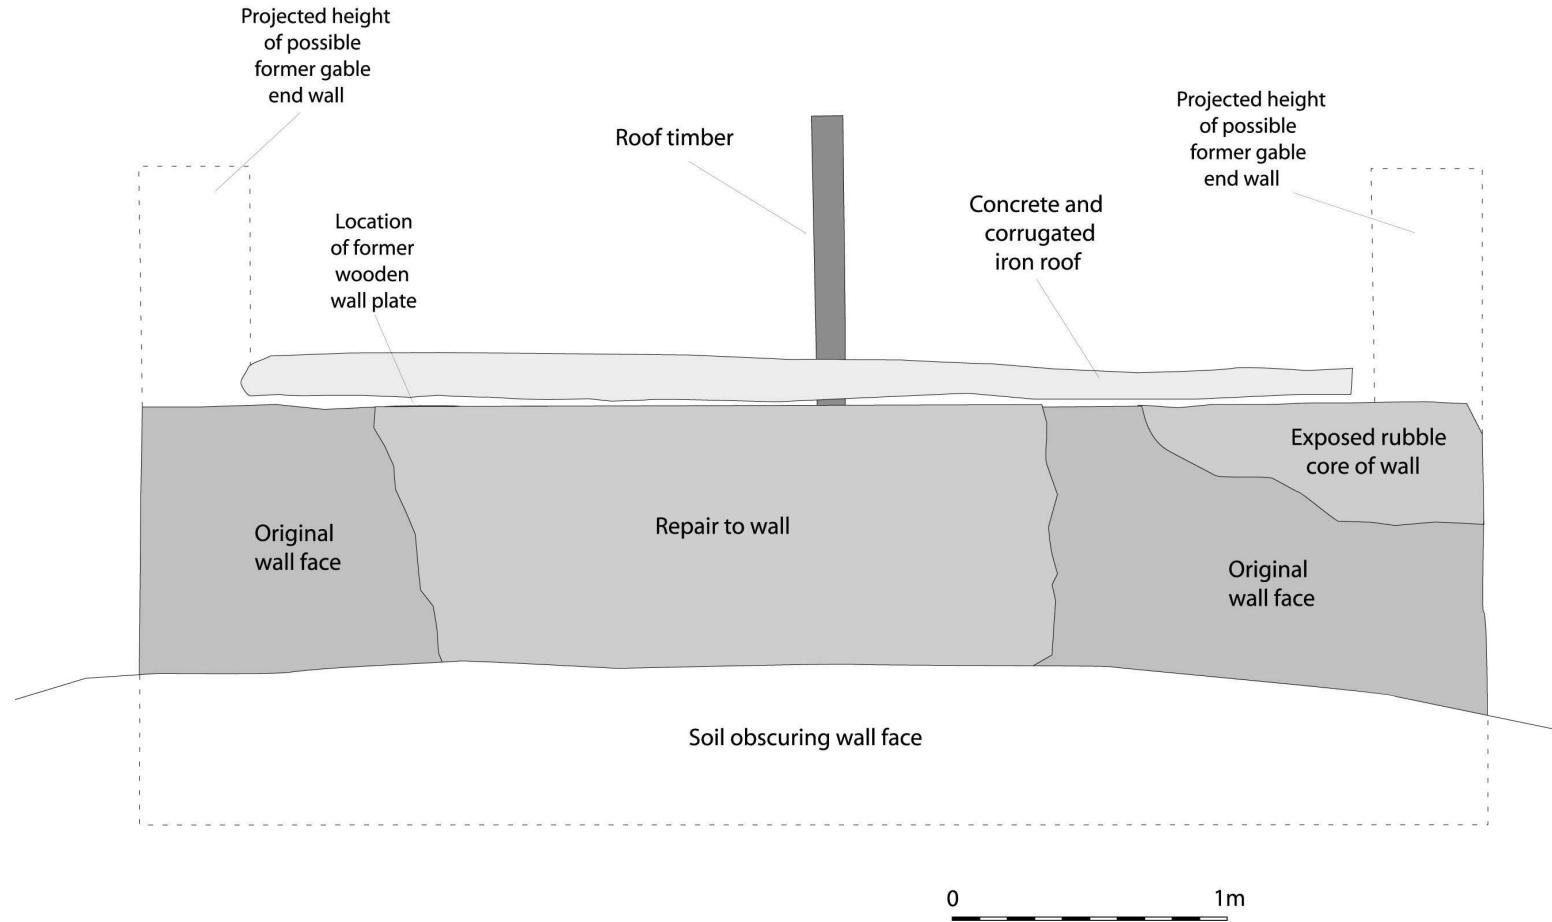
**Figure 4:** South facing elevation

The building has experienced mixed fortunes having seemingly been the subject of substantive repairs on at least two occasions. There is evidence that the southern wall has been substantially rebuilt. These works would also have necessitated the removal and reinstatement of the roof. The inclusion of brick in the repaired wall section suggests that this happened in the later 19<sup>th</sup>/ early 20<sup>th</sup> century.

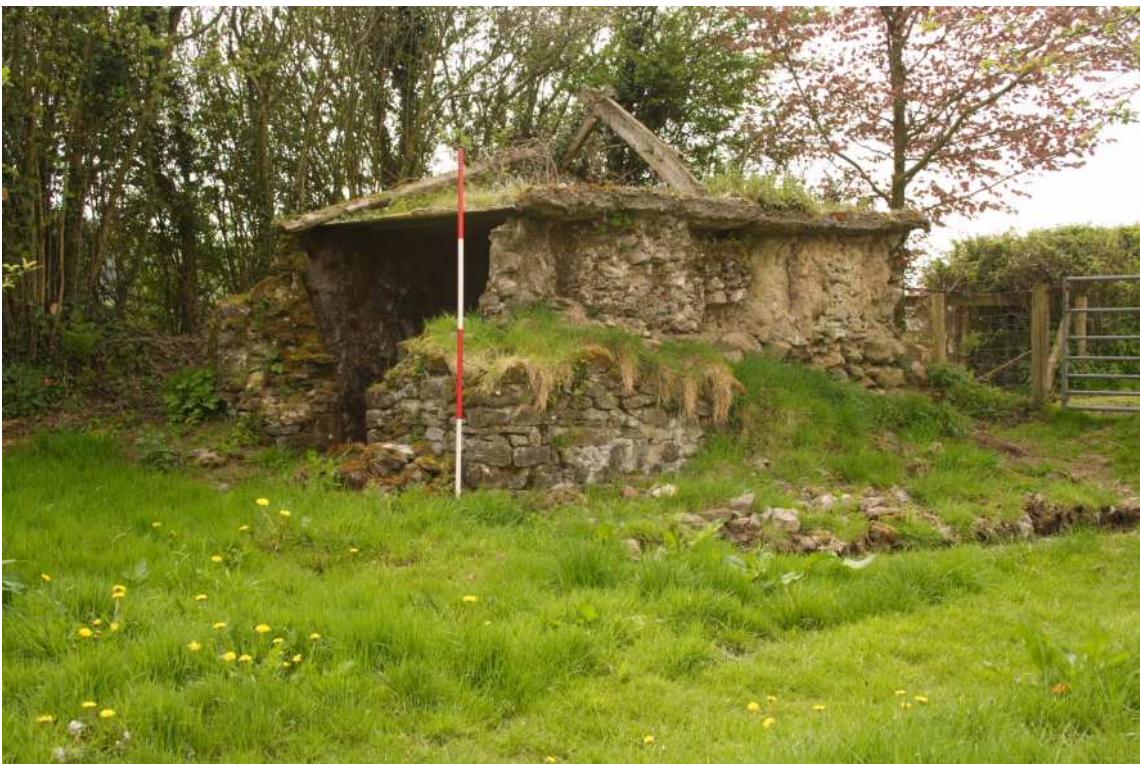
**Photo 1:** General view

The apple store is a traditional small vernacular building constructed from clom or earth walling on a low stone base. The building is situated in the corner of an historic orchard some 70 metres to the west of the farmhouse and farm buildings. The fabric of the building has undergone considerable repair and rebuilding during its lifetime. At the time of the recording it had been abandoned and was falling into disrepair.
